1. FACTUAL INFORMATION

On 23 February 2008, a SIKORSKY S-61N helicopter, registration EC-FVO, based at the A Coruña Airport as the "Helimer Galicia", was dispatched at 20:14 to take part in the search for a body that had been sighted floating in the vicinity of the south part of the Playa de San Jorge (San Jorge Beach, Ferrol, A Coruña).

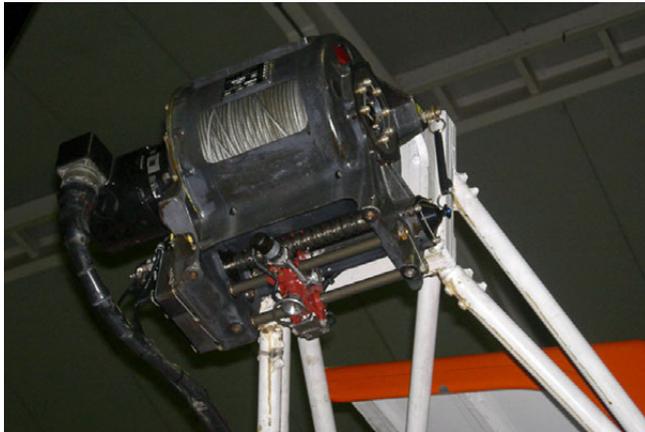
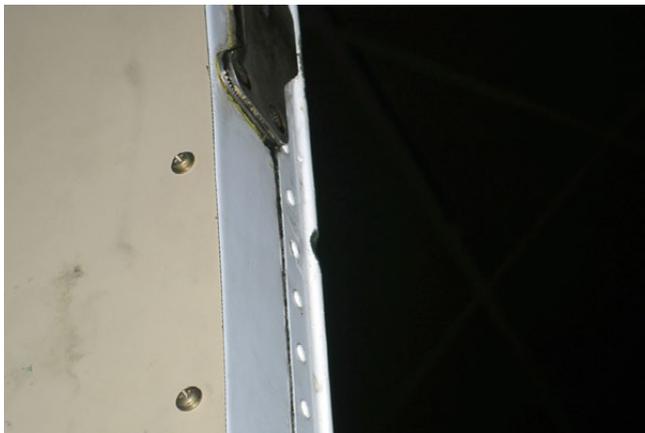
The only evidence found of any relevance to the incident was the broken cable on the external hoist installed over the cargo door on the right side of the helicopter, and scratch marks and other imprints on the edges of the hinged door, some of which could have been produced by rubbing with the hoist cable.

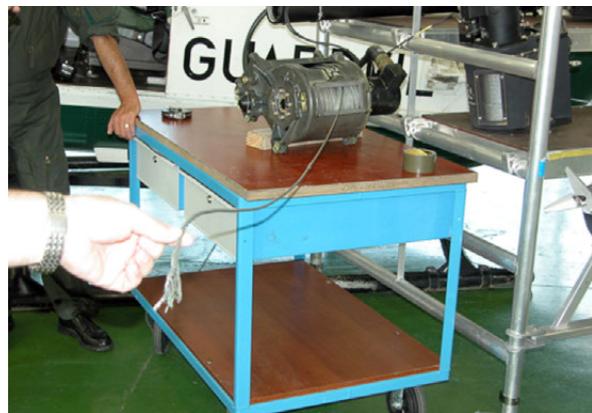
Photograph 5

- All of the hoist's documentation was in order.
- The hoist was in good condition and working as specified in the applicable documentation.
- Based on the documentation supplied by the operator, its procedures specify a hover height above water of 70 ft when lifting people with the hoist. Since the approximate length of cable lost in the incident exceeded this length, it is very likely that the cable broke at the cable entry guide to the hoist.

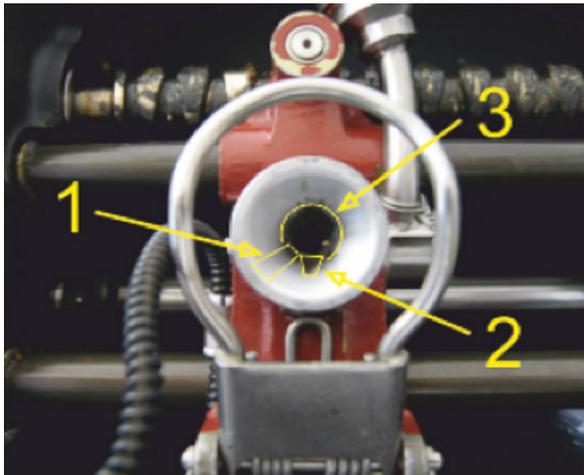
Photograph 7

- The marks shown in Photograph no. 6 were found on the surface of the cable entry guide to the hoist. It was determined that:
 - The n.º 1 mark, which was fairly deep, was produced by friction-compression with the cable over tensioned and at an angle in excess of 20° from the vertical.

- The n.º 2 mark was typical of the friction that results when people are raised into the helicopter.
 - The n.º 3 marks correspond to normal swinging of the cable within the allowed 20° angle.

As regards the hoist, the studies described in 1.5.3 determined that it was in good condition and working as expected based on the contents of the applicable documentation. Said studies also determined that the cable very likely broke at the cable entry guide to the hoist, where a fairly deep mark, labeled n.º 1 on photograph n.º 7,

was found that had been caused by friction-compression with the cable over tensioned and at an angle in excess of 20° from the vertical. This indicates that the cable entry guide to the hoist was the component that was supporting the hoist cable when it broke.

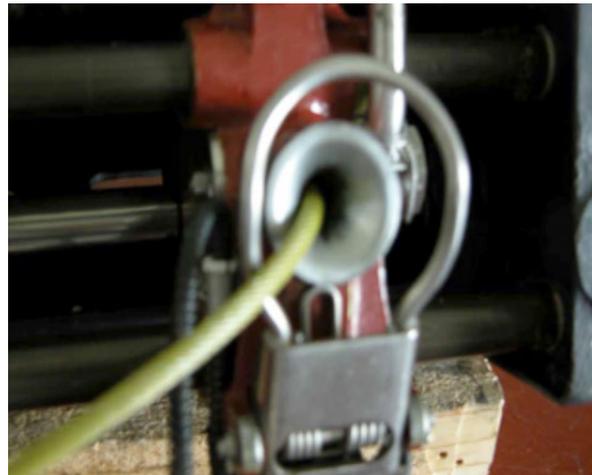
Photograph 7

- Photograph n.º 7 simulates the cable position necessary to produce mark n.º 1, which is considerably in excess of the allowed 20° angle.
- Lacking the results of the metallographic analysis of the cable, it is believed that the cable very likely broke as a consequence of operating the hoist outside its limits of operation.

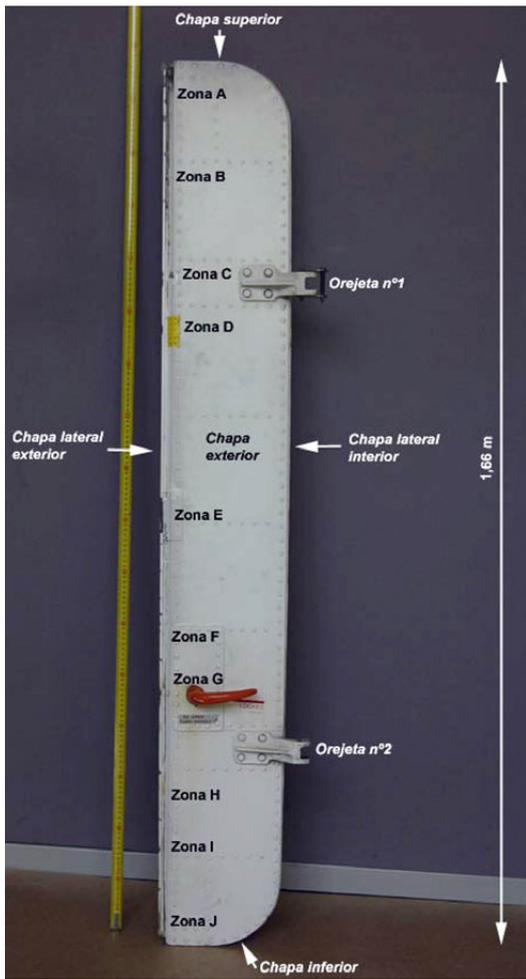
Photograph 8

There is no general deformation of the hinged portion of the helicopter door. In general, most of the damage noted on the structure corresponded to friction marks and imprints on the cylindrical rod located between the outer sheet metal and the outer sheet metal

on the side of the fuselage, and are associated to most of this rod zones, showing chipped white paint. Photograph n.º 8 shows the different sections considered in the analysis of this component.

Also of note are the two areas adjacent to the two locks on this part of the door, located on its side (zones C and G in photograph n.º 8), and which show friction marks on both the outer metal and on the cylindrical rod. These marks line up with certain friction marks found on the strike plates on the locks (see photograph n.º 10), which seems to indicate that these marks could be due to relative motion between these areas and a single element located on the other component of the helicopter door.

An analysis conducted at INTA of the damage exhibited by this component, the findings from which are shown in 1.5.4, lists three areas, C, D and G in photograph n.º 8, where these marks were significant.

Said analysis concluded that the damage present in areas C and G in photograph n.º 8, next to the strike plates on the hinged part of the door, had characteristics that indicated they had probably been produced by the relative motion between these areas and a single component located on the other component on the helicopter door. This indicates that the damage had, in all likelihood, resulted from friction between the sliding component and the hinged component of the door during normal opening and closing operations of the cargo door.

The most significant mark found was an imprint located on the cylindrical rod in area D of photograph n.º 8. Its nature appears to indicate that it was produced under local loading that was practically perpendicular to the outer sheet metal on the side of the fuselage. As with the marks mentioned in the preceding paragraph, these characteristics are believed to indicate possible interference with the sliding component of the cargo door. In any case, they do not correspond to the marks that would have been made had there been any interference with the hoist cable.

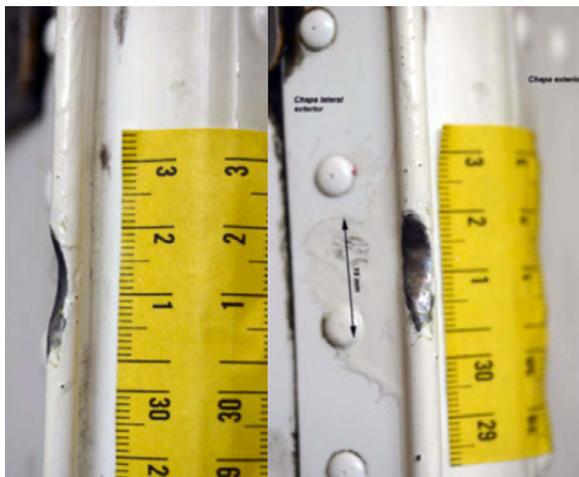
Photograph 9

The most significant imprint mark is on the cylindrical rod in zone D of Photograph no. 8, where the deformed surface, a close-up of which is shown in photograph n.º 9, exhibits a very bright texture without practically any directional markings. The nature of this mark seems to indicate that it was produced under local loading that was practically perpendicular to the outer sheet metal on the side of the fuselage.
