**DATA SUMMARY**

Date and time	<b>Wednesday, 5 March 2008; 08:25 local time<sup>1</sup></b>
Site	<b>Yaiza (Island of Lanzarote)</b>

Registration	<b>EC-FJV</b>
Type and model	<b>AEROSPATIALE AS-350B2</b>
Operator	<b>Helicópteros Insulares, S. L.</b>

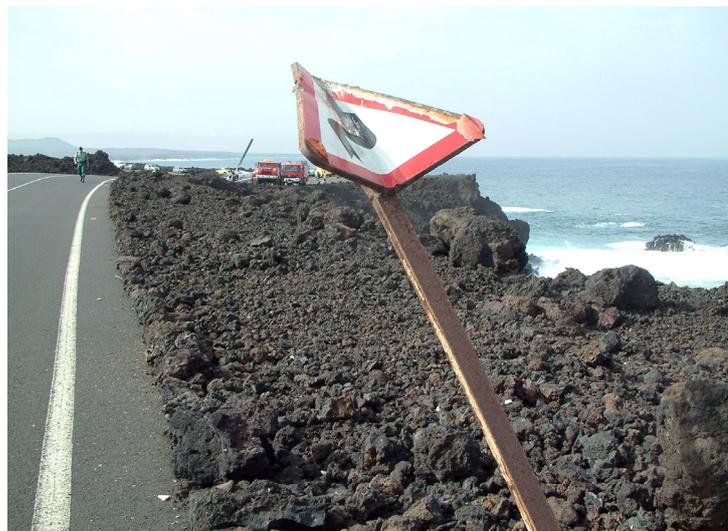
Figure 2. Traffic sign with the helicopter in the background

The initial impact was between the tail rotor and a traffic sign warning of dangerous curves (Figure 2). The triangular part of the sign was bent practically from top to bottom, and was perforated in the center. The signpost was bent at its base at a 60° angle from the vertical and in the direction of the aircraft's flight, and slightly toward the road.

The impact of the tail rotor with the traffic sign caused the signpost to bend, pivoting about its base, such that the top part of the sign bent back and down enough so as not to be impacted by the second blade. This hypothesis is consistent with the condition of the sign after the accident, as it was bent at a 60° angle from the vertical.

In addition, the orientation of the crease, practically vertical, as well as the angle of the signpost provide some idea of the aircraft's direction of motion: following the direction of the road. This same conclusion is reached upon observing the location of the aircraft wreckage. Likewise, from the distance between the wreckage, and in particular the tail rotor, and the sign, it can be deduced that when the first impact took place, the aircraft's horizontal speed was significant. The fact that no part of the helicopter impacted the ground during the first impact is indicative of an essentially zero descent rate.

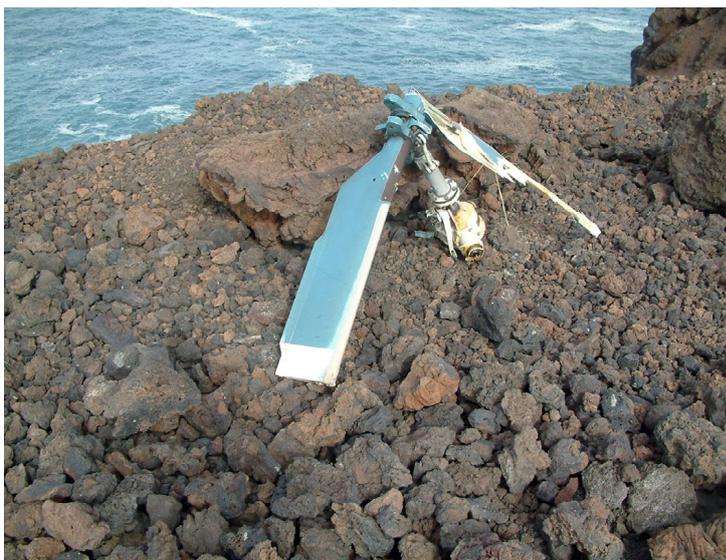
Figure 3. Anti-torque rotor

The tail rotor was found fifty meters further away, in the aircraft's direction of motion and to the right of the road. It had detached due to the breakage of the tail gearbox fittings, the drive shaft and the pitch control linkage. Of the two tail rotor blades, one was practically undamaged while the other one had broken near the root.
