DATA SUMMARY

Date and time	Monday, 23 June 2008; 13:20 h¹
Site	4.5 km west of the Madrid-Cuatro Vientos Airport

Registration	EC-GCX
Type and model	CESSNA 177 RG "Cardinal"
Operator	Private

REPORT

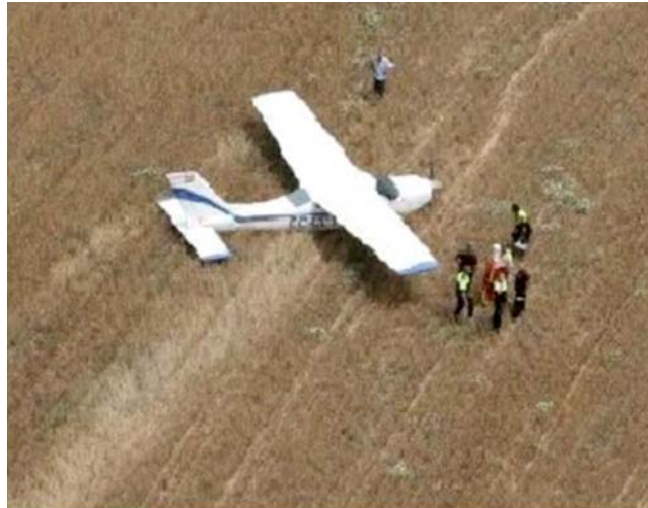
Figure 2. Aircraft after landing

The aircraft did not exhibit any significant damage apart from those in the inferior part of the fuselage, produced during the landing run on the ground.

The lower part of the fuselage was also saturated with engine oil.

As for the power plant, the forward crankshaft retainer on the engine was out of its housing and shifted forward. There was also a hole in the top part of the crankcase near the no. 4 cylinder. The propeller showed signs of having impacted the ground with no applied power. The blade tips were bent backward and there were noticeable scratch marks parallel to the width of the blades.

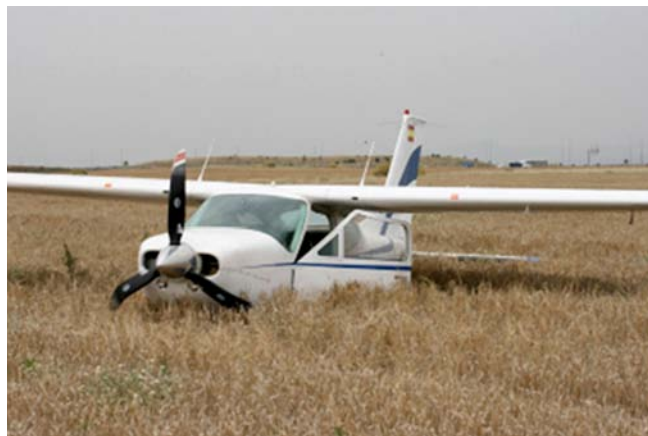
Figure 3. Aircraft on the ground

The assembly was removed from the group without any difficulty once the blades, whose tips were scratched and bent backwards (see Fig. 3) were confirmed to be in the lower pitch position. The damage to the blades showed that the aircraft had contacted the ground without thrust and at low rpm's.

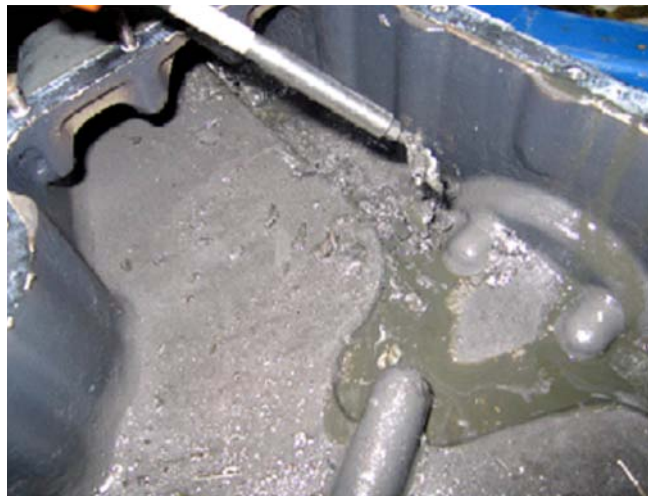
When the engine was disassembled, a large amount of metallic, both magnetic and non-magnetic, shavings were found in the lower crankcase (Fig. 4) and greasing ports, and especially in the filter mesh at the suction to the engine oil pump. When the inside of this pump was inspected, its components were found to be in good condition, with only minor wear caused by friction between the gear teeth and the housing. The pump did not show any signs of having been run without oil.

Figure 4. Metal particles and shavings in the crankcase

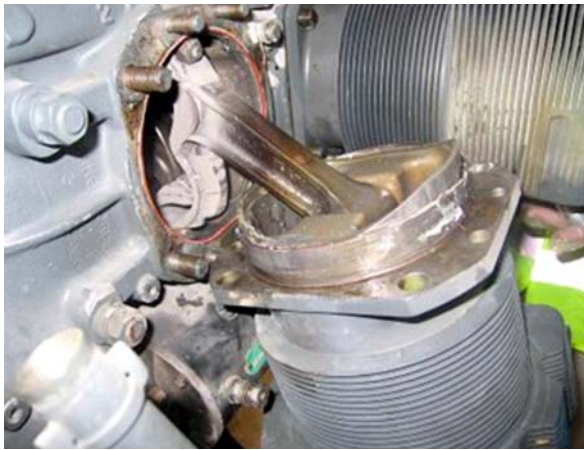
The cylinders were then disassembled from the main crankcase. The connecting rods on the nos. 2, 3 and 4 cylinders had detached from the crankshaft and showed signs of severe overheating, as evidenced by the flow of material in a longitudinal direction, especially in the no. 2 cylinder (Fig. 5). Some of the crankshaft bearings had also fractured and exited the race, causing scorching of the journal (Fig. 6). The damage to the main components increased with their distance from the oil pump. The no. 1 cylinder connecting rod remained attached to the crankshaft and its bearings; though they also showed signs of a lack of grease, they were not scorched.

Figure 5. No. 2, cylinder, partly disassembled, showing broken connecting rod

In summary, the damage found was consistent with an engine operated at high rpm's, possibly above the overspeed limit, in combination with a loss of oil that impeded its proper lubrication and resulted in excessive heating of the engine's moving parts.

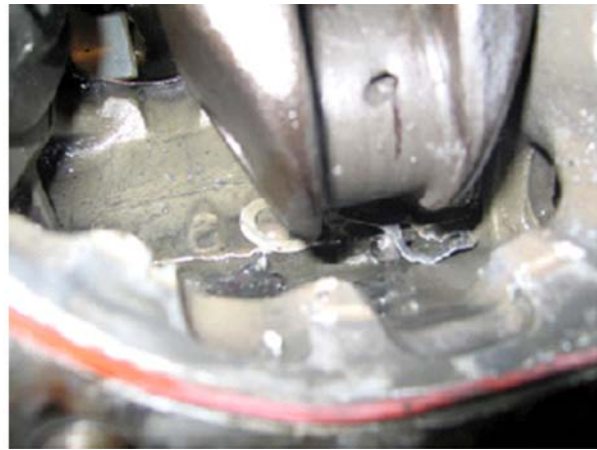
Figure 6. Scorched crankshaft journal and loose metallic debris

The engine did not show any of the typical signs of seizing, such as static fractures of connecting rods and cylinders without any apparent deformations. In this case, considerable plastic deformation was found, caused by pulling in excess of the material's creep load at high temperature over a period of time, typically resulting from operating the engine at high rpm's, even above the maximum allowed (overspeed) with increasingly insufficient lubrication.

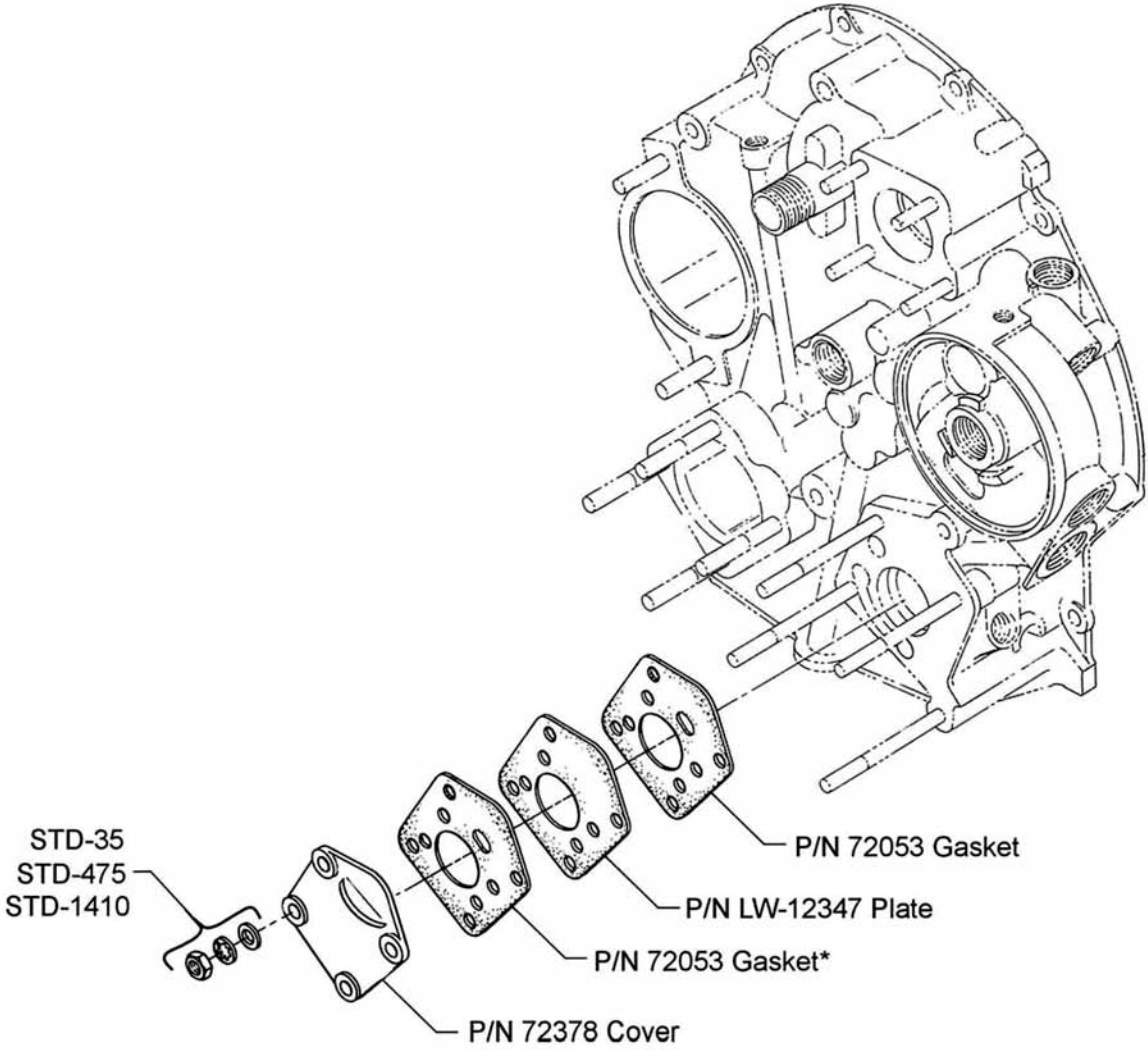
Propeller Governor Pad Plate and Gaskets

The use of a P/N LW-12347 propeller governor pad plate and two P/N 72053 gaskets on dual magneto engines with rear mounted propeller governor drives is necessary with some propeller governors to eliminate the possibility of oil leakage between the propeller governor and the accessory housing.

* Replaced by gasket specified by airframe or propeller governor manufacturer when propeller governor installed.

As a product improvement, to insure against oil leakage, the propeller governor pad plate and gaskets are being incorporated and will not effect operation with any propeller governor drive installed on the engines. See illustration.
