DATA SUMMARY

Date and time	5 August 2008; 18:40 h¹
Site	Madrid-Cuatro Vientos Airport

Registration	EC-HHX
Type and model	CESSNA 172 RG
Operator	Centro de Formación Aeronáutico Aerofan

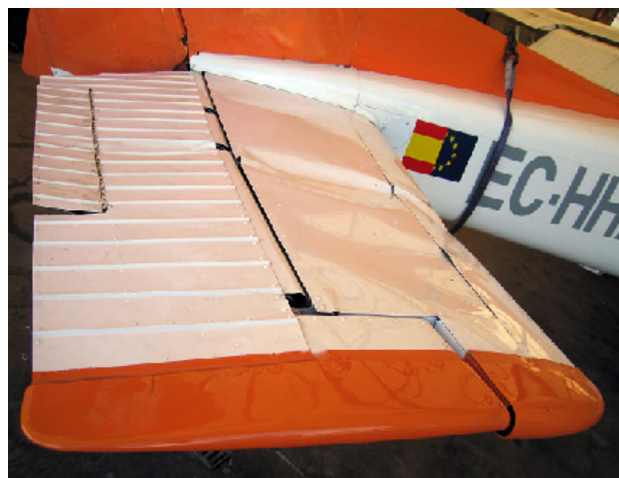
The aircraft suffered slight damage to its right wing tip and tail cone. The aft of the rear portion of the fuselage was scratched, with the right horizontal stabilizer suffering most extensive damage when it was bent slightly upward as it bore part of the aircraft's weight during the landing. Figure 1 shows the damage to this stabilizer.

Figure 1. Damage to right stabilizer

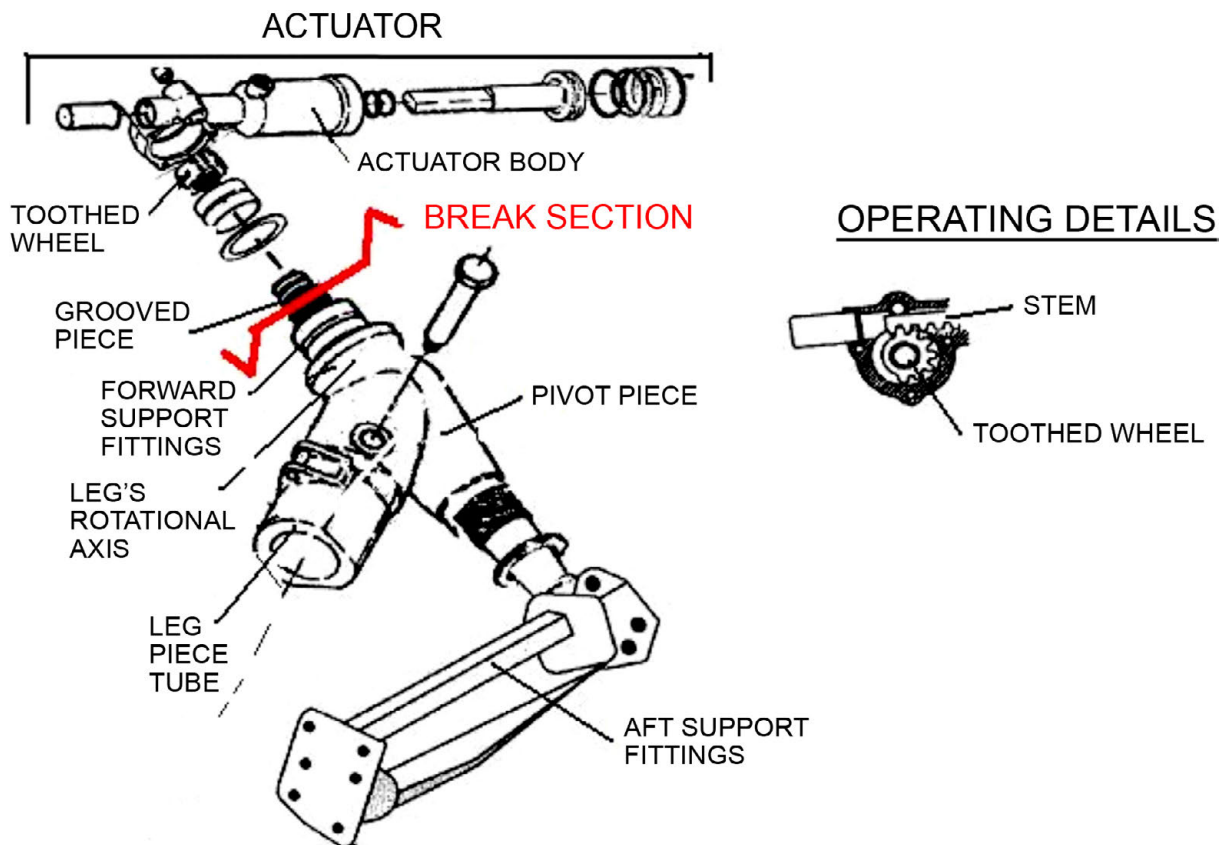
In addition, when the actuating mechanism on the right main landing gear leg was inspected, its rotational axis was broken some 3 mm from the actuator housing. The diagram in Figure 2 shows the location of the fractured section.

Figure 2. Functional diagram of the right gear leg

Figure 2 shows, in red, the position that fractured. As we can see, the break is in the area of the nip where the rotational axis joins the actuator. The break, thus, is in the grooved piece.

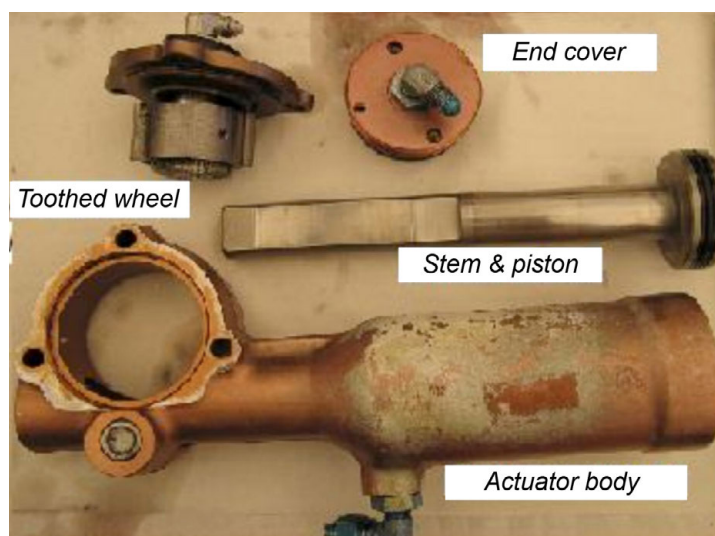
Figure 3 shows the actuator disassembled into its main components. The most significant damage observed was: the break in the grooved section, the lower part of which started at the nip with the toothed wheel, and the top part of which was within 3 mm of said wheel; the deformation of the axis of the toothed wheel with respect to its cover; and, on the flat surface of the stem, some marks perpendicular to its axis.

The deformation of the toothed wheel's axis seems to have occurred as a result of the axis tilting as the break developed. The marks on the stem are believed to correspond to the different positions in which the stem contacted the roller on the actuator during the

Figure 3. Disassembled gear actuator

various efforts to actuate the gear in flight in the circuit at 4,000 ft with the axis of rotation already broken.

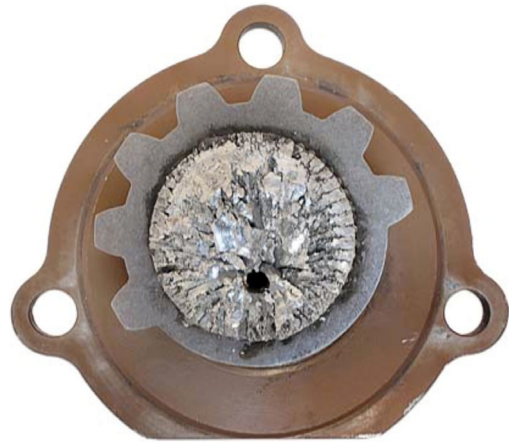
The fracture in the section of the rotational axis indicated is basically perpendicular to the grooves, and therefore to the right leg's axis of rotation. Figure 4 shows a front view of the break in the axis of rotation as seen from the side with the toothed wheel.

Figure 4. Cross-section of fracture

The fracture surface evidenced macrofractographic and microfractographic features typical of progressive fatigue failure.

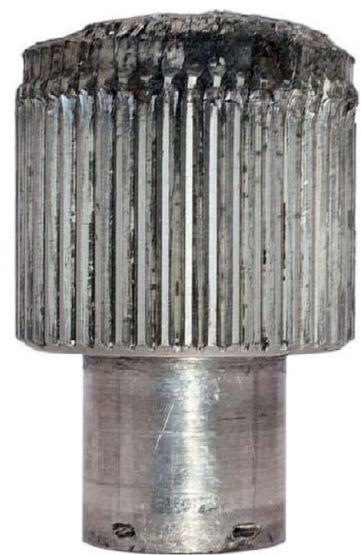
As shown in Figure 5, the broken part on the shaft joining the actuator to the rotating element (pivot) exhibited a practically circumferential fracture located in the area of the transmission radius with the part that had become embedded in the pivot.

The grooved area exhibited parallel longitudinal cracks in the fillet area adjacent to the fracture (see top part of image in Figure 5). These cracks penetrated into the material in the toothed area.

The filleted area where the longitudinal cracks were exhibited a plastic deformation that was at an angle with respect to the generatrix.

Figure 5. Grooved area

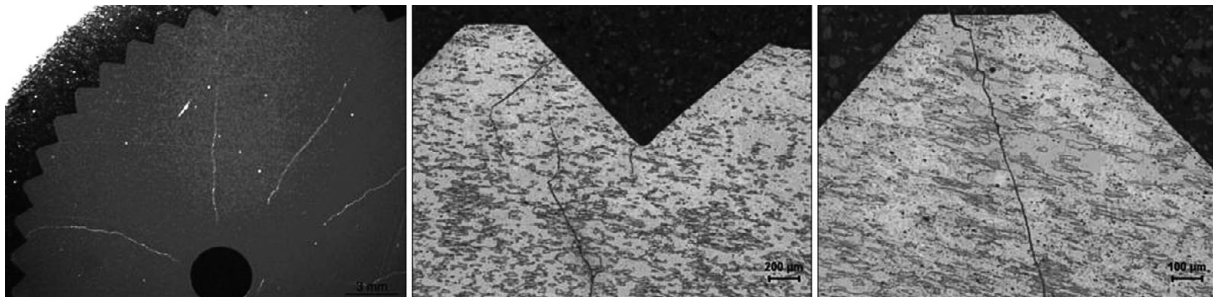
The longitudinal cracks found on the grooved axis started outside the grooves, both in the valleys, sides and crests of the grooves. A cross-section of a metallographic specimen did not reveal any type of metallurgical defect or signs of corrosion (see Figure 6).

Figure 6. Cross section near the fracture zone. Close-up of cracks
