DATA SUMMARY

Date and time	4 September 2008; 15:38 UTC¹
Site	Seville Airport

Registration	F-GLEC
Type and model	AEROSPATIALE SN-601 Corvette S/N: 30
Operator	Airbus

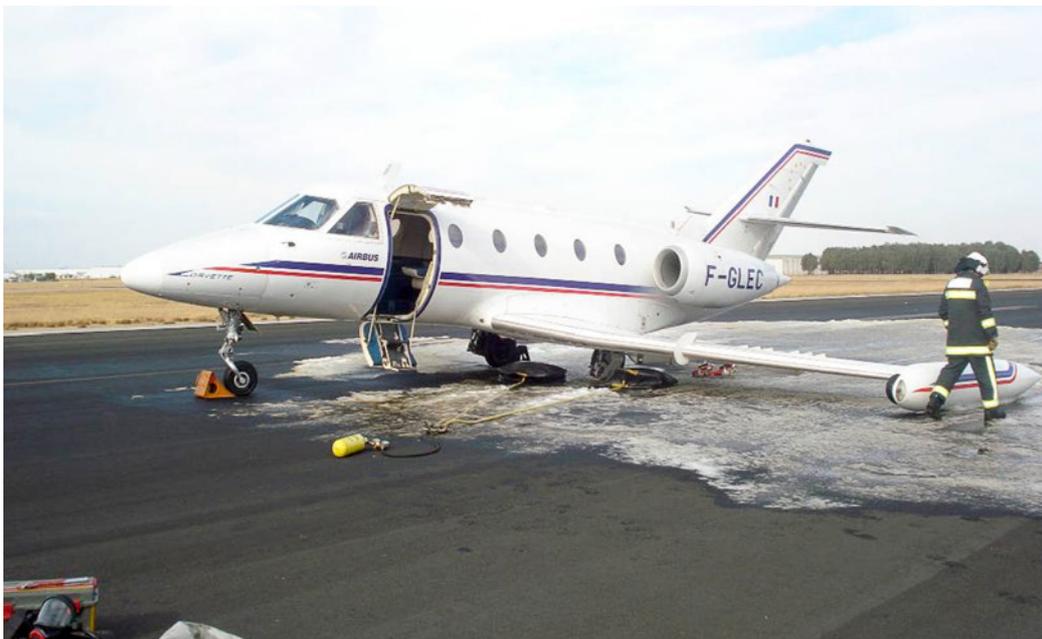
Figure 1. Condition of aircraft on runway

After touching down at 15:39:30, during the last part of the landing run the left wing gradually descended until it made contact with the runway surface, sliding along it over the course of some 50 m until the aircraft came to a stop within the paved area (Figure 1).

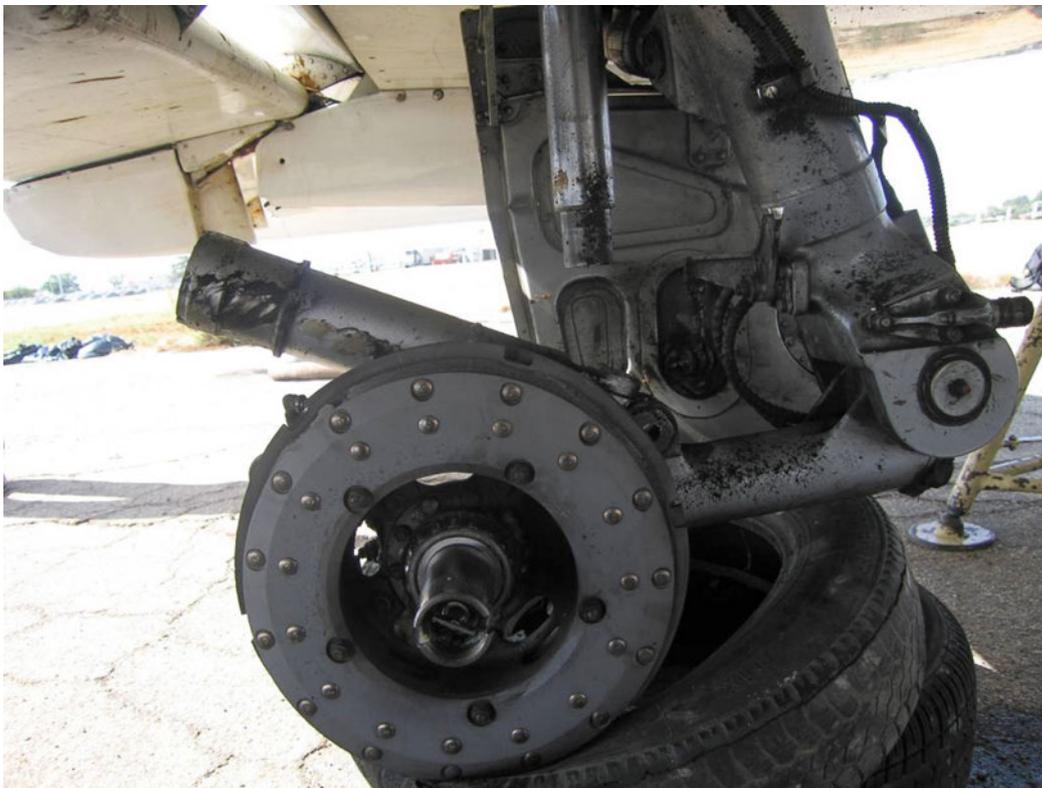
Figure 2. Left main landing gear leg

The shock absorber on the left leg lost its integrity as a result of the outer cylinder separating from the piston, though neither component evidenced any signs of impact or deformations (Figure 2).

The internal failure of the shock absorber resulted from the complete loosening of the locking nut on the upper cylinder or piston which holds the sealing assembly in place. Neither the nut nor the shock absorber components displayed any damage that would indicate that the fault took place as a result of unusual conditions different from those present during normal operations.

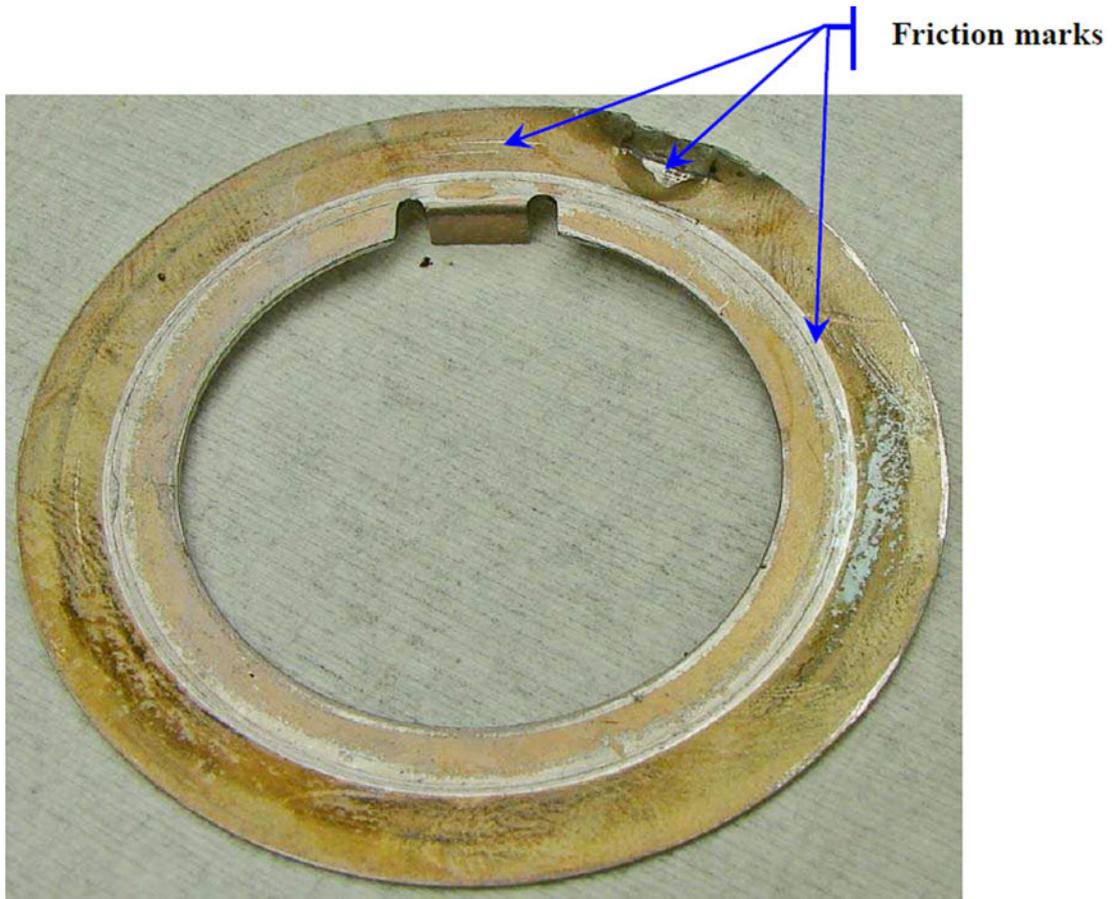
Figure 5. As-found condition of retaining washer

The bend in this nut's retaining washer (item no. 27) was apparently within the limits for being housed inside the slot on the nut and stop the movement of the assembly (Figures 5 and 6). It also had circular friction marks halfway along its circumference (Figure 5).

A check of the friction marks on the washer revealed that it was able to keep the piston from rotating but not the nut, which turned gradually over the course of an indeterminate number of cycles, until it became completely loose.

REC 48/11. It is recommended that Messier-Dowty, the manufacturer of the shock absorber with P/N 15330001A, revise the anti-rotation system for the nut on the piston sealing assembly (P/N 15381), either by modifying the design or the continuous airworthiness instructions, so as to ensure that the system remains operable throughout the useful lifetime of the shock absorber.

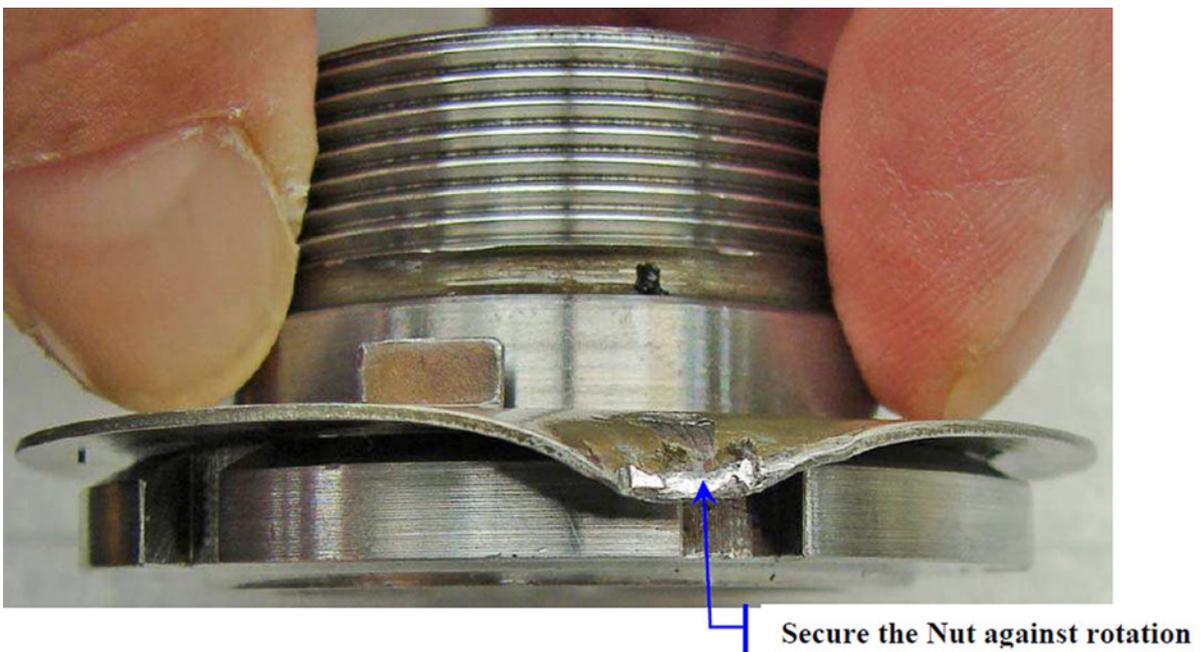
Figure 6. Nut and washer as assembled

The nut used to hold the set of seals, bearings and segments firmly in place inside the inner cylinder (item no. 28) did not exhibit any marks or damage, either to the body or threads.
