DATA SUMMARY

Date and time	Tuesday, 11 November 2008; 10:30 local time
Site	Ibón de Miralles, Plan (Huesca)

Registration	EC-KQI
Type and model	AS 350 B3
Operator	Heliswiss Ibérica

REPORT

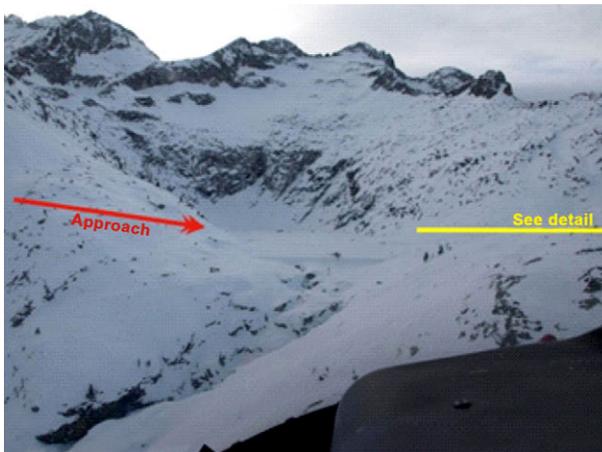
The first dam they inspected was the Ibon de Miralles dam, which comprises the lower part of a mountain cirque and whose retention wall faces north (Figure 1).

Figure 1. Aerial photo of cirque glacier and dam

In the valley where the helicopter was flying, and given the white light conditions present, the entire surface near the water in the dam satisfied the conditions for a whiteout phenomenon, due to the snow cover on the slopes near the water, the frozen surface of the water and the snow atop the wall, all of which combined to make a uniformly white surface. At the tops of the mountain sides there were rocky outcroppings visible that interrupted the uniformity in the highest parts of the slopes.

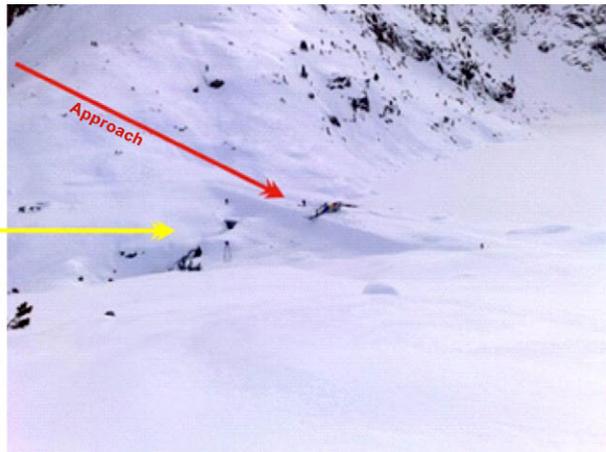
On the day of the event, the sides of the cirque, the retaining wall and the surrounding area were covered by snow and the surface of the water was frozen (Figure 2).

Figure 2. Close-up of wall and wreckage on day of event

The pilot chose as the approach and landing point an area along the central part of the dam wall toward its western end. The wall was 8.5 m wide and 98 m long. On the day of the event, the snow on the wall rose to two different heights, being greater on the left side of the helicopter's flight path (see Figure 2).

The left skid, its ski and the partially open front left door were partly buried in the snow. The damage exhibited by the main rotor blades and the driveshaft to rotors indicates that the helicopter was under power when it reached the ground. The way that the structural parts, cowlings and engine links were twisted and broken are consistent with the aircraft's left side impacting the ground.

The helicopter could have rolled over due to the torque produced as the helicopter, which was moving uncontrollably to the left, was stopped when its left skid and ski impacted snow that was at a higher level.

REC 07/11. It is recommended that the National Aviation Safety Agency (AESAs), in the requirements for the issue of authorizations to aerial work operators, include specifically crews training on the spatial disorientation phenomenon and, particularly to those operators intending to perform activities in periodically or permanent snowed mountains, training on "whiteout" phenomenon.
