DATA SUMMARY

Registration	EC-DMR
Type and model	CESSNA F-172-RG
Operator	Top Fly

Operation	General Aviation – Instruction
Phase of flight	Landing

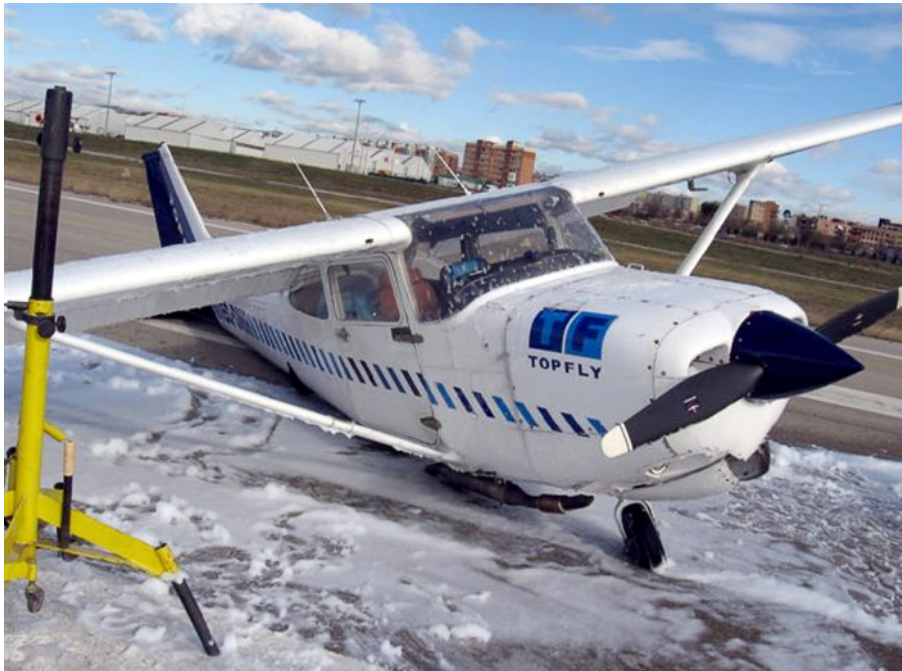
Figure 1. Photograph of airplane

During the landing run the instructor kept the airplane's weight on the left wheel. After coming to a nearly full stop, the right wing dropped, its tip resting on the ground and the airplane doing a 180° turn.

The airplane's right wingtip and horizontal stabilizer, which was also resting on the ground, were damaged. The right main landing gear leg and the nose wheel leg also suffered significant damage.

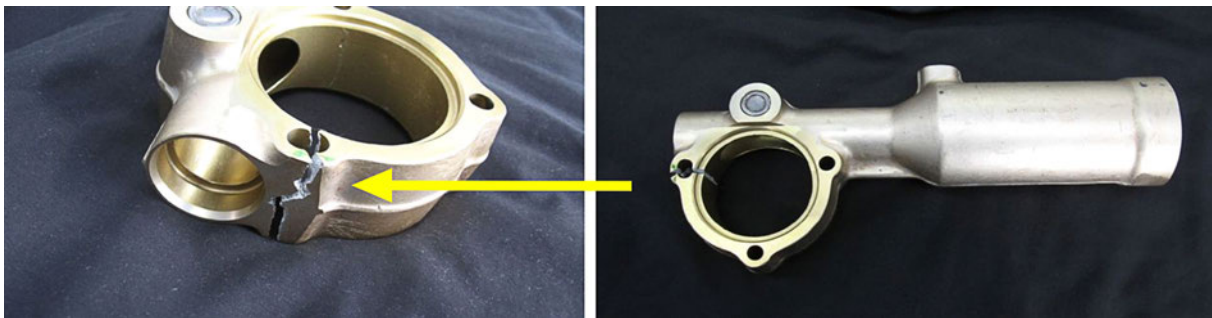
Figure 2. Broken actuator

The post-incident inspection revealed that the actuator for the right gear leg was cracked, as shown in Figure 2, which prevented it from properly performing its function of extending the leg.

The accident was caused by the fracture of the actuator in the right main landing gear leg which resulted from a static overload fracture due to local stresses that had formed in the annular region of the actuator.

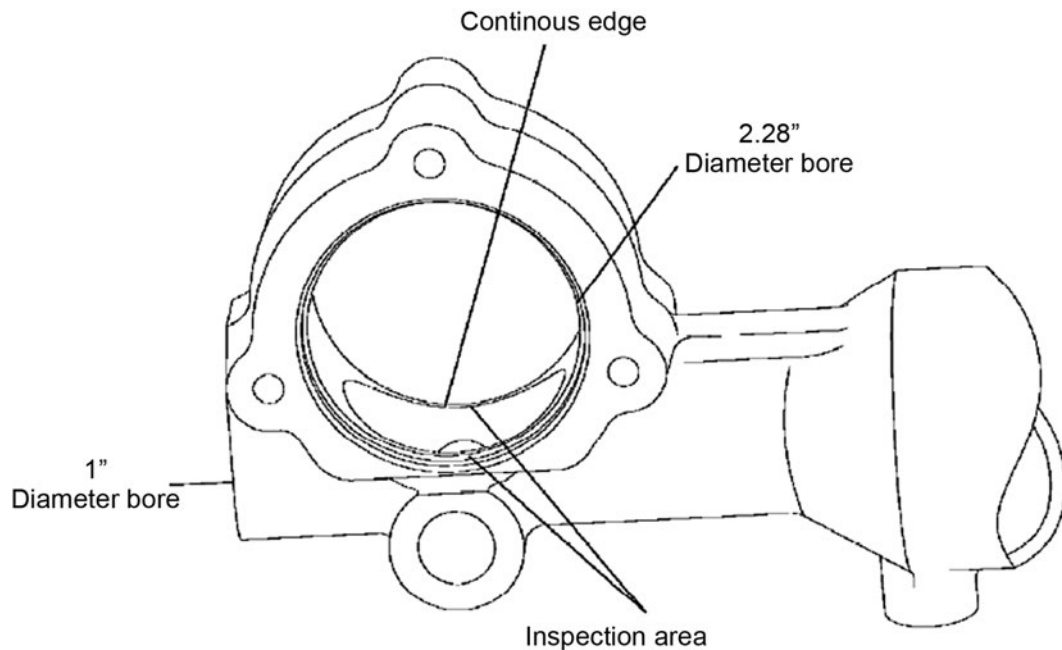
Figure 3. Main landing gear actuator inspection

The modification involves polishing the edge of the 2.28-inch diameter hole on the main landing gear actuator ring using fine-grained sandpaper to achieve a continuous polish starting from the edge of the 1-inch diameter oval hole so as to eliminate any sharp edges or tool marks that can be detected with the finger (see Figure 3).

NOTE: Inspection continuous edge of saddle-shaped hole and circumference of 2.28-inch diameter bore and step

It also details the areas to inspect, which do not coincide exactly with those areas where the actuator ring in this incident fractured, as well as the inspection method (using liquid penetrants).

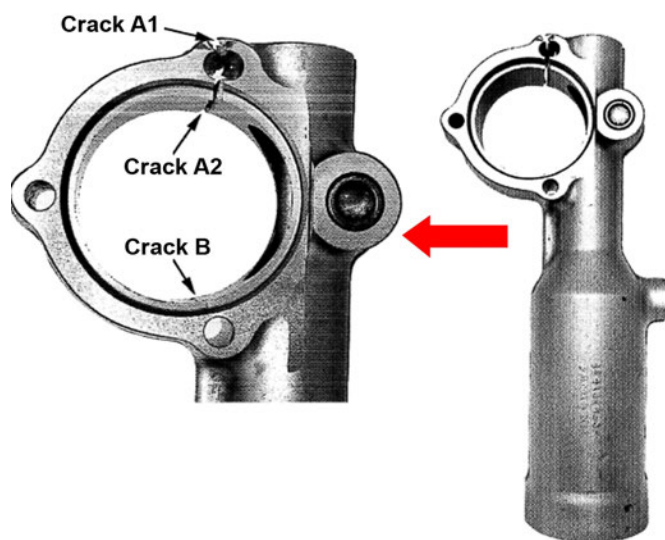
Figure 6. Cracks in the actuator

Three cracks were found in the annular part near the two orifices located where the ring joins the actuator's tubular body.

Cracks A1 and A2 (see Figure 5) were located at one end of the assembly. The walls of the upper hole were cracked through.

Crack B only ran through one of the walls on the inner orifice. Along with this crack, another small crack that was detected on the ring's outer wall that did not penetrate through the thickness of the wall.

- The fracture mechanism involved was microvoid coalescence, typical of static overload fractures, and which resulted from the effects of a tensile load leading to local circumferential stresses in the annular section of the actuator.

The maximum static load that the actuator on the right leg could withstand was probably exceeded on one or several occasions, resulting in stresses that gave rise to the appearance of the cracks that were detected during the investigation. These cracks weakened the area, which structurally was less sound, causing the collapse of the actuator.
