DATA SUMMARY

Registration	OE-KPC
Type and model	CESSNA TU 206 F
Operator	Private

Type and model	THIELERT, Centurion 4.0
Number	1

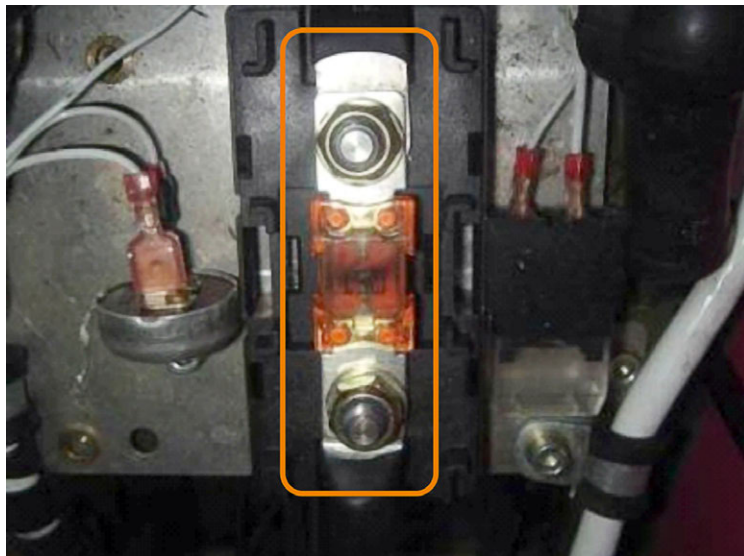
Figure 2. Battery fuse

The inspection of the electrical system revealed that a 150A fuse near the 'Batt 1' battery had blown, see Figure 2.

As noted earlier in Section 1.7, the 150A fuse located next to the battery 'Batt 1' was blown (see Figure 2).

- The attempt to restart the blocked engine in-flight caused the fuse located between 'Batt 1' and the main bus to blow. This rendered the flaps and communications systems inoperative, as well as other systems that, though irrelevant to the investigation of this accident, are important to flight safety.

REC 04/12. It is recommended to the European Aviation Safety Agency (EASA) that the suitability of the design of the electrical system contained in the STC (EASA.A.S.02565) be evaluated in terms of the location, identification and possible replacement of the 150-amp fuse situated next to 'Batt 1'.

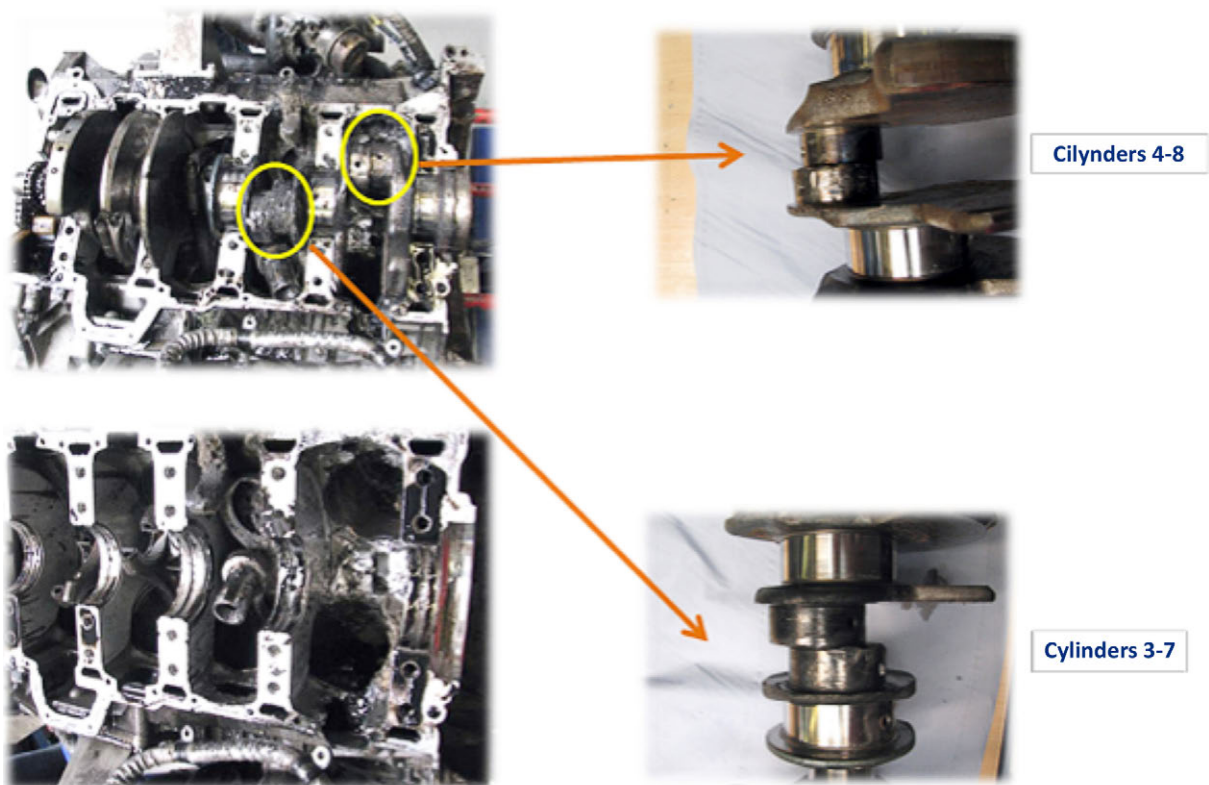
Figure 3. Damage to the engine

The engine block was perforated due to impacts from internal engine components.

The cylinders are arranged from back to front, paired in the sequence 1-5, 2-6, 3-7 and 4-8. The connecting rods and pistons on cylinders 4 and 8 were destroyed, and the connecting rods on 3-7 were severely damaged. Cylinder 6 was also affected. The rest were not.

The crankshaft pins on the most affected cylinders had bluish stains, a sign of overheating. The pieces and fractures were also subjected to metallographic testing, which revealed the fast nature of the fracture process. See Figure 3.

Based on the information obtained, the most likely cause of the damage was a lack of lubrication to the engine, though the source of this lack of lubrication could not be identified.

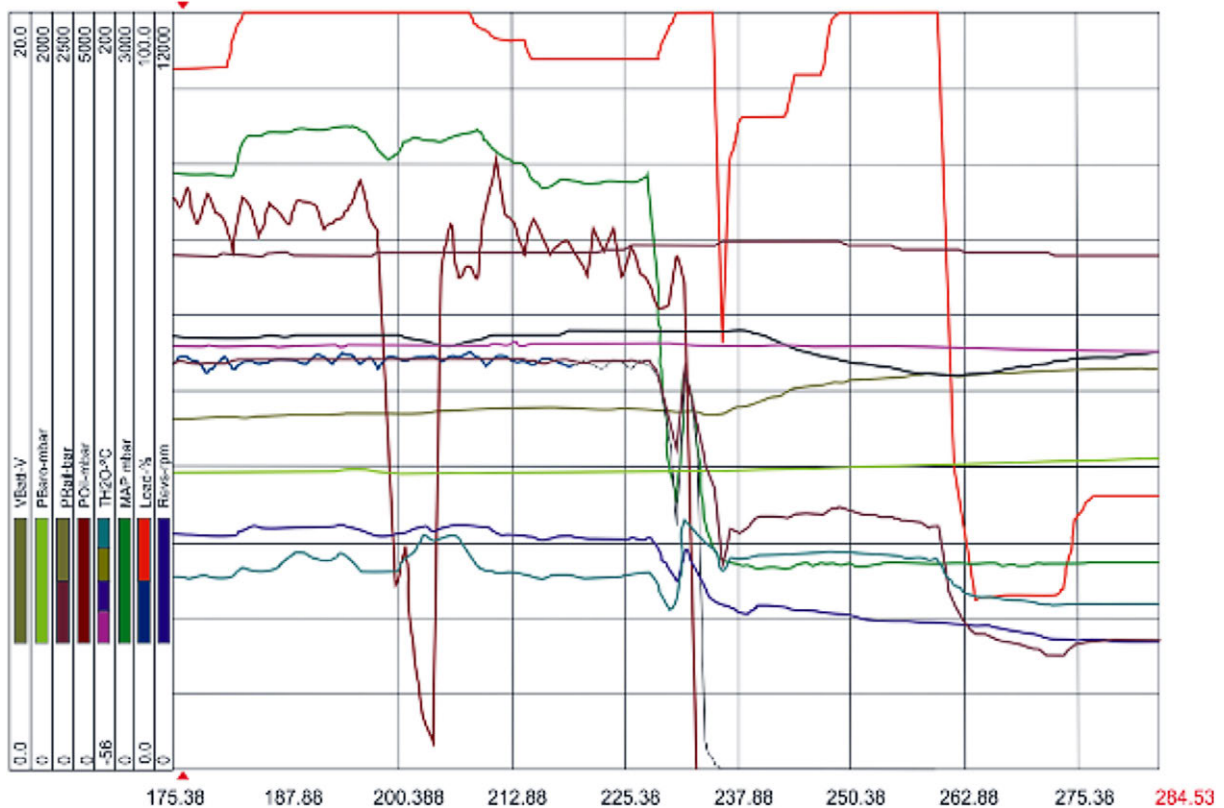
Figure 4. Graphs the values recorded in the last segment of the flight

- Then, 29 seconds after *Poil* reached a value of 171 mbar, the oil pressure dropped to 0 mbar, engine and propeller RPMs started to decrease gradually and the fuel supply pressure disappeared. The time stamp on the FADEC indicated that *Poil* fell to 0 mbar at 11:13:14.
- The power supply to the FADEC was transferred to 'Batt 2' 93 seconds after *Poil* fell to 0 mbar.
- From this moment on, the aircraft commenced a gradual descent until the water landing.

Figure 4 shows the variation in the readings⁵ recorded in the last segment. The units⁶ on the horizontal axis are in seconds.

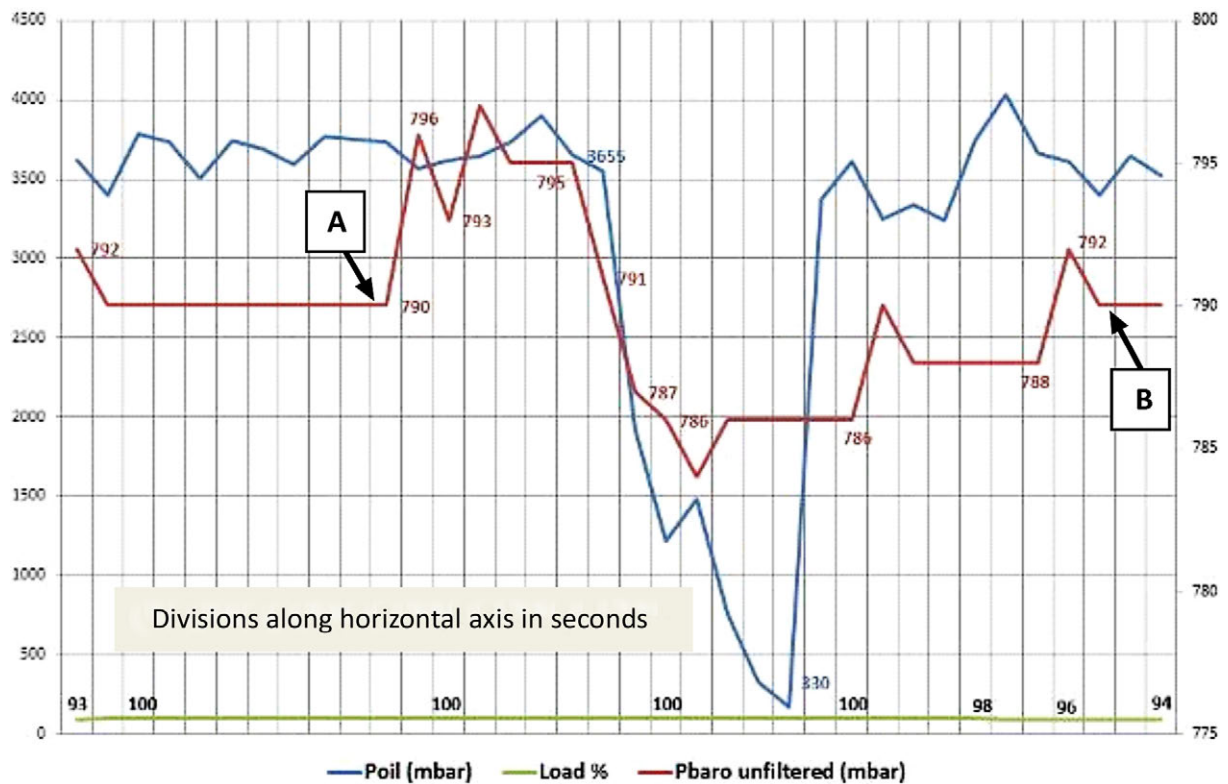
Figure 5. Variation in oil pressure, engine load and barometric pressure

However, when the FADEC readings for the *P_{baro}* and *Po_{il}* parameters in the minute prior to the failure were analyzed, the following was noted (see Figure 5):

These events very likely occurred during the maneuver described by the pilot as a "sweep turn", performed to confirm the presence of the traffic below him that had been reported by ATC.

An assessment of the time interval (about 6 seconds) during which the engine was subjected to an oil pressure that was 50% below normal in-flight pressure indicates that since the engine parameters remained within the allowed values (green arc) during the flight, the lack of lubrication during this time must have been offset by the presence of a residual film of lubricant in the engine.

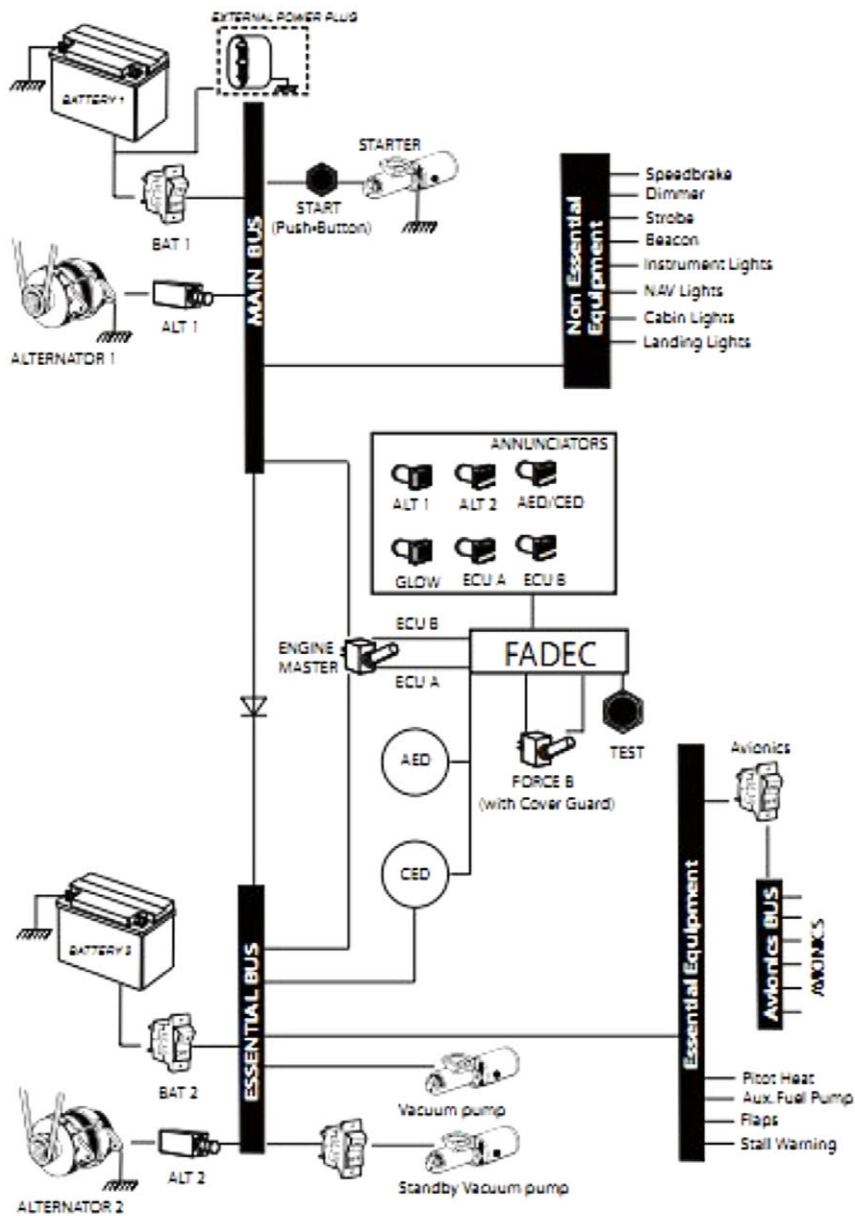
Figure 7-8: Basic Schematic of the Electrical System of the Cessna (T)U206F & G (28V) with Centurion 4.0 installation

A comparison of the electrical diagram in the STC technical documentation with that of the supplement shows significant differences. In particular, the diagram in the Supplement to the Flight Manual shows that when the 'Alt 1' and 'Alt 2' alternators are not working, the communications and navigations systems, pitot heating, flaps, fuel pump and stall warning, all of which are supplied by the ESS BUS as part of the essential equipment, are supplied by both batteries, 'Batt 1' and 'Batt 2', which was not the case on the accident aircraft.

The electrical system installation on the accident aircraft was inspected. The results of this inspection showed that it corresponded accurately to that shown in the diagram contained in the STC technical documentation shown in Appendix 2 of this report, but not to that contained in Section 7 of the Supplement to the Flight Manual (see Appendix 1).

REC 05/12. It is recommended that the European Aviation Safety Agency (EASA) reconsider the approval of the Supplement to the Flight Manual of the Cessna TU206F aircraft with a Centurion 4.0 engine installed so that it:

- Properly reflects the information regarding the electrical system.
- Provides the pilot with adequate instructions on what to do (or not do) in the event of an in-flight engine failure.
