**DATA SUMMARY**

Registration	<b>G-KPAO</b>
Type and model	<b>ROBINSON R-44</b>
Operator	<b>Avonair</b>

The Robinson R-44 helicopter, registration G-KPAO, had departed from Ampuria Brava (LEAP) airport in Gerona at 10:00 for Castellon airport (LECN) with three persons on board (pilot and two passengers), as noted in the flight plan.

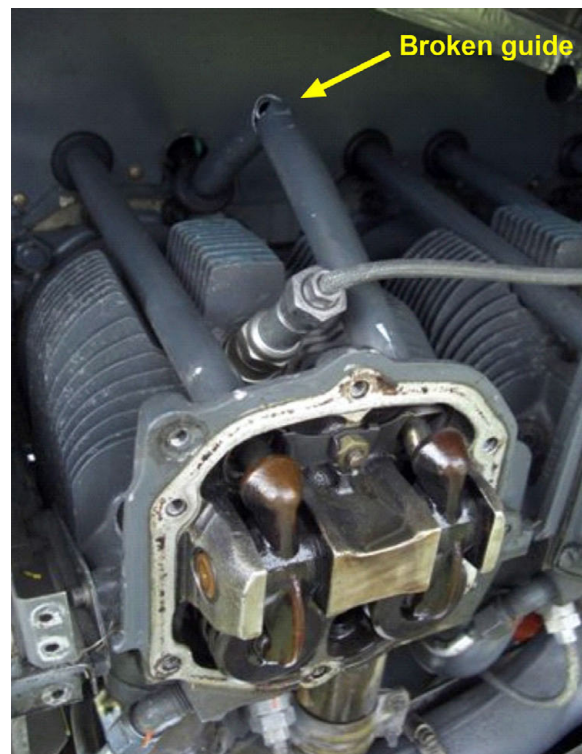
Figure 1. Photograph of broken guide

The post-accident inspection revealed that the pushrod for the number 2 cylinder exhaust valve was broken and its external guide bent. They were disassembled and inspected. The cap and tappet, which are located at the end of the pushrod, as shown in Figure 2, were also disassembled. Damage was observed on the tappet.

An excessive clearance between the rod and the guide means the latter is not perfectly straight, resulting in increased friction and also allowing excessive amounts of oil to pass through, which then accumulates between the rod and guide. When it solidifies, it contributes to limiting valve movement. Both factors favor a potential blockage of the valve.

The incident occurred because the No. 2 cylinder exhaust valve was blocked in the closed position, which resulted in the breaking of the rod and the bending of the guide. This led to a loss of power that forced the pilot to perform an emergency landing.

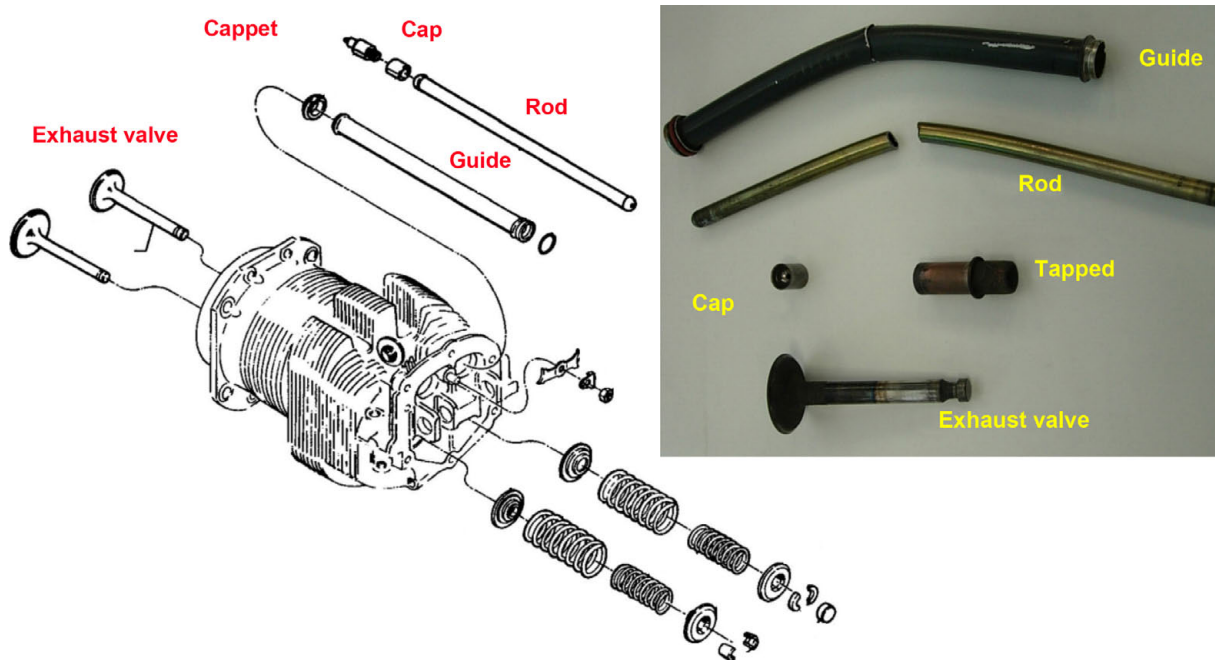
The remaining cylinders were examined to see if they complied with the specifications required in Service Bulletin 338 C. It was noted that the No. 1 and 3 cylinders had clearances of 0.300", No. 4 cylinder 0.027", No. 5 cylinder 0.017", and No. 6 cylinder 0.028". In other words, two were at the upper limit, two others were close to the maximum although within limits and another was close to the minimum, though also within limits.

Figure 2. Broken guide, pushrod, tappet and cap

After measuring the clearance of the cylinders, it was noted that these were close to the limits in every case, meaning it was possible that the maximum allowed clearance was exceeded in the No. 2 cylinder.
