## Report A-011/2009

Accident involving  
a Eurocopter AS 350 B3,  
registration EC-IOJ, in Mollet  
del Vallés (Barcelona),  
on 22 June 2009

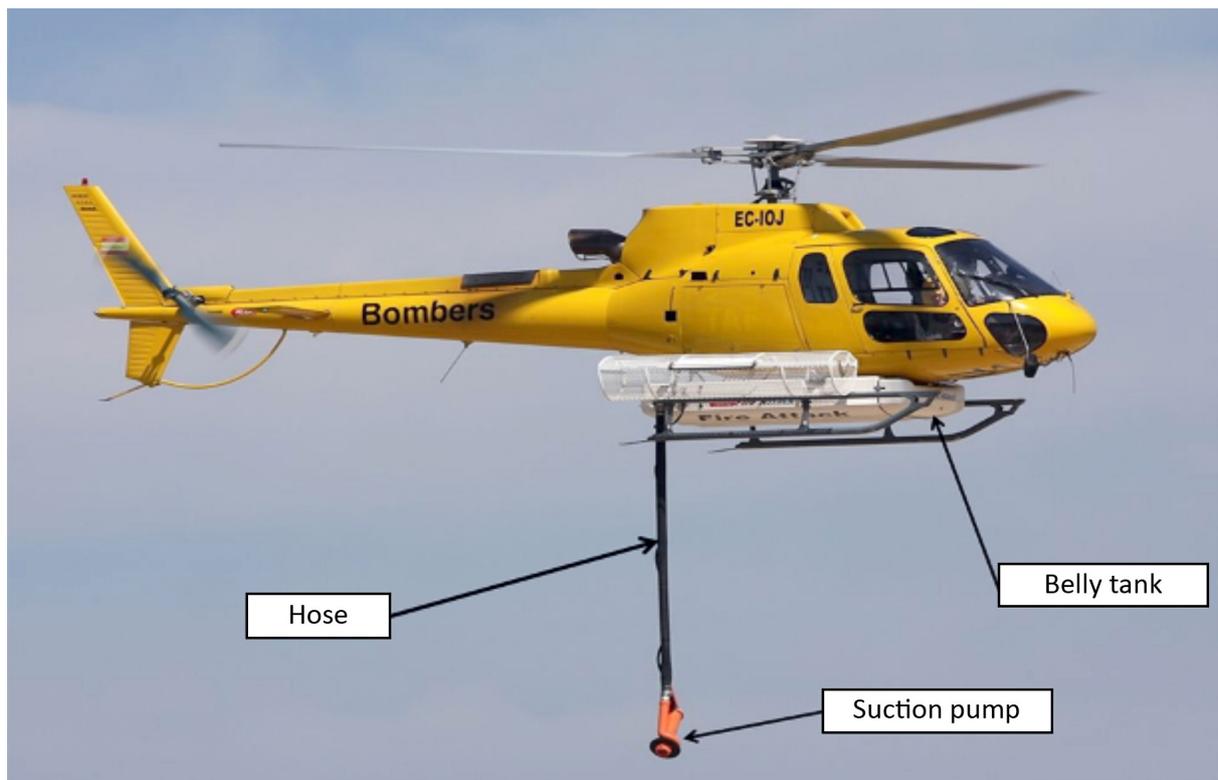
Figure 1. Accident helicopter outfitted with firefighting system

The helicopter was equipped with a firefighting system called the "Simplex Fire Attack System", Model 310. The system's design was covered under EASA Supplementary Type Certificate IM.R.S 0078, Revision 1, validated by the EASA.

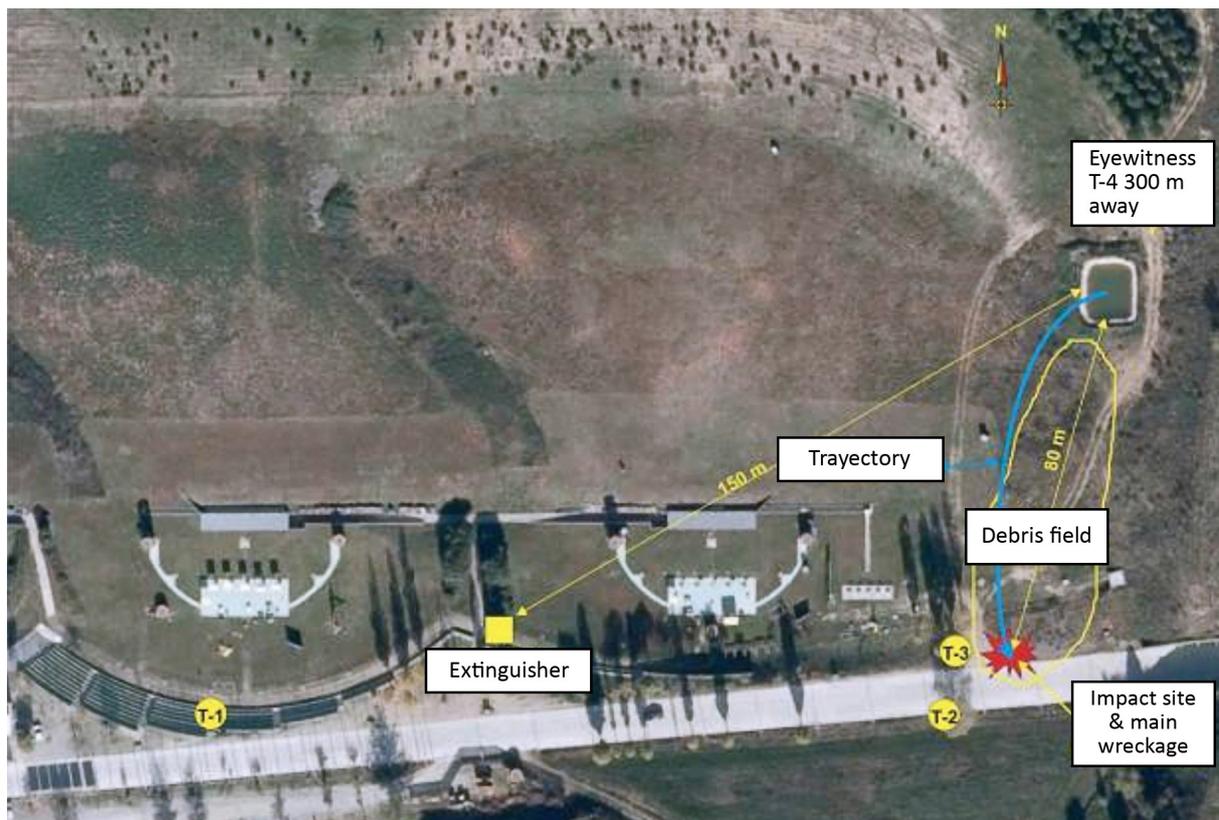
The main aircraft wreckage was concentrated in an area about one meter away from the right edge of the entrance road to the shooting range. A small amount of debris was found elsewhere (see Figure 2).

Figure 2. Location of wreckage and eyewitnesses

The extinguisher located in the helicopter was found some 110 m west of the impact point, between the first and second set of bleachers (see Figure 2). It was broken and bent such that a portion of its circumference along the midpoint was completely flat.

The accident was seen by four eyewitnesses situated at different locations, labeled T1, T2, T3 and T4 (see Figure 2), close to the impact site. Their statements revealed the following:

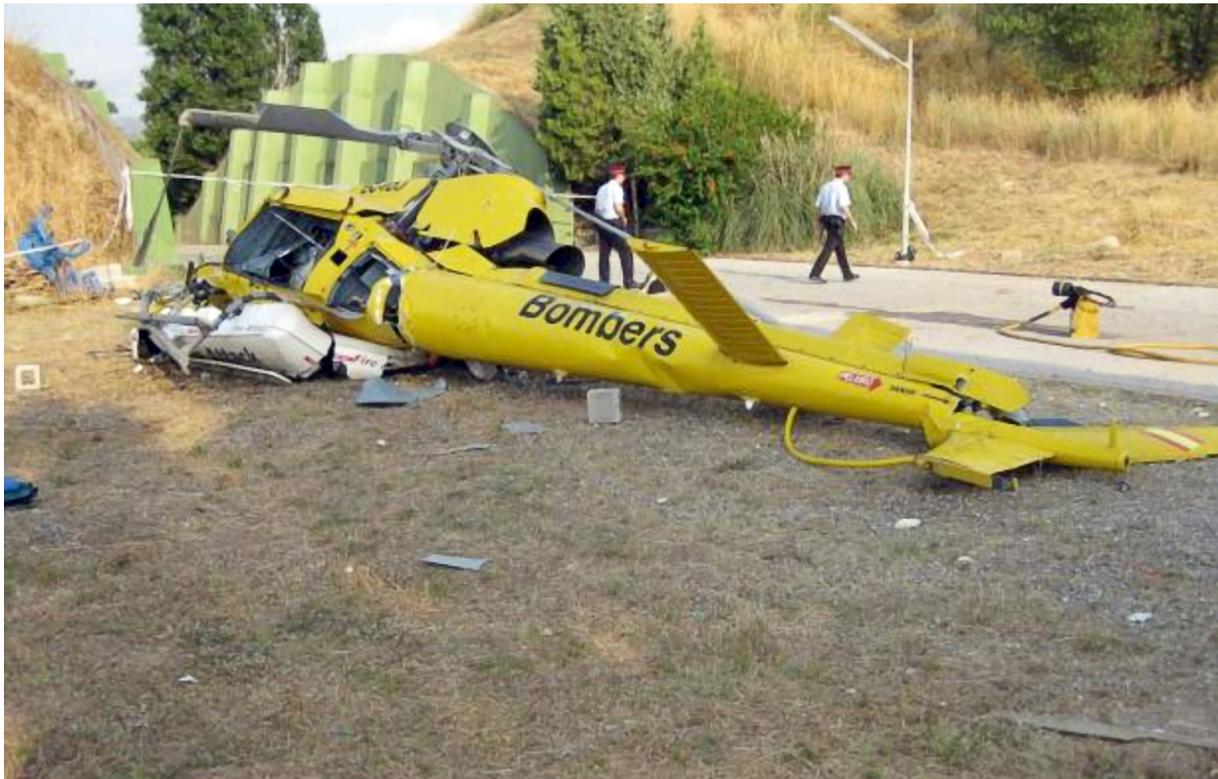
The helicopter showed signs of having impacted at a high pitch angle and at a slight right bank angle. While the aircraft's nose and cabin exhibited severe damage, the rest of the airframe and the tail section showed no evidence of an impact, nor were there drag marks along the ground. The main aircraft wreckage was oriented on a heading of 130° (see Figure 3).

There was red paint at a point 1.8-m away from the root on the leading edge and top surface of the blue main rotor blade, which was resting on the ground to the right side of the helicopter, and a broader patch of orange paint on the leading edge and lower surface. The blade had fractured 2.45-m away from the root with severe impact marks on the leading edge.

Figure 3. Main wreckage

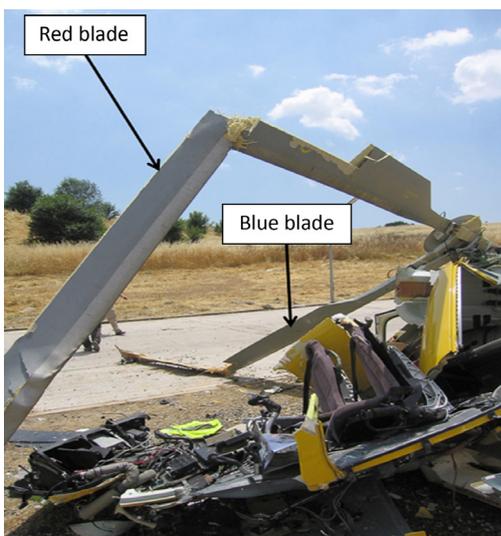
The blades were severely damaged, though the only damage exhibited by the yellow blade was delamination at the tip. The other two —red and blue— had fractured and lost a large amount of material, showing signs of high impact damage.

Figure 4. Condition of red and blue blades

There were red paint marks on the leading edge and top surface of the blue blade at a distance of 1.8 m from the root, corresponding to where this blade impacted the extinguisher, which was located to the right and below the pilot's seat and was ejected when the helicopter impacted the ground. The extinguisher was found some 110 m west of the impact point. It was broken and bent such that part of its circumference at the halfway point was completely flat, consistent with an impact with a flat surface such as the blade's. This same blade also had orange paint marks on the leading edge and bottom surface, evidence of an impact with the suction pump, possibly in the area of the spiral tubing, which has a lower strength than the part with the electric motor. This caused this area to break into several pieces, which were scattered over the ground. Moreover, the blade was broken at a point 2.45 m from the root, exhibiting irregular marks on the leading edge from a severe impact against a blunt object. The irregular shape of this impact area and the lack of orange paint rule out an impact against the suction pump, and seem to indicate that the blade could have

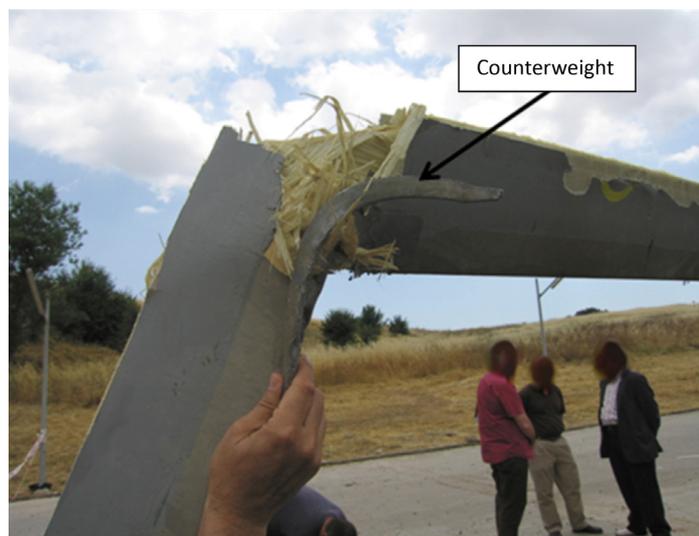
The red blade, which was toward the front part of the helicopter, was partially sheared 2.75-m away from the root due to an impact from its leading edge and to its side impacting the ground (see Figure 4). The counterweight that is located behind the leading edge in this area (see Figure 5) was ejected and found some 240 m west of the crash site.

Figure 5. Red blade. Close-up of detached counterweight

The red blade was also broken near its halfway point, with the outer part hanging vertically. The impact was extremely violent and resulted in a portion of the blade's counterweight detaching, this part being found 240 m west of the impact site. The deformation of the detached counterweight—it was round and matched the cylindrical shape of the suction pump housing perfectly—and the marks on said housing indicate that these two components impacted each other, leading to the fracture of the blade.

The red blade violently struck the suction pump motor, resulting in the fracture and detachment of part of that blade's counterweight.

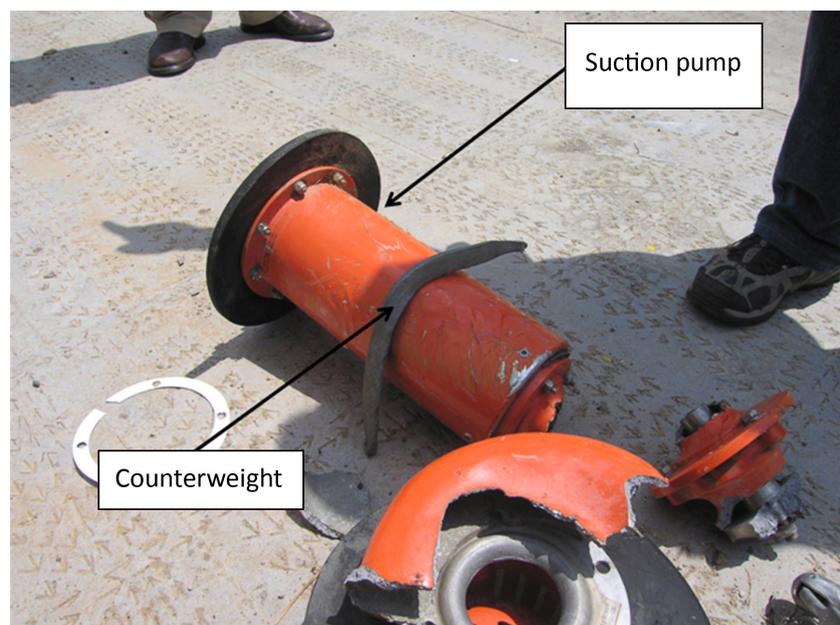
Between the pond and the impact point there were debris with impact marks, belonging mainly to the suction pump —filter, guard, spiral tubing, electric motor assembly, protective housing— as well as components that had detached from the main rotor blades.

**Figura 6.** Restos de la bomba de succión y contrapeso desprendido de la pala roja

Scattered between the pond and the impact point were the remains of various suction pump components—filter, guard, spiral tubing, electric motor assembly and protective housing—all with impact marks. Also found in this area were pieces that had detached from the main rotor blades.

- REC 12/12.** It is recommended that SIMPLEX modify the design of the water-dropping system so that it can be detached from the aircraft in the event that the suction pump or hose on the system is inadvertently ensnared.
- REC 13/12.** It is recommended that the EASA and the FAA establish the mechanisms necessary to ensure that water-dropping system SIMPLEX 310 can be detached from a helicopter in the event that the suction pump or hose on the system is inadvertently ensnared.
