DATA SUMMARY

Date and time	Sunday, 2 August 2009; 09:39 local time
Site	On approach to Barcelona Airport

Registration	G-CPEM
Type and model	BOEING 757-236
Operator	British Airways

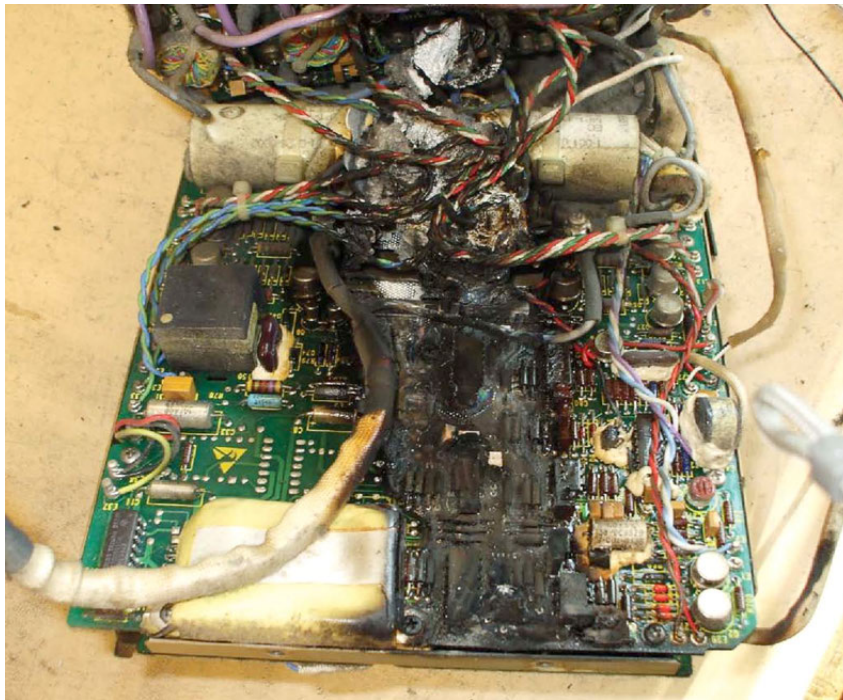
Figure 2. Static inverter after incident

The only damage to the aircraft was limited to the static inverter that was taken from the forward avionics compartment, situated under the cockpit floor. The outer housing showed signs of discoloration by fire and emitted an acrid odor. Opening the inverter revealed obvious signs of fire in some of its components (Figure 2). The fire that originated in the static inverter did not spread to other equipment.

An assessment was made of the damage to the static inverter. Based on the location and extent of the damage, it was determined that the problem resulted from overheating of an carbon composition resistor, R170.

The process began with the deterioration of that resistor and its overheating, which affected first the capacitor located next to the resistor and then, as the fire grew, spread to other nearby capacitors. These elements can combust for a period of time, which can result in the smoke that was detected in the passenger cabin and cockpit.

- The static inverter burned as a consequence of the overheating of resistor R-170.

Finally, in December 2009, the FAA issued an Airworthiness Directive (2009-26-03), effective 1 February 2010. The directive required replacing the R170 resistor with a new one and changed its location in the inverter to avoid resistor overheating and the transfer of heat to adjacent components within the resistor (capacitors C50 and C51). For Boeing 757s, this change had to be made within the 42 months following the entrance into effect of the AD, that is, before 1 February 2012.

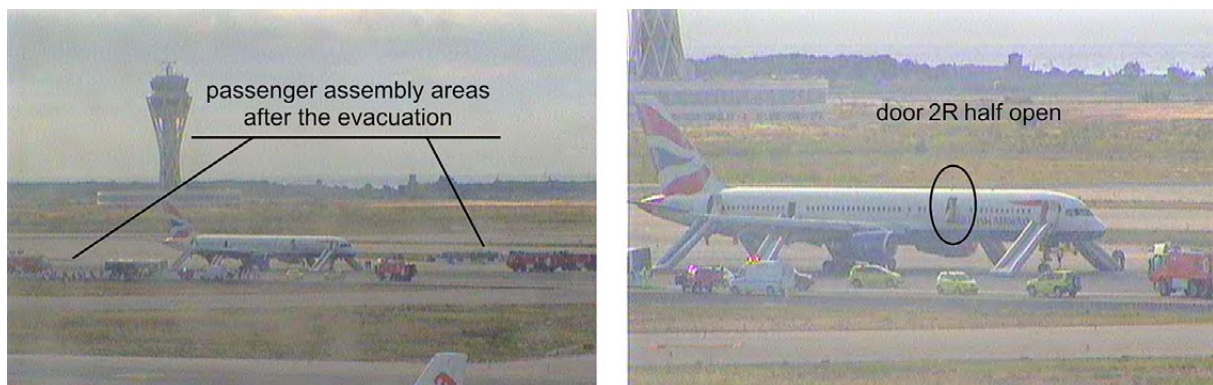
Figure 3. Evacuation footage from airport surveillance cameras

The aircraft was evacuated using four ramps on the left side of the aircraft and three on the right. The video of the evacuation showed that door 2R, located forward of the right wing, did not open completely and the slide did not deploy. The door started to open but was not fully opened. After completing the evacuation, one of the firefighters who boarded the airplane pushed the door fully open, after which the slide deployed properly.

The open-assist mechanism on door 2R failed during the evacuation of the aircraft, though a subsequent attempt by a firefighter showed that it was possible to open, though with greater physical effort.

As for the slide, any problem with its installation or maintenance can be ruled out, since it deployed properly when the firefighter fully opened the door. The inspections of the open-assist mechanism indicated that there was very little gas flow from the tank to the actuator after the rupture of the frangible disc, and that it was insufficient to overcome the inertia and resistance of the door during the opening sequence. It was not possible to determine with certainty the cause for the lack of pneumatic fluid in the tank though, by the process of elimination, it appears to have been caused by a problem with the frangible disc.
