DATA SUMMARY

| Site | Ibiza Airport |

| Registration | N31145 |
| Type and model | PIPER PA 46-500TP "Malibu": Serial number 46-97215 |

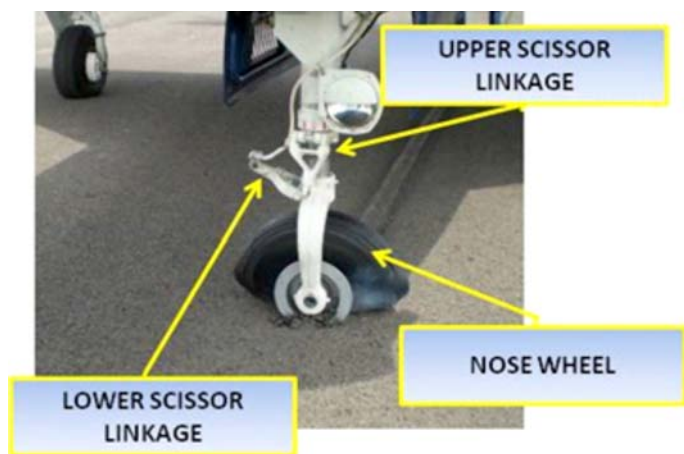
Figure 1. Nose landing gear

Upon reaching the scene, emergency services noticed that the airplane was in good overall condition, but that the nose gear wheel was turned 90° with respect to the aircraft’s longitudinal axis. The tire casing was destroyed and the wheel was worn from rolling on the pavement.

It was also noted that the scissor linkages on the nose gear (mechanism that transmits the torque on the wheel to the upper gear assembly and that limits the travel of the strut depending on the weight on the wheel while on the ground) had become loose.

Figure 1 shows a photograph of the nose gear after the incident, as seen from the front of the aircraft. Notice how, as mentioned earlier, the wheel is at a 90° angle with respect to the aircraft’s longitudinal axis. The scissor linkages on the gear, labeled on the figure, are separated, with the upper one pointing forward and

the bottom one pointing to the right of the aircraft. Finally, the tire is practically destroyed.

- The incident took place because the linkages on the nose gear scissors separated. This separation caused the nose wheel assembly and its attachment fitting to the lower part of the strut to rotate about its axis while on the ground into a position that was perpendicular to the direction of motion. Judging by the position of the wheel in Figure 1, the assembly twisted to the right, and is consistent with the pilot's action to exit the runway.

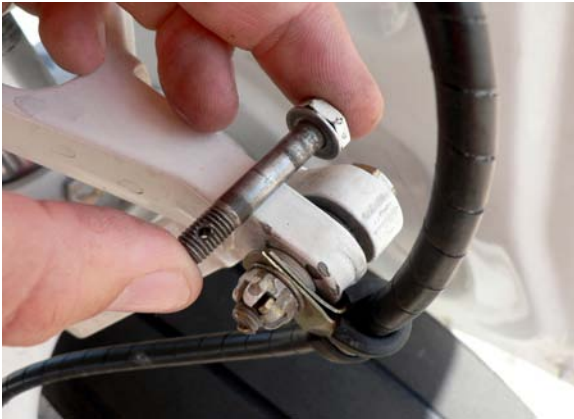
Figure 2. Screw detail

The screw that under normal conditions joins the scissor linkages through their lugs was found attached to the lower linkage, though without a nut. Under normal conditions, the screw has a crown nut that is held in place using a split pin. None of these components was found during the visual inspection.

Figure 2 shows a properly installed attaching screw and crown nut, which hold the two scissor linkages together.

As the figure shows, neither the body nor the orifice for the split pin on this screw exhibit any deformation or any other sign of having been subjected to excessive stresses. There is also no damage to the threaded portion.

The as-found condition of the screw indicates that, in all likelihood, the linkages separated when the screw became unthreaded.

- The normal appearance, integrity and characteristics of the screw that attaches the linkages, which exhibited no damage to its body, split pin orifice or thread, indicate that the separation did not occur as a consequence of possible overloading of the nose gear.

- The linkages separated as a result of the loss of the nut on the screw that holds the linkages together, even though the nut should have been crowned and had a split pin to hold it in place.

screw that was recovered, the loss of the nut and the subsequent separation of the scissor linkages is believed to have occurred due to the progressive loosening of the nut from the screw and to an existing fault of the pin. This fault could have been due to the fracture of the pin as a result of using the incorrect material, to the improper installation of the pin or to its absence.
