DATA SUMMARY

Date and time	Saturday, 29 May 2010; 11:45 local time¹
Site	San Luis Aerodrome (Menorca)

Registration	N-554RB
Type and model	BEECHCRAFT E55 BARON
Operator	Private

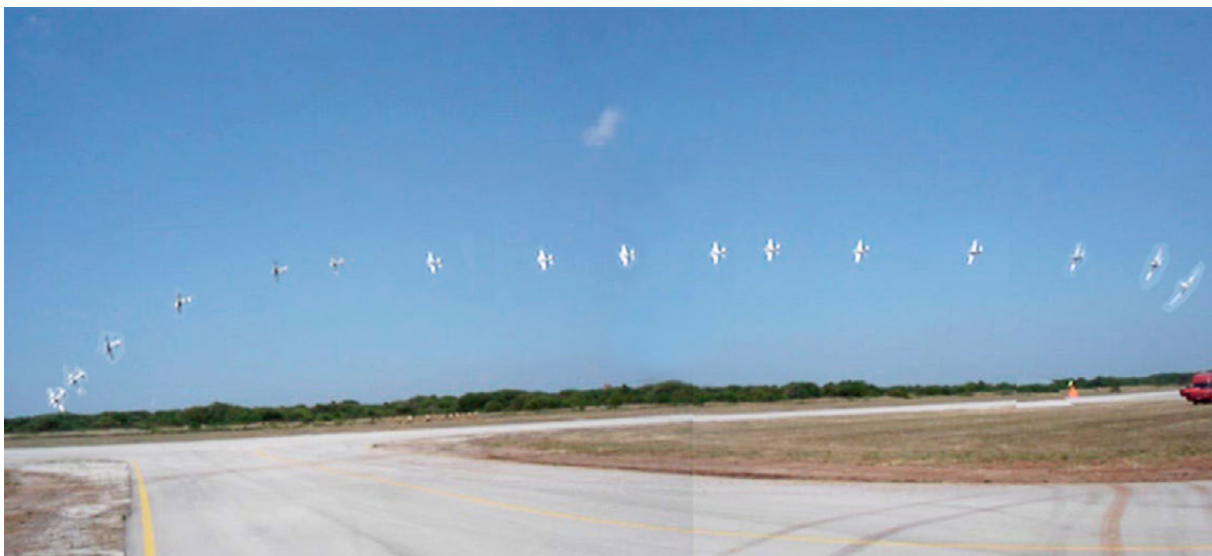
Figure 1. Flight path taken by the aircraft

After taking off, the aircraft turned left to follow the scatter points on the course at an approximate altitude of 200 ft above ground level (see figure 1). The pilot then turned left again to line up with the second scatter point on the ground (see Appendix 2). During this turn, the aircraft's left bank angle was close 90°, and the aircraft crashed to the ground, resulting in an explosion that engulfed the aircraft in flames.

Based on data gathered from video of the accident, the aircraft made a 180° turn over a span of eight seconds.

The turn was not in fact steady, with even higher bank angles being observed when passing above the two scatter points. During the last turn, a bank angle of almost 90° was observed before the aircraft lost control and impacted the ground.

Figure 1 shows how at the end of its flight path, the aircraft started to level out but was unable to complete the recovery maneuver due to the low altitude available.

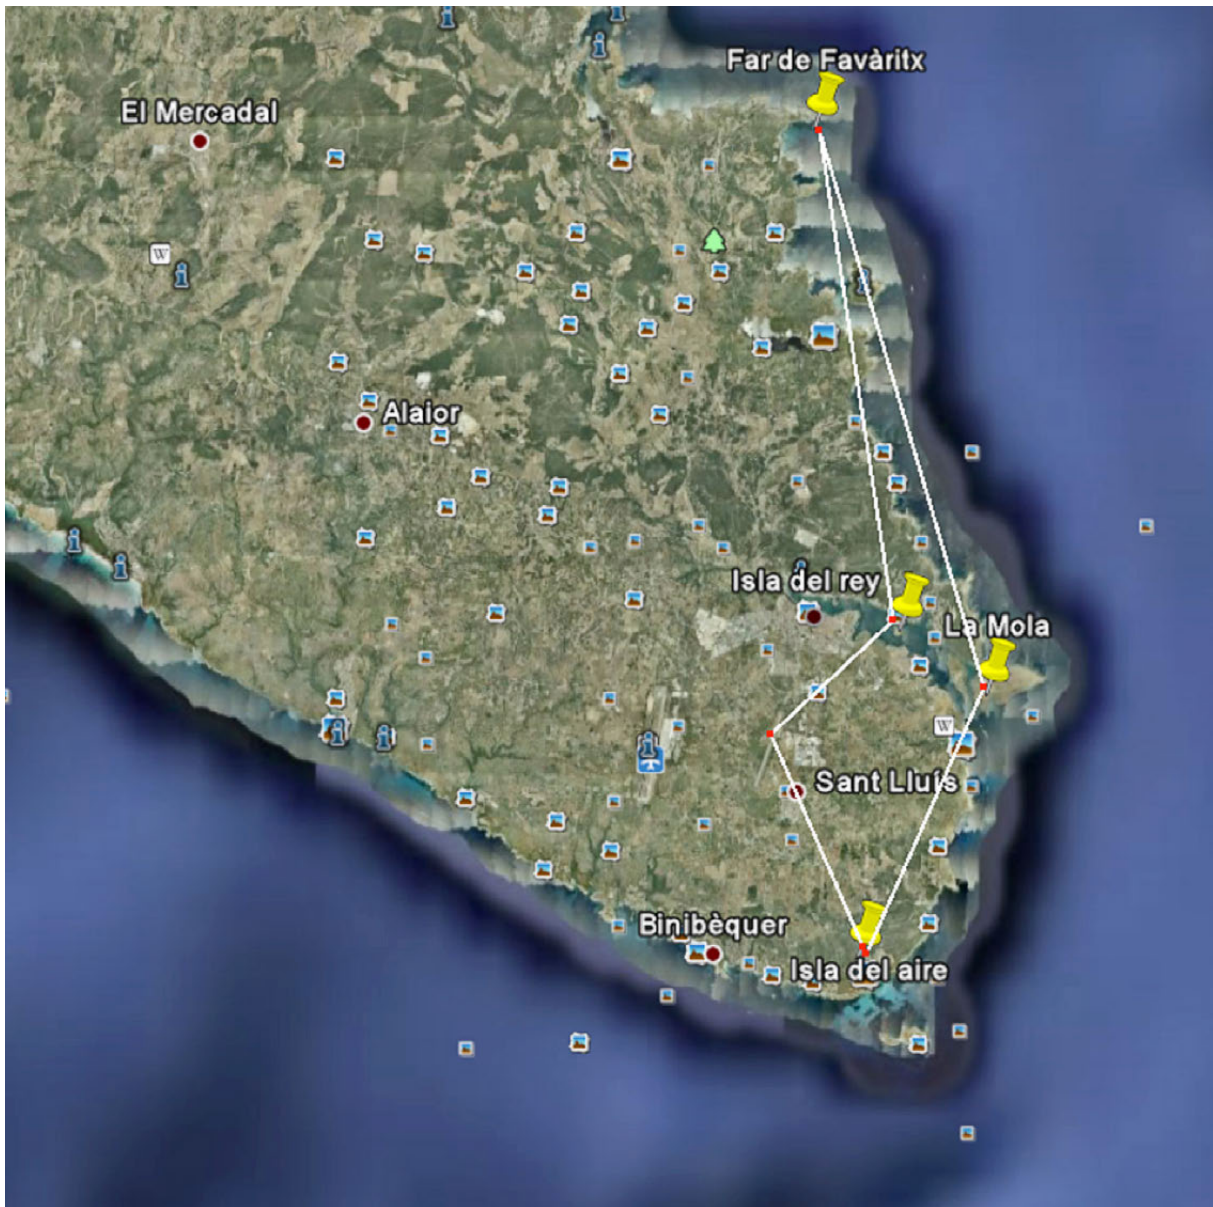
APPENDIX 1
Circuit planned for the event

The pilot of the aircraft was scheduled to take place in an air race that same afternoon. He had run through the course that morning (see Appendix 1), and he was planning to continue practicing. After fully refueling the aircraft with 207 l, he prepared everything for taking off from runway 02 at the San Luis Aerodrome in Menorca.

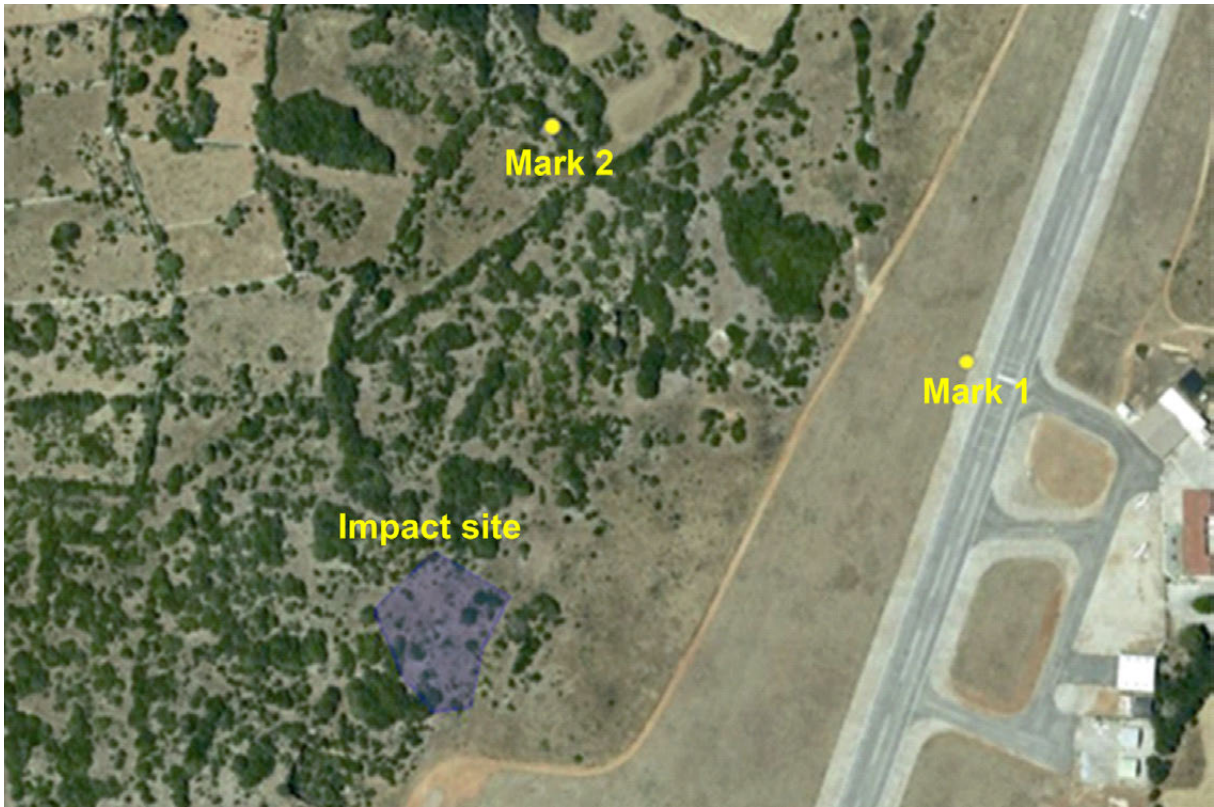
Location of scatter points on the circuit

The aircraft took off from runway 02 at the San Luis aerodrome in Mahón. In keeping with the requirements for the race, it had to take off and fly left of two scatter points placed in the vicinity of the aerodrome before heading to the Isla del Aire point at the south of the island. This maneuver required making a 180° turn.

Based on video footage of the accident, the aircraft made the turn in 8 seconds. For level flight at a constant altitude, making a steady turn from the runway centerline to the second scatter point requires a bank angle of 67°⁶ and a speed of 107 kt. At this bank angle, the stall speed increases by 55% with respect to the level flight stall speed, meaning that for the configuration of the aircraft in the turn (gear and flaps up), the stall speed would have been 128 kt, in excess of the airplane's actual speed.

As a result of the above, a recommendation is issued that air race circuits be designed to ensure that course changes do not require pilots to make abrupt maneuvers and that a certain minimum altitude above ground is attained before a pilot is required to make a turn to remain in the circuit.

REC 15/12. It is recommended that the Royal Aero Club-Records, Racing and Rally Organization and the Real Federación Aeronáutica Española include, as part of their internal instructions on the design of air race circuits, criteria that are similar to those specified by the FAA in its Order 8900, establishing specific limits on course changes and paying particular attention to the low-altitude, low-speed maneuvers required after takeoff to enter the circuit.
