**DATA SUMMARY**

Date and time	<b>Tuesday, 12 October 2010; 12:17 local time<sup>1</sup></b>
Site	<b>Monte Alkurruntz, valle de Baztán (Navarre)</b>

Registration	<b>F-GJLM</b>
Type and model	<b>PIERRE ROBIN DR 400-180</b>
Operator	<b>Private</b>

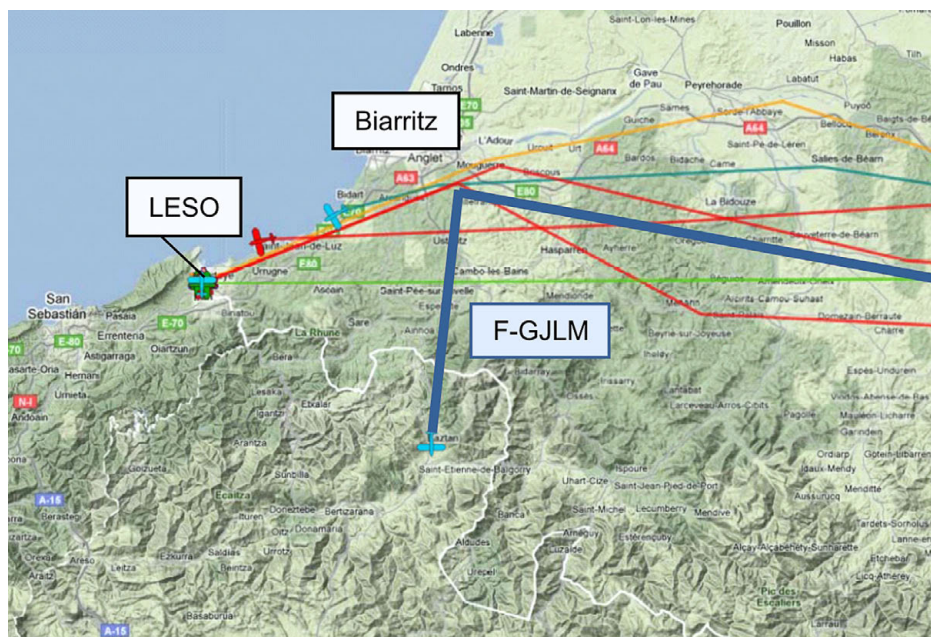
In keeping with this new plan, on Tuesday, 12 October, all of the aircraft departed, with aircraft F-GJLM taking off in the sixth position. The race organizer took off first, as he himself stated, and after verifying that the weather at Biarritz made landing there possible, instructed the other aircraft to start the journey. All of the aircraft were equipped with a satellite tracking system (GPS). Figure 1 shows the flight paths obtained from this system. The accident aircraft was flying practically on a westerly heading toward the Biarritz VOR/DME until, at 12:00 h, instead of continuing to San Sebastian to the southwest like the other aircraft, it turned south and headed for the Pyrenees.

Figure 1. Race route: flight paths of other aircraft in the race and of F-GJLM

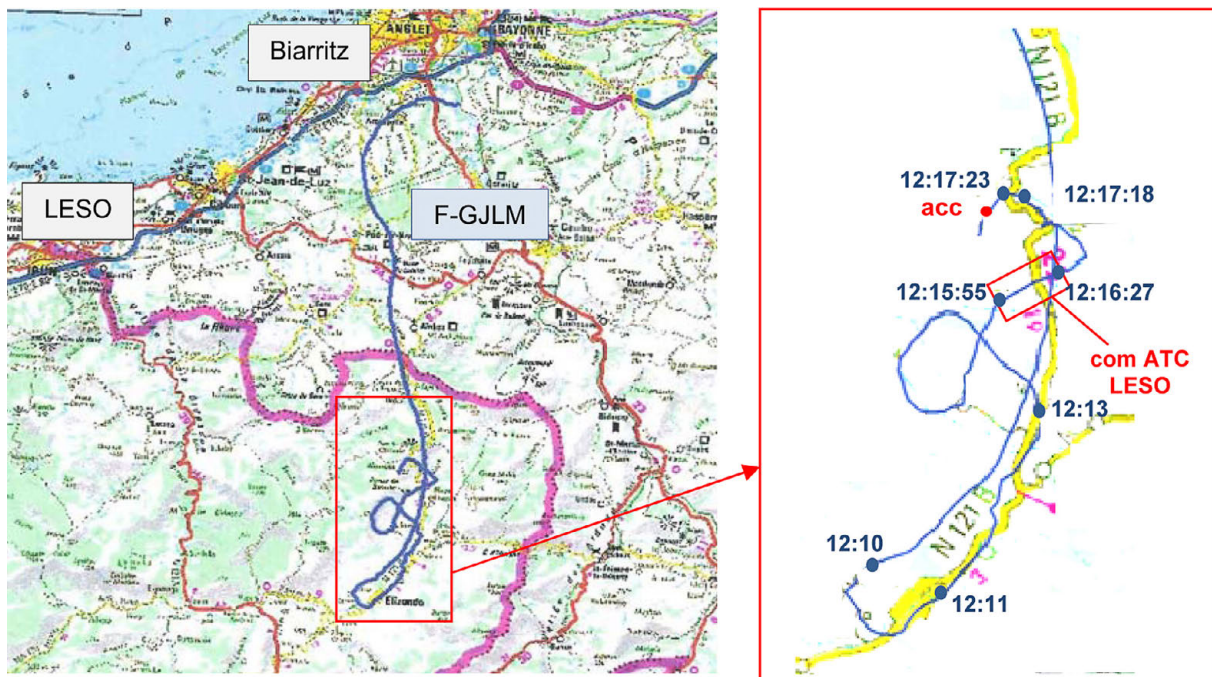
At 12:00 h, the aircraft changed course to the south after reaching Biarritz. It followed road N121B to the town of Elizondo, which it reached at 12:11 h. From then on, the aircraft headed back to the north. It followed road N121B for two minutes, made a full turn, advanced to the north and then started another turn. It was during this turn that the impact occurred.

Figure 2. Radar flight path of final 17 minutes of flight

12:11-12:13	North heading along road N121B. Climb from 1,700 to 2,200 ft.
12:13-12:15:55	Full turn. Climb from 2,200 to 3,500 ft
12:15:55-12:16:27	Northeasterly heading and descent from 3,500 to 3,200 ft. 1 <sup>st</sup> exchange with LESO TWR: 3,500 ft and 100 kt. 2 <sup>nd</sup> exchange with LESO TWR: 3,400 ft and 100 kt. 3 <sup>rd</sup> exchange with LESO TWR: 3,300 ft and 120 kt.
12:16:27-12:17:18	Northwesterly heading.
12:17:23	2,200 ft and 140 kt airspeed.
12:17:23-12:17:28	Southerly heading and descent from 2,200 to 2,000 ft.
12:17:28	Last confirmed radar echo: altitude 2,000 ft and 140 kt.

The last radar returns are consistent with the area in which the wreckage was found, as well as with the aircraft's heading at the time of impact, though the last radar echo received by ATC was at 12:17:35 h from a position slightly south of Alkurruntz Mountain, and the aircraft was found northeast of this peak. The last return, therefore, was likely calculated by the system and can be ruled out as a valid echo.

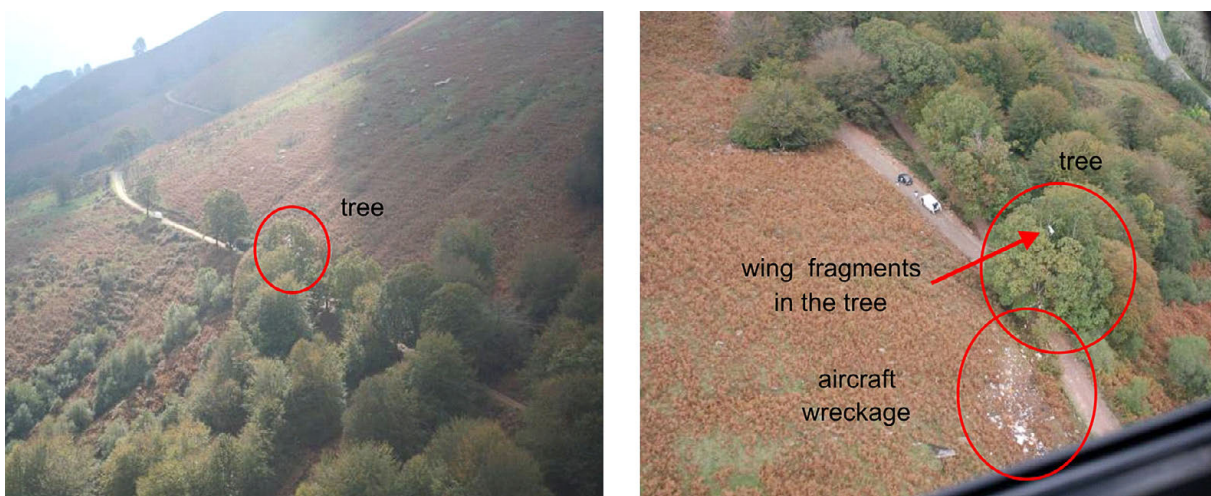
The wreckage showed signs of a frontal impact at high speed. The aircraft first struck a tree (Figure 3), which caused it to lose its wings, and then the side of Alkurruntz

Figure 3. Aerial view in direction of flight (left) and debris field (right)

Mountain. The aircraft, made of wood and fabric, broke into small pieces that scattered along the mountainside. The most distant fragments were 68 m away from the tree. The bodies of the passengers and the pilot were between 51 and 68 m away, the propeller was 47 m away and the empennage was 27 m away. The fabric from one of the wings was hanging from a tree and fragments from the other wing were found on the ground.

The way in which some of the tree branches had been cut indicates that they were cut by the propeller. Other branches had been torn off and dragged and were found on the ground.
