DATA SUMMARY

Date and time	Friday, 3 December 2010; 09:46 h UTC¹
Site	Sabadell Airport (LELL) (Barcelona)

Registration	EC-KJN
Type and model	TECNAM P2002-JF
Operator	Top Fly

APPENDIX I
Diagram of aircraft trayectory

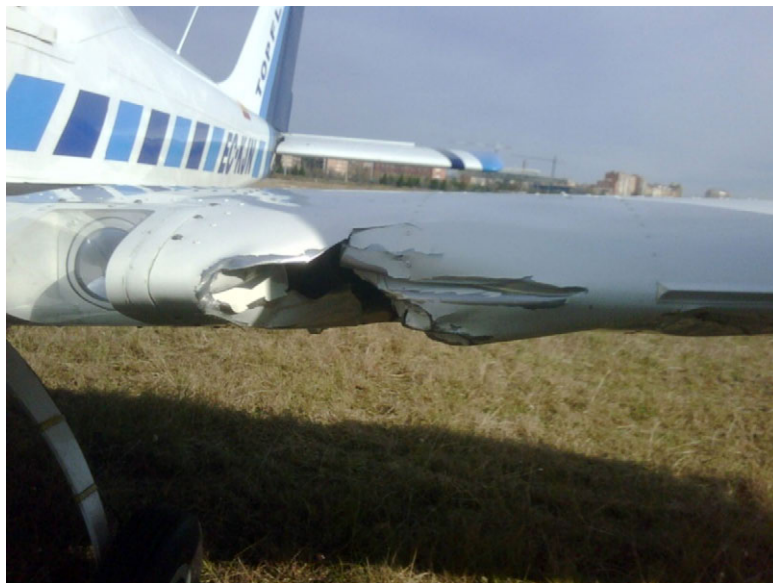
The student was not injured. There was considerable damage to the aircraft's left wing. One of the four units that comprise the PAPI was damaged. An aircraft that was preparing to land two minutes later had to execute a go-around and the runway was closed to traffic for 25 minutes.

Figure 1. Damage to the aircraft

The incident occurred due to the improper application of the technique for taking off in a crosswind. The student pilot's little experience and the lack of effective supervision by the training center were contributing factors.

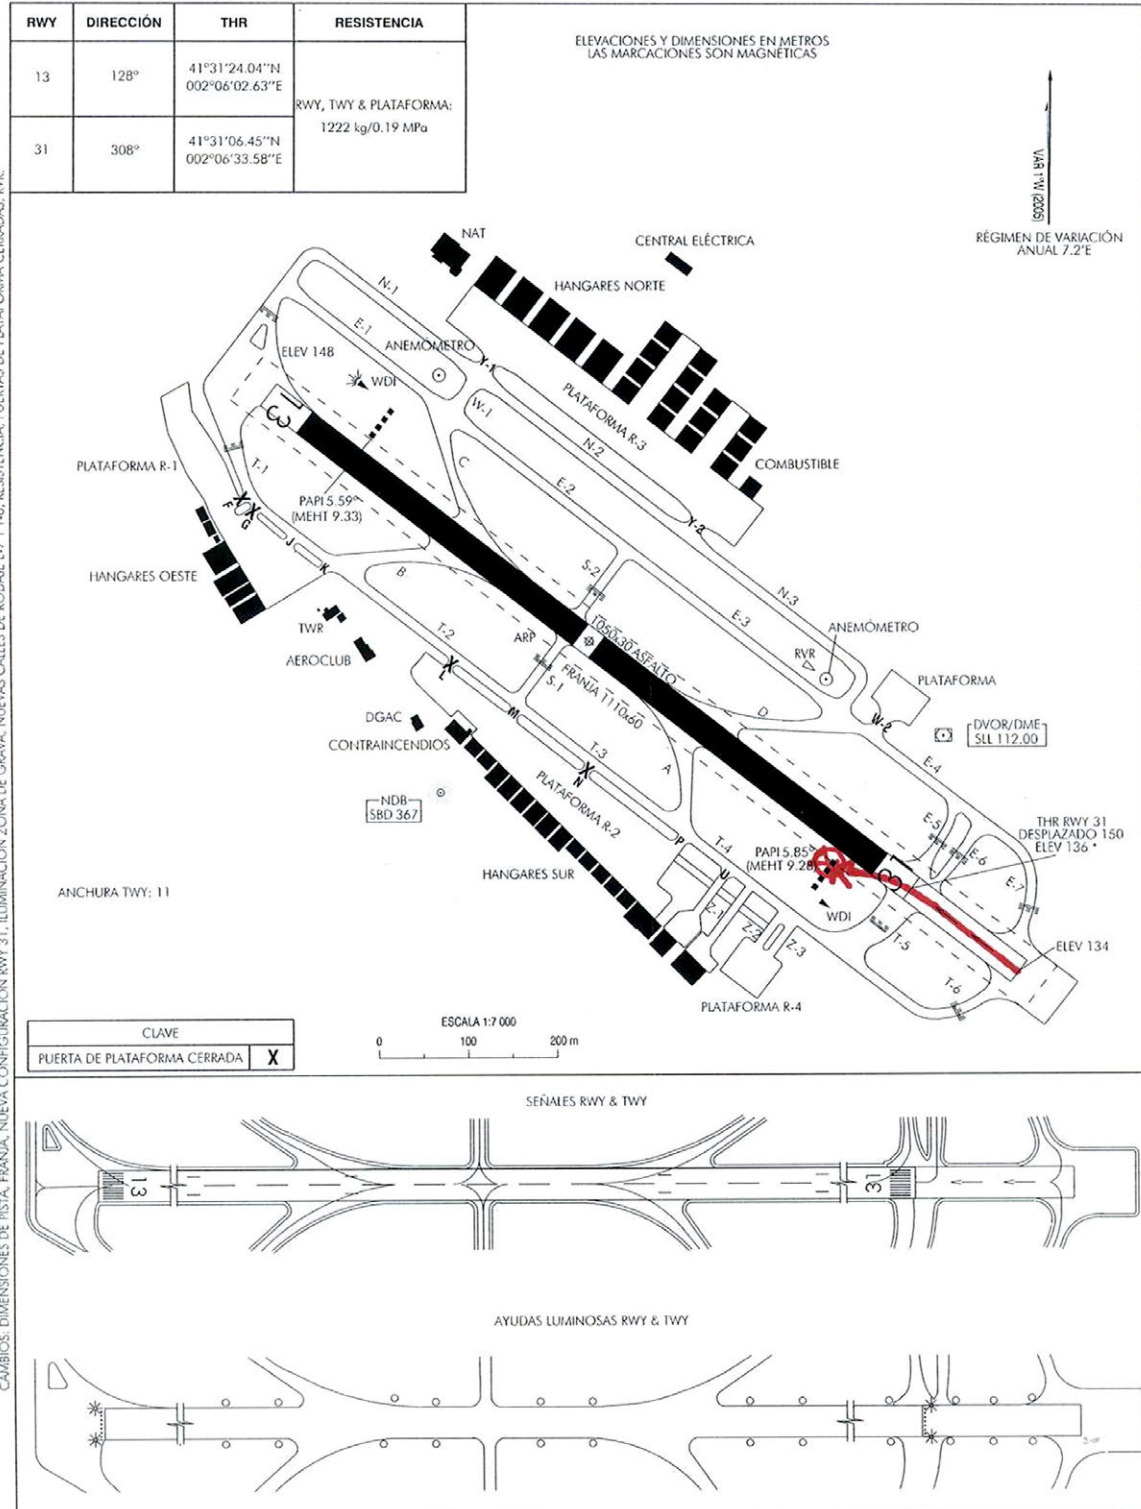
On 3 December 2010 at 09:30, a student pilot was scheduled to make a local solo flight, leaving from and returning to LELL, onboard a Tecnam P2002-JF aircraft, registration EC-KJN. According to the student's statement, he had prepared all of the necessary documentation and had filed it with the Operations Department at the flight school in order to obtain his instructor's authorization, a prerequisite for making the solo flight. After doing the pre-flight check of the aircraft, the student contacted the control tower, which cleared him to proceed to the runway 31 holding point. Once there, and having completed the relevant engine checks, the student reported being ready for takeoff. The tower instructed him to line up and hold, and subsequently cleared him to take off, reporting wind from 250 to 270 at 15 kt². On starting the takeoff run, the aircraft ran over a bump and started to bounce and veer to the left. The student tried to correct the course with the rudder pedals. When he reached an IAS³ of 40 kt, the student decided, while still on the runway, to cut the throttle and apply the brakes, but the aircraft departed the runway and struck a PAPI⁴ (see Appendix I).

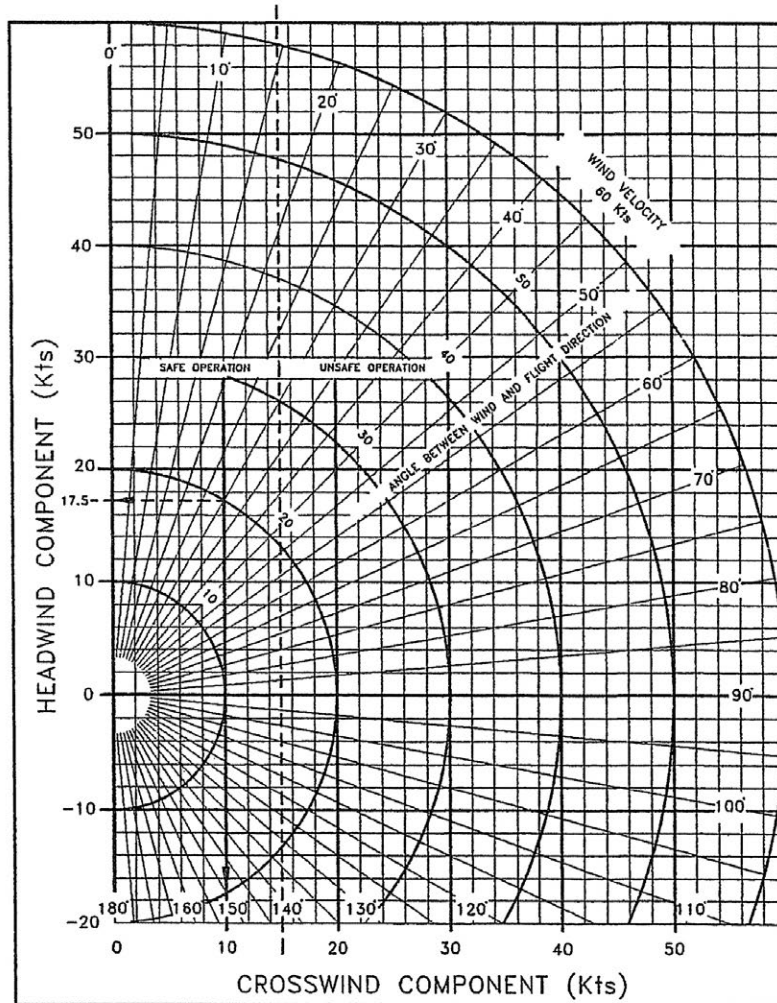
Fig.5-3.CROSSWIND CHART

According to the Aircraft Flight Manual in the school's possession, dated 29 March 2004, the maximum demonstrated crosswind velocity was **6 kt**. In the graph adjoining this section, however (see Appendix II), the limit separating the Safe Operation zone from the Unsafe Operation zone was 15 kt.

Maximum demonstrated crosswind velocity is 6 kts

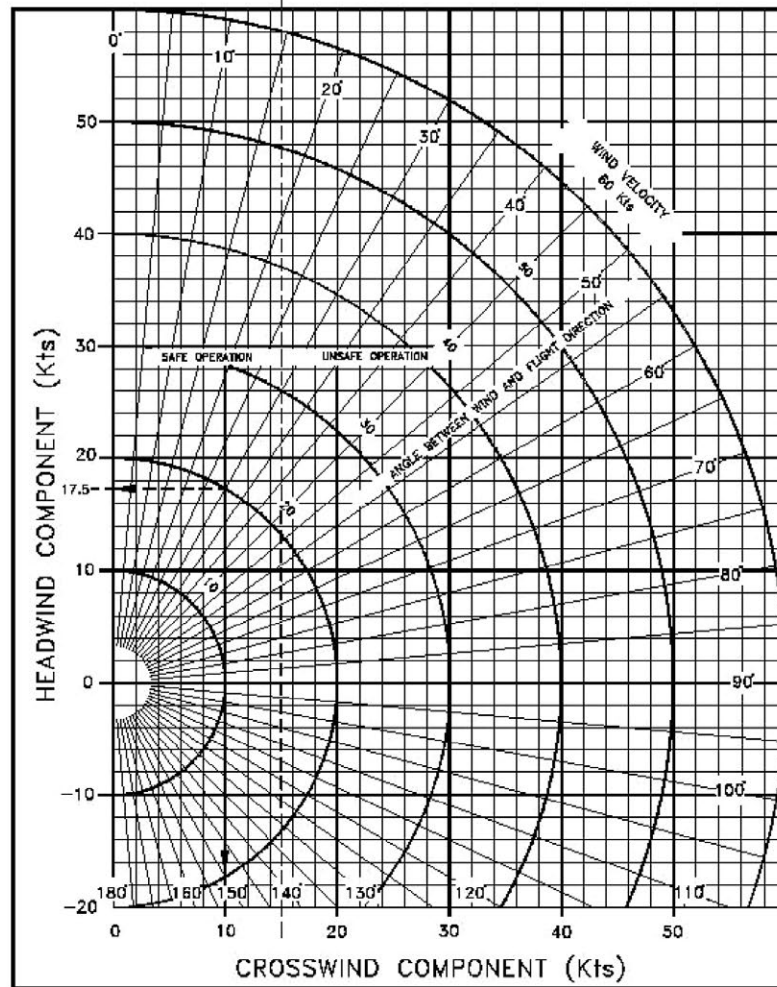
Fig.5-3.CROSSWIND CHART

This manual was compared with the updated version (notified via Service Bulletin no. P2002/03, approved by the EASA on 3 August 2005) sent by the manufacturer, which revealed one change in this regard. The *maximum demonstrated crosswind velocity* had been changed to **22 kt**, though the limit between the Safe and Unsafe Operation zones

was still 15 kt. The manufacturer was asked about this significant difference between the crosswind speeds, to which it replied that initially, it had been unable to conduct tests at speeds in excess of 6 kt, and that until winds in excess of 22 kt were present, it could not verify that the aircraft could withstand those conditions. With regard to the 15-kt limit, the manufacturer committed to making the relevant updates, though this Commission is unaware of any such changes having been made yet.

Maximum demonstrated crosswind velocity is 22 kts
