REPORT IN-010/2011

Date and time	Saturday, 9 April 2011, at 12:59 UTC¹
Site	Menorca Airport (LEMH), Maó (Menorca)

Registration	EC-IJS
Type and model	Bombardier-CL600-2B19 CRJ 200
Operator	AIR NOSTRUM

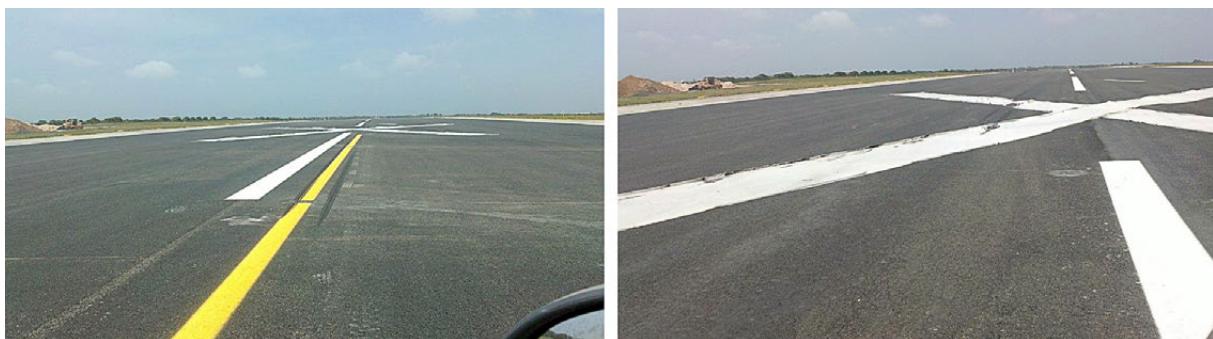
Figure 2. Landing marks, first from right gear and then from left, near the fourth runway-closed marking

The crew also stated that the runway lacked the proper marking to indicate it was closed. The airport reported that the closed runway was marked, consisting of ten x-shaped markings, two painted in front of the displaced thresholds and eight cloth x's laid out along the runway. These markings are in keeping with Chapter 7 of Annex 14, as well as with Aena's Movement Area Markings Manual (see Appendix C), which stipulates the marking to be displayed at either end of a closed runway and along its length. The "x" shapes situated along the runway were made out of cloth and not painted on the pavement because the runway was practically ready to be reopened, a circumstance that the regulation takes into consideration in the event of temporary runway closings. The dimensions of the markings and the separation between them also adhered to regulations.

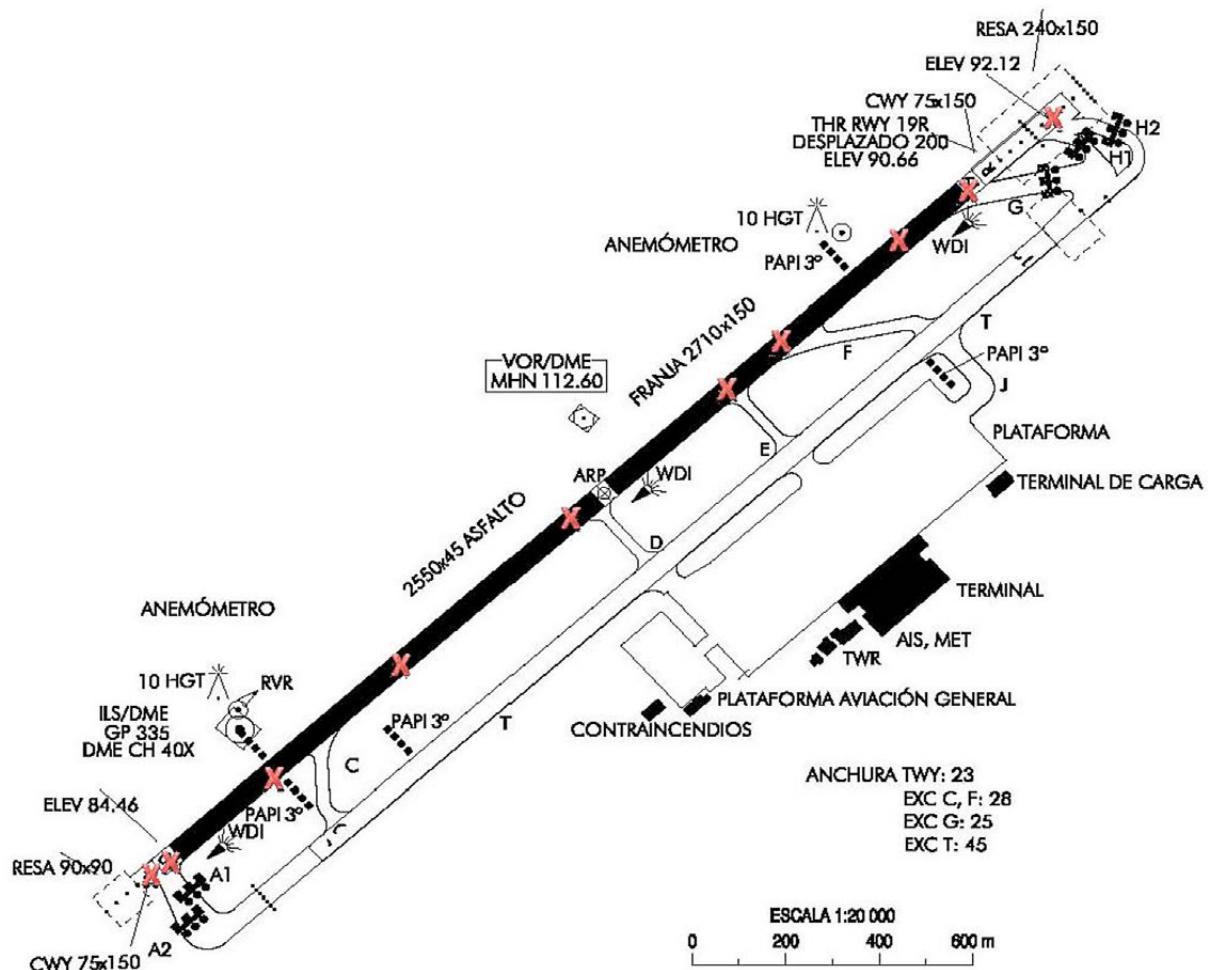
Diagram of the runway-closed markings and information on runway-closed signs

The airport reported that the horizontal runway-closed markings used consisted of ten x-shaped symbols, two painted on the displaced runway thresholds and eight made of

cloth on the runway (see Appendix C, Diagram of the runway-closed markings and information on runway-closed signs).

- The crew acknowledged the clearance to land on runway 01R.
- The crew landed on runway 01L.
- Runway 01L was closed to traffic and had markings in accordance with ICAO Annex 14, as well as with Aena's Movement Area Markings Manual.
