**DATA SUMMARY**

Date and time	<b>Thursday, 9 June 2011 at 09:40 UTC<sup>1</sup></b>
Site	<b>Tenerife North Airport (GCXO), Tenerife</b>

Registration	<b>EC-KDP</b>
Type and model	<b>PIPER PA-34-200T "Seneca II"</b>
Operator	<b>Private</b>

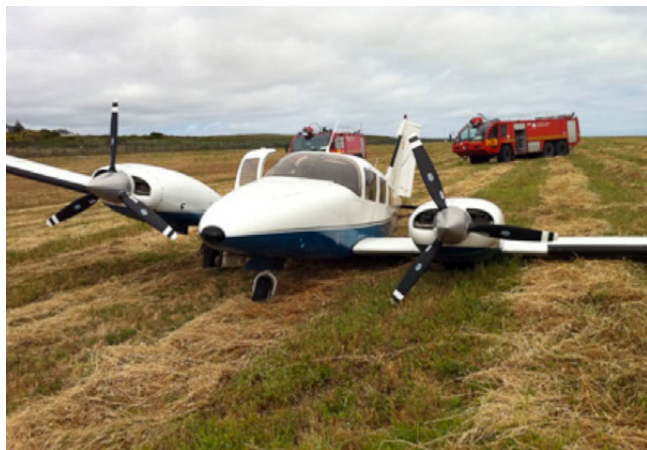
Figure 1. Final position of the aircraft

The aircraft suffered damage mainly to its left wing (wingtip, aileron and flap). The pitot tube was also torn off and there were dents and scratches on the underside of the fuselage and on the rear horizontal stabilator.

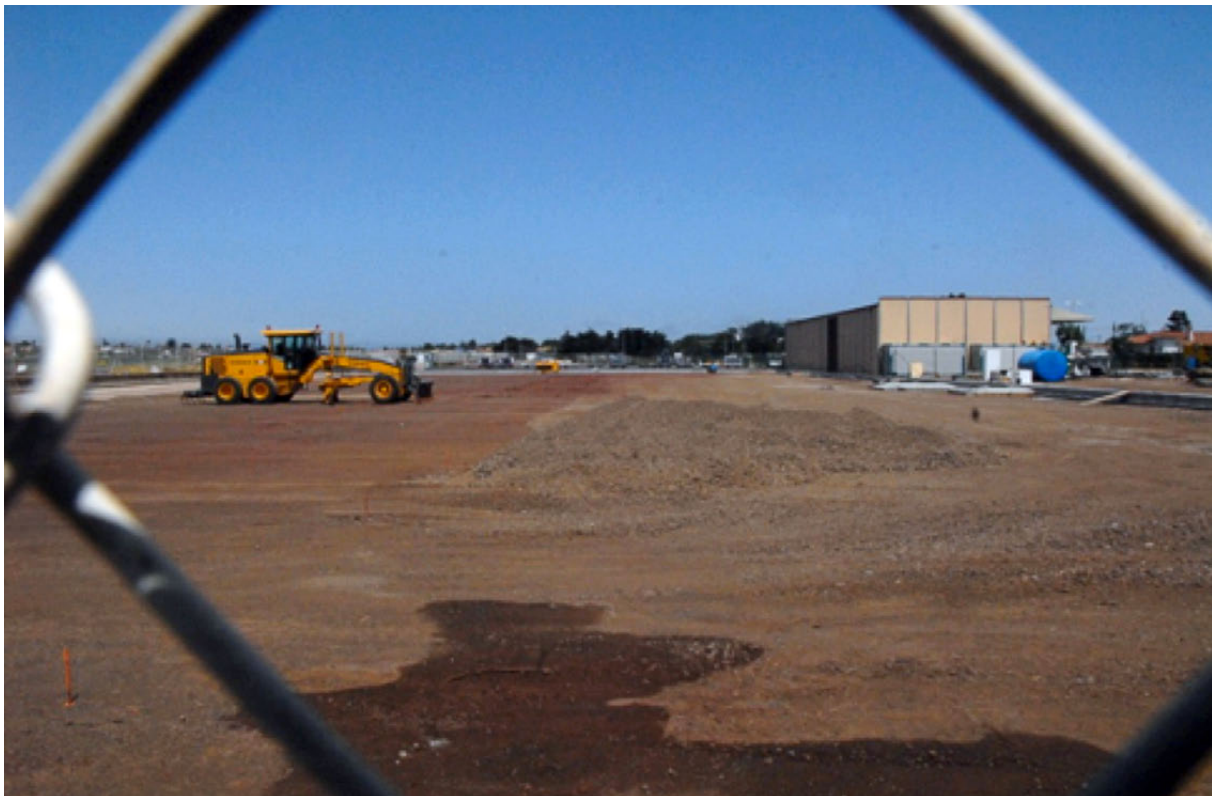
At the time of the incident work was being done on the airport apron in an area near the aircraft's usual parking stand (within some 20 m). The work consisted of breaking up the pavement and digging some two meters deep for the purpose of building a new apron and hangar (see Appendix 1 and figure 4).

Figure 4. Work near the aircraft's usual parking stand

The aircraft was normally parked outdoors in the general aviation parking, very close to the area where work was being performed to expand the apron, which meant that the prevailing northerly winds typical on the island would carry dirt and dust in the direction of the parked aircraft.
