Report A-018/2011

Accident involving
a CESSNA 182 T aircraft,
registration SP-CFM,
at the Asturias airport,
on 6 June 2011

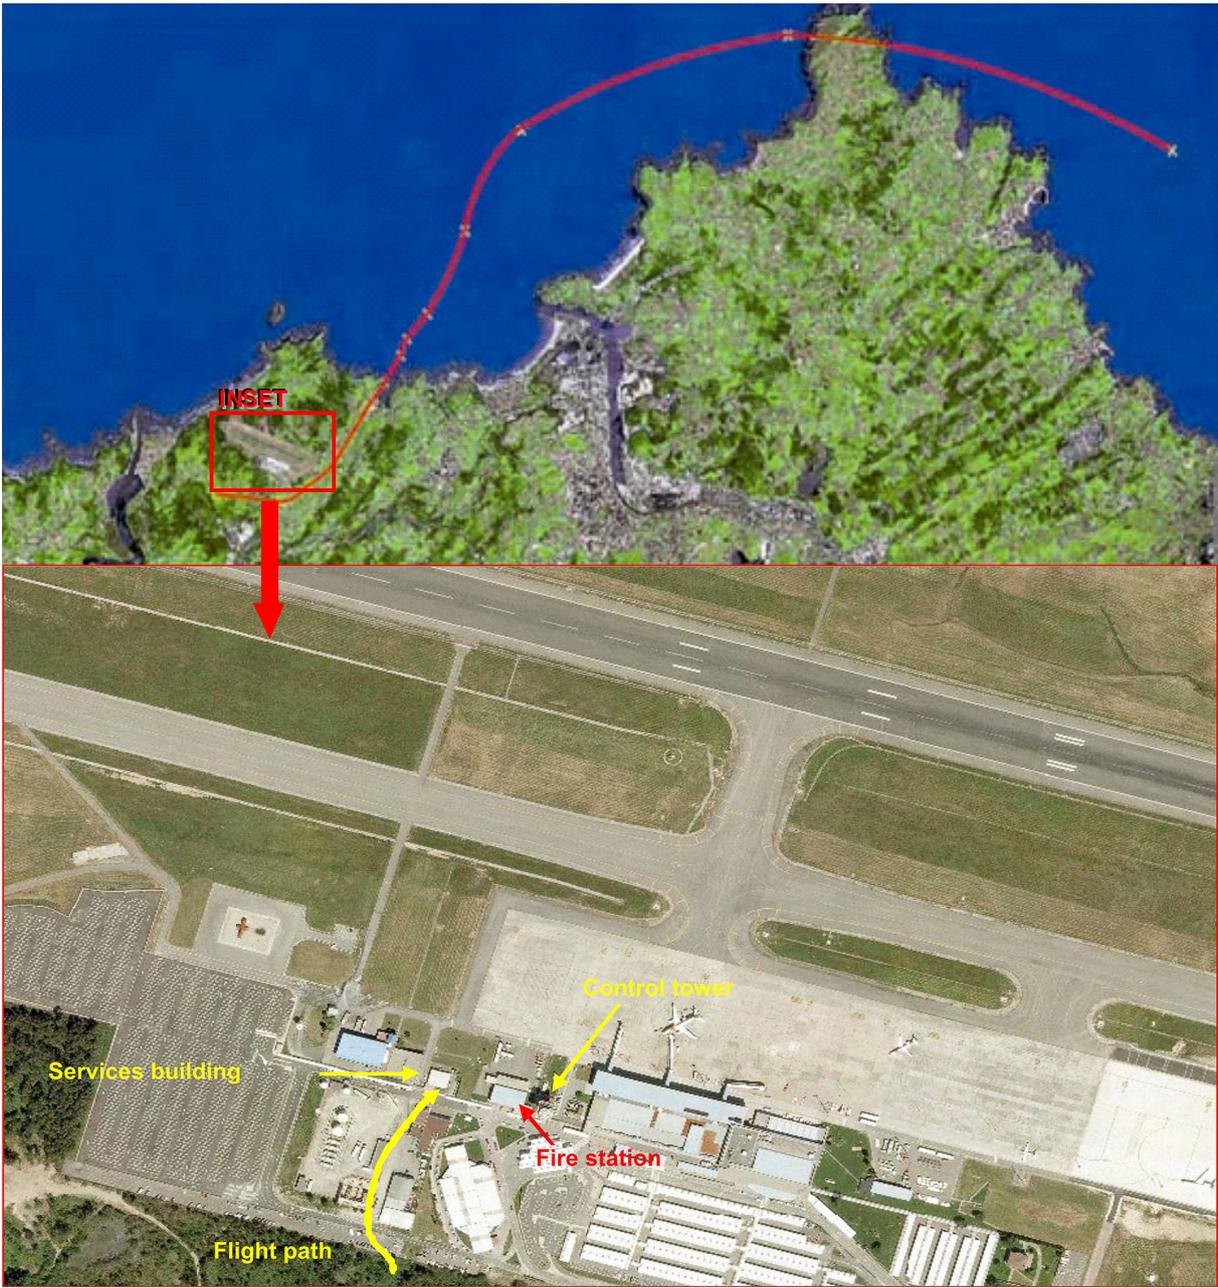
Figure 1. Radar track and last moments of the aircraft trajectory

Despite having received this information, at around 13:59 the aircraft crossed over the coastline some 1.3 NM away from the airport in the direction of the airport. A few seconds later the controller informed the aircraft that the airport was in low visibility conditions (making a visual landing impossible). There was no apparent reaction from the aircraft, which continued to descend until it finally impacted the ground within the airport complex.

- In the time between the aircraft's last message to the tower and its being found by emergency crews, the airplane had crossed the extension of runway 11 from the northeast to the southwest, perpendicular to the runway centerline. It then made a turn of just over 180° and impacted in controlled flight the accessible platform atop the airport services building, near the tower.

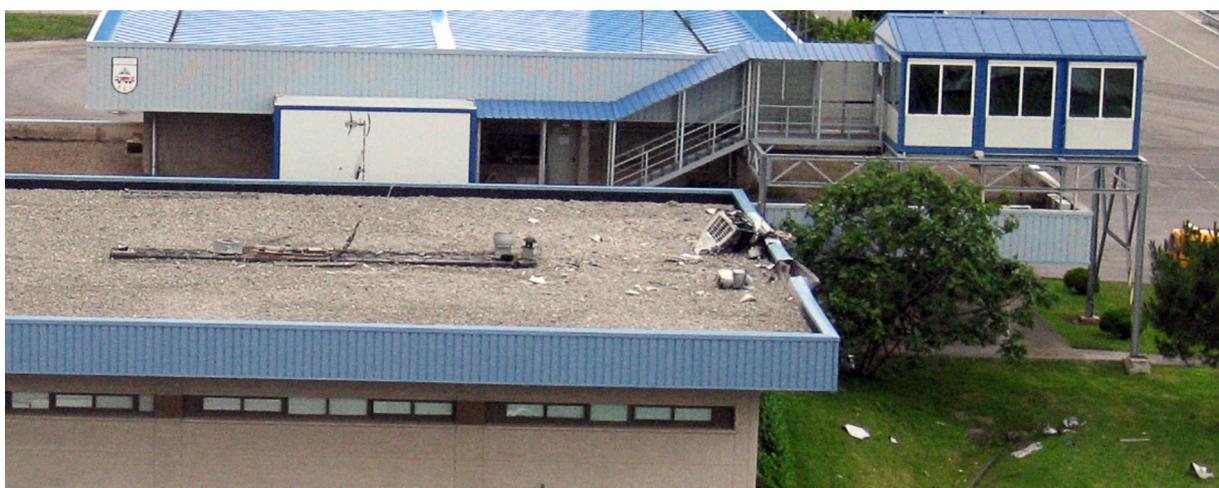
The aircraft struck the HVAC equipment of the airport's services building, tearing it away from its support structure (figure 2).

It also struck the edge of the roof, breaking the wall and the sheet metal covering it. Part of the HVAC equipment fell on the lawn located next to the building's entrance.

Figure 2. Photograph of damage to the services building roof

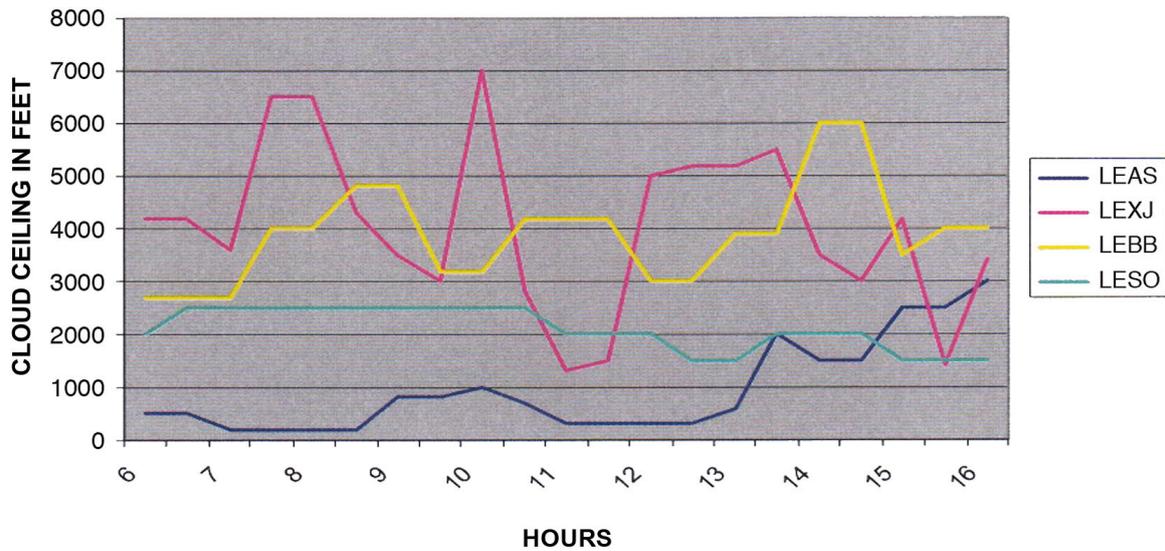
The graph in figure 3 shows the cloud ceiling present at the various airports along the aircraft's path from 06:00 (UTC) until 16:00 (UTC).

Figure 3. Cloud ceiling at the various airports

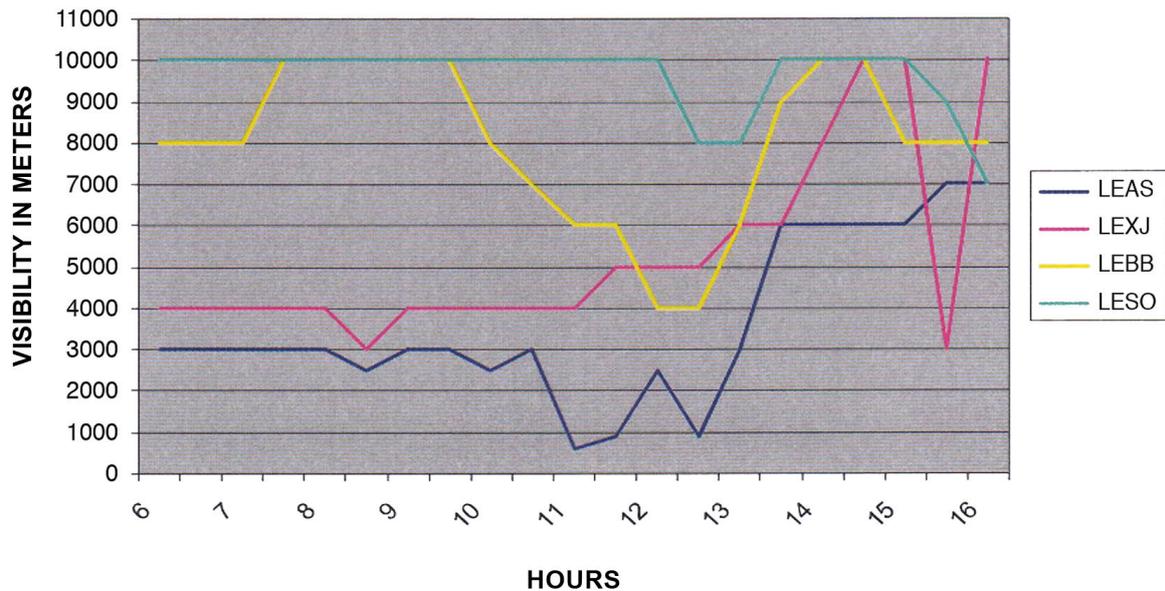
The graph in figure 4 shows the visibility at those airports for the same time period.

Figure 4. Visibility at the various airports

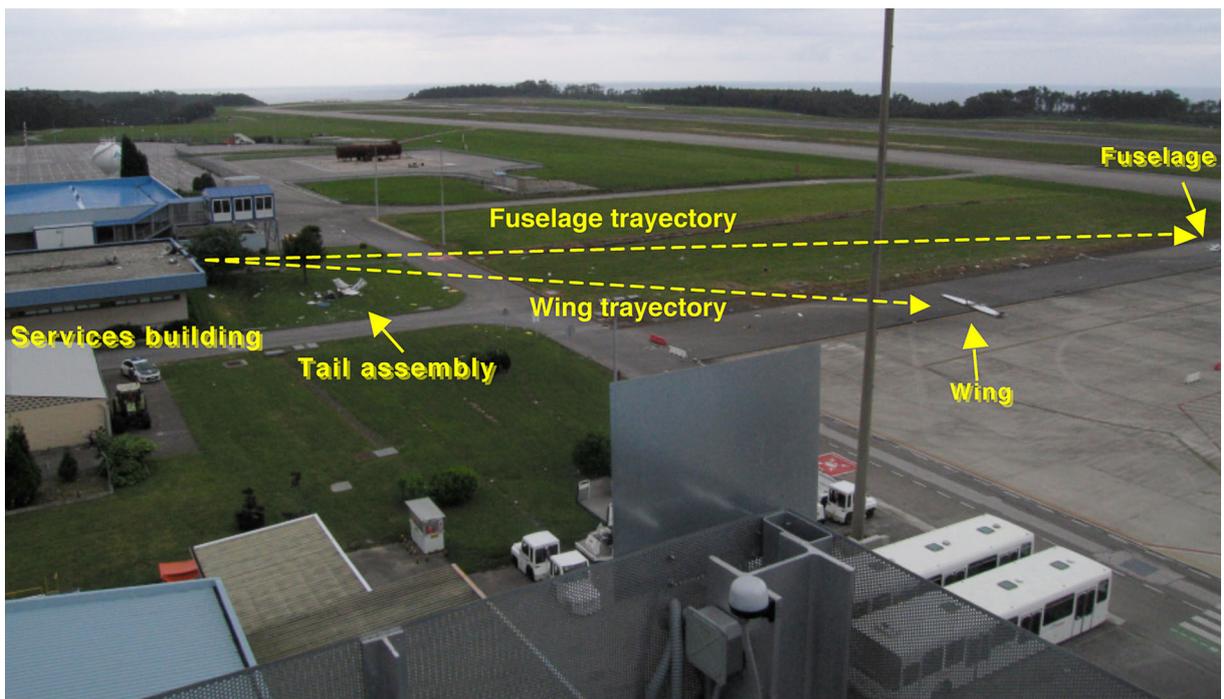
Figure 6. Photograph of wreckage taken from the tower

- As a result of the impact the airplane broke into three pieces, the tail assembly, fuselage and wing, which were ejected forward.
- The occupants, who died on impact, were expelled from the airplane and found next to it on the ground.

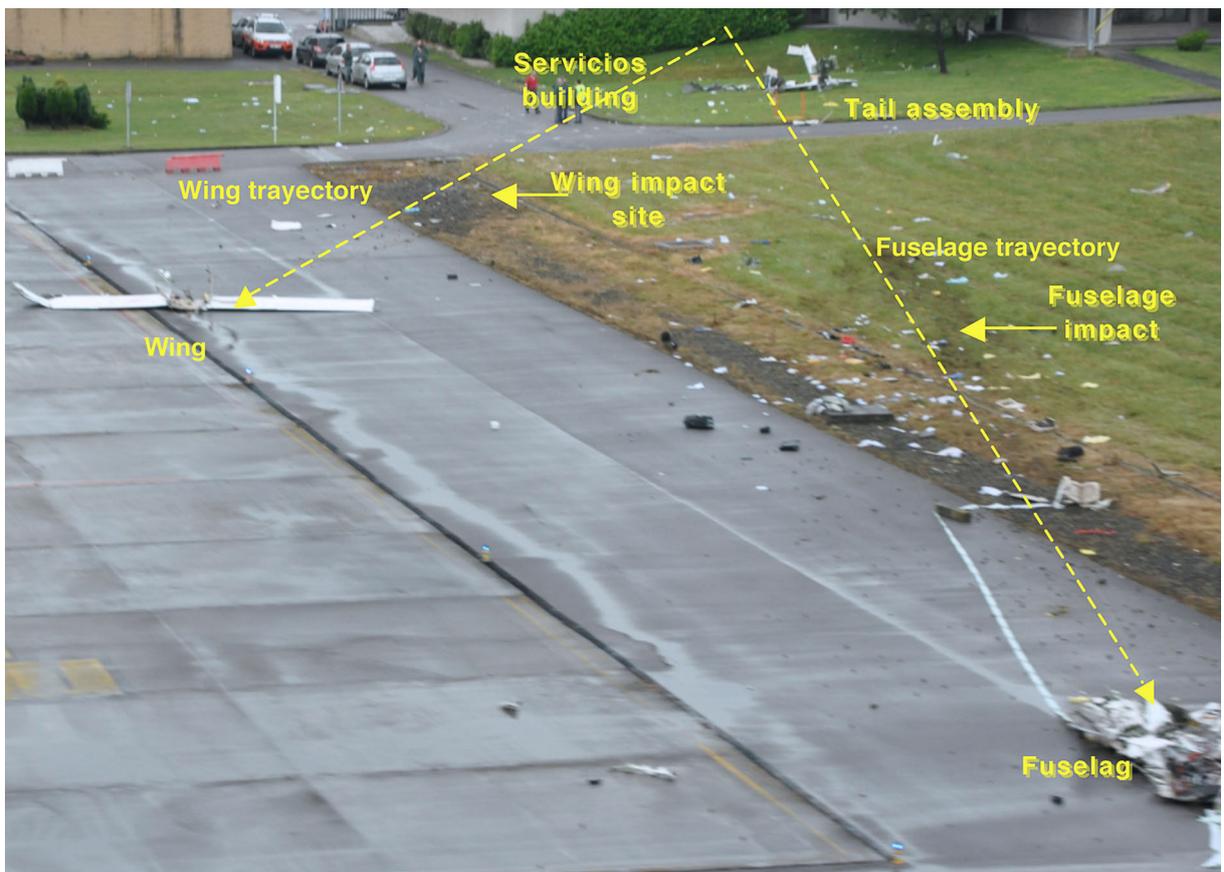
Figure 7. Photograph of wreckage taken from the runway

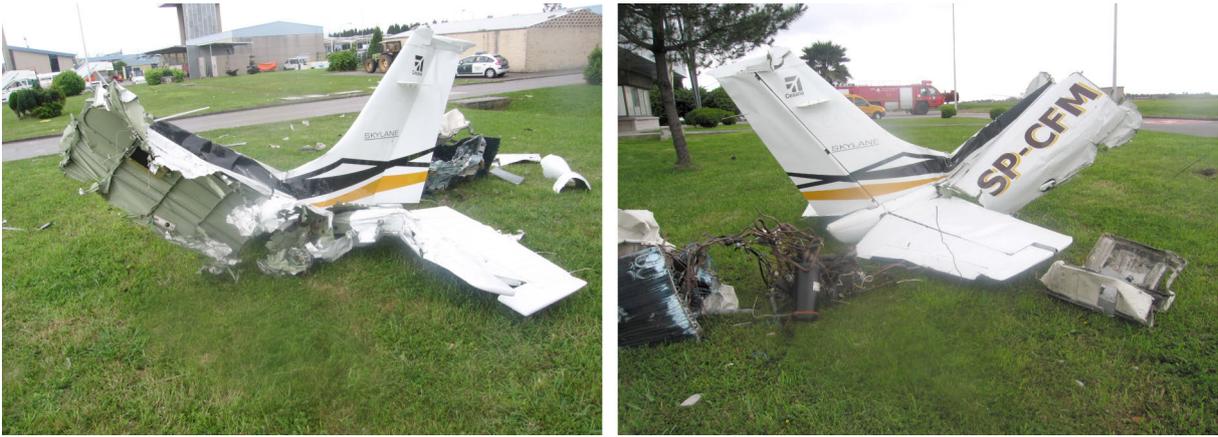
Several smaller pieces were ejected in various directions and scattered in a 100 m radius. The rear section of the fuselage, which remained attached to the tail assembly, had a gash on its left side. The right side was less affected. Part of the climate control equipment was found next to the tail cone, as shown in the right picture of figure 8.

Figure 8. Photographs of tail assembly

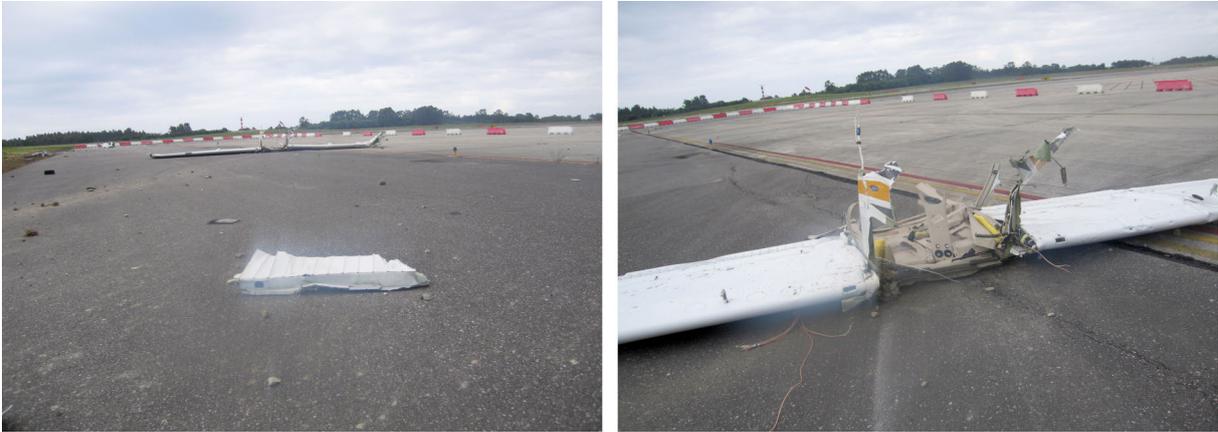
The wing was torn off in one piece and fell on the same section of grass as the above section, sliding on its top side to the apron, where it stopped. It was not badly damaged and had almost all of its components, except for the tip of the left aileron, which detached and was found 20 m further forward.

Figure 9. Photographs of the wing

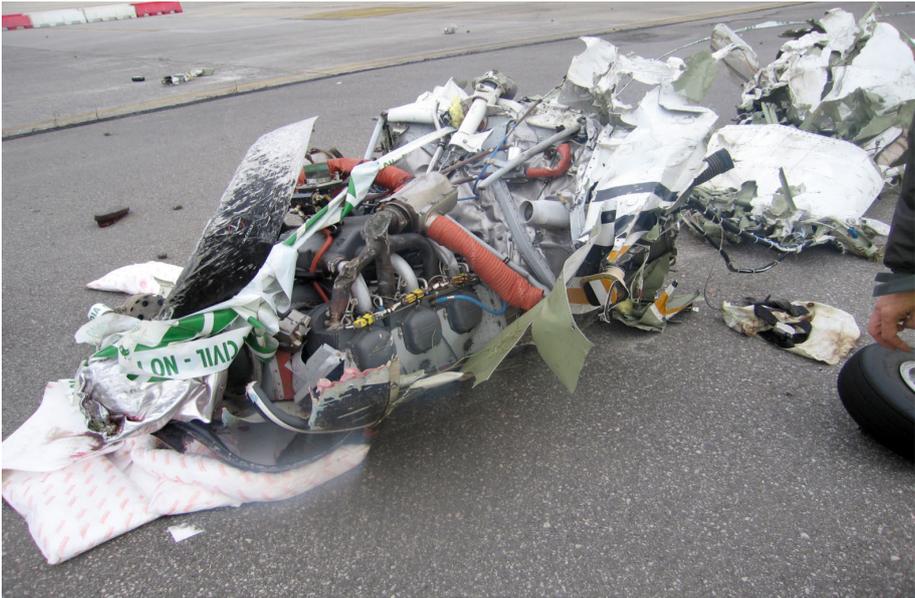
The entire assembly was heavily damaged. The front part, which housed the engine, was upside down and detached from the cockpit area.

The cockpit was completely destroyed, making it difficult to ascertain the positions of the controls. The throttle controls, propeller pitch and mixture were not in the full forward position.

Figure 10. Front part of the airplane
