**DATA SUMMARY**

Date and time	<b>Monday, 11 July 2011, 21:00 local time</b>
Site	<b>San Carles de la Rápita (Tarragona)</b>

Registration	<b>EC-JLB</b>
Type and model	<b>AIR TRACTOR AT-802A</b>
Operator	<b>SAETA (Servicios Aéreos Europeos y Tratamientos Agrícolas)</b>

Date of approval	<b>19<sup>th</sup> September 2012</b>
------------------	---------------------------------------

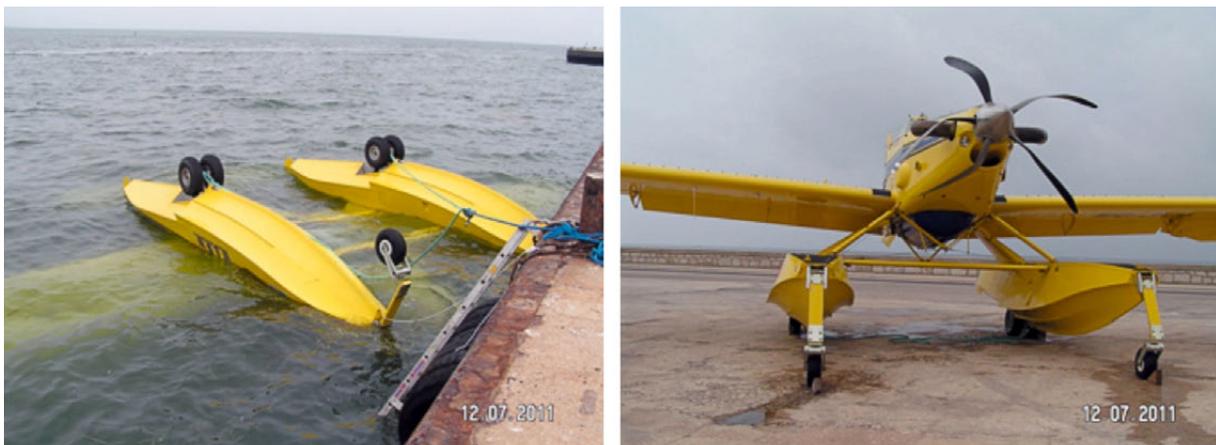
At 21:00, while taking on water, the aircraft suffered an accident due to the fact that the gear was extended. The aircraft turned over and remained floating on the surface upside down. The pilot waited for the cockpit to fully flood, took the air bottle and left the aircraft under his own power without sustaining any injuries. The aircraft suffered minor damage to the left aileron and the propeller blades.

Figure 1. EC-JLB before and after being recovered from the water

There was minor damage to the aircraft's left aileron and propeller blades, indicative of an impact at low speed. The landing gear, which had been visually confirmed as being down before the recovery, was confirmed to be locked. The aircraft was placed on the gear once it was recovered from the water.

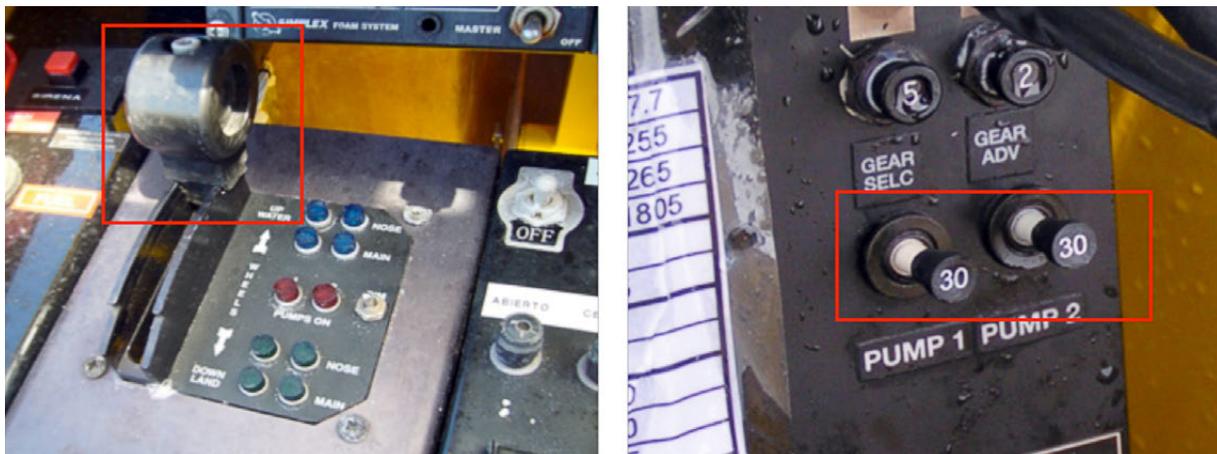
In the cockpit the gear lever was correctly situated in the gear up position and the circuit breakers for the hydraulic pump motors (labeled PUMP 1 and PUMP 2) were tripped. The gear extension lever was guarded, the propeller lever was in the forward position, the flaps were extended 20° and the water scoop system was in manual. The GEAR ADV breaker associated with the acoustic notification for the gear was not tripped.

Figure 2. Gear lever in the UP position and tripped gear pump breakers

One possibility is that the lever was placed in the gear up position just before the water landing, so that the gear did not have time to fully cycle. The hydraulic pump motors would have turned on to move the gear and the contact with the water with the motors running would explain why the breakers were found tripped after the accident. However, the gear retraction cycle, even if not completed, should have at least started, and in the case of EC-JLB, none of the gear components showed signs of moving toward the retracted position. Thus, while this hypothesis does explain the position of the breakers and gear lever, it does not account for the gear position.

It seems very likely, then, that the breakers were opened at the start of the flight by the pilot while preparing for the flight.

**REC 38/12.** It is recommended that SAETA (Servicios Aéreos Europeos y Tratamientos Agrícolas), as the operator of the flights, and concerning the checklists:

- Enhance its pilot training with regard to the need to execute the checklists as an important safety element that aids in ensuring that the airplane is properly configured, and also bearing in mind that it is a single-pilot operation.
- Analyze the suitability of the checklists used as a possible reason for the routine pilot practice of not completing the lists during operations. The review should at least consider aspects such as the font size, the numbering of items and the amount of items on each list.
- Adapt the checklists to the additional equipment installed onboard each aircraft. Specifically, with regard to aircraft EC-JLB, the checks made prior to the operation of the gear position warning system should be included.
