DATA SUMMARY

Date and time	Saturday, 17 September 2011; 11:12 UTC
Site	Palma de Mallorca Airport (Spain)

Registration	EC-LAJ	LN-RRH
Type and model	AIRBUS A320-214	BOEING B-737-800
Operator	Orbest	SAS

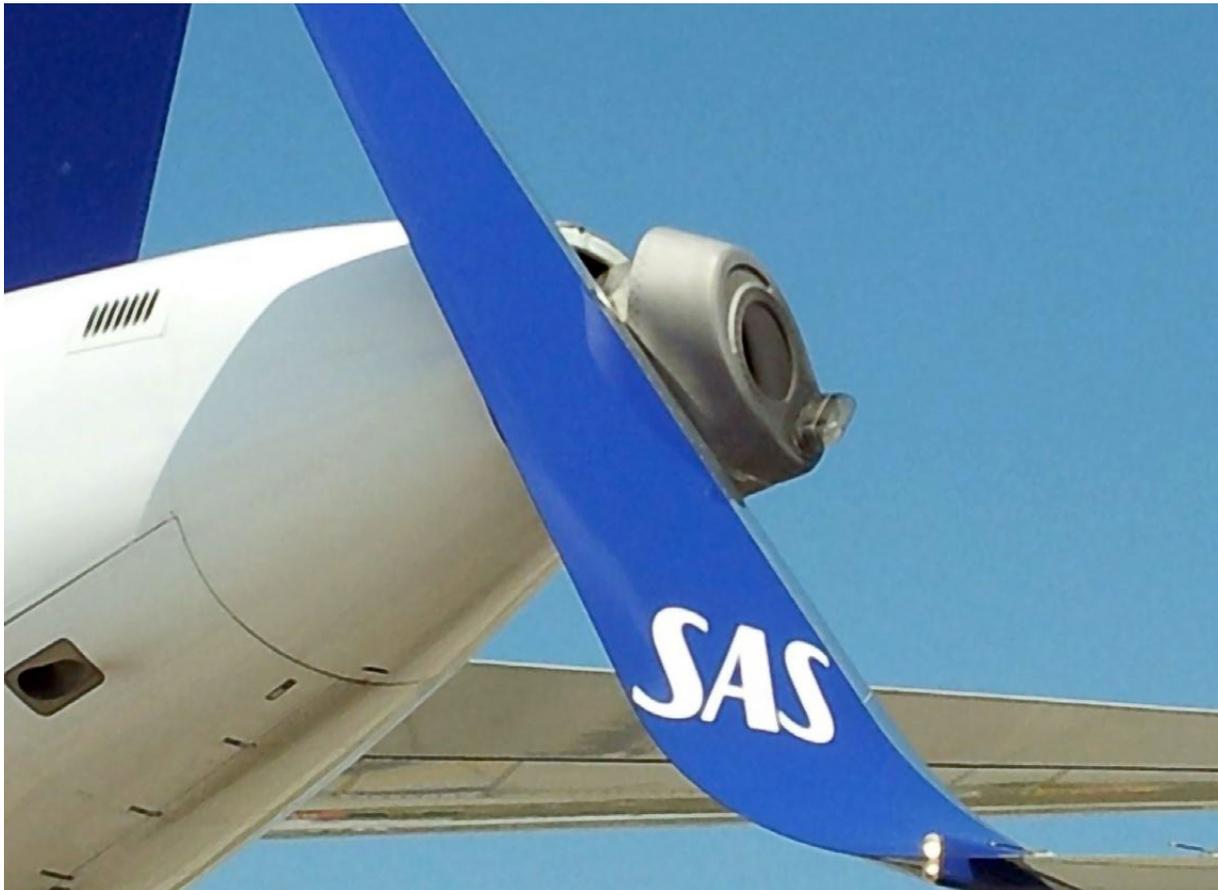
The controller sent a marshaller to check whether the two aircraft had impacted. He reported that there had been contact and that the left winglet on the B-737 was stuck on the APU exhaust cone on the A-320.

Figure 1. Photograph of the B-737's winglet caught on the A320's APU exhaust nozzle

The Airbus A320, registration EC-LAJ, suffered damage to the aft part of the fuselage that required replacing the entire section aft of frame 84, along with the APU exhaust gas pipe and the rail structure holding this part. The firewall on frame 84 also had to be repaired.

The damage to the Boeing B737, registration LN-RRH, was limited to the leading edge on the left wing and part of the skin on the left winglet.

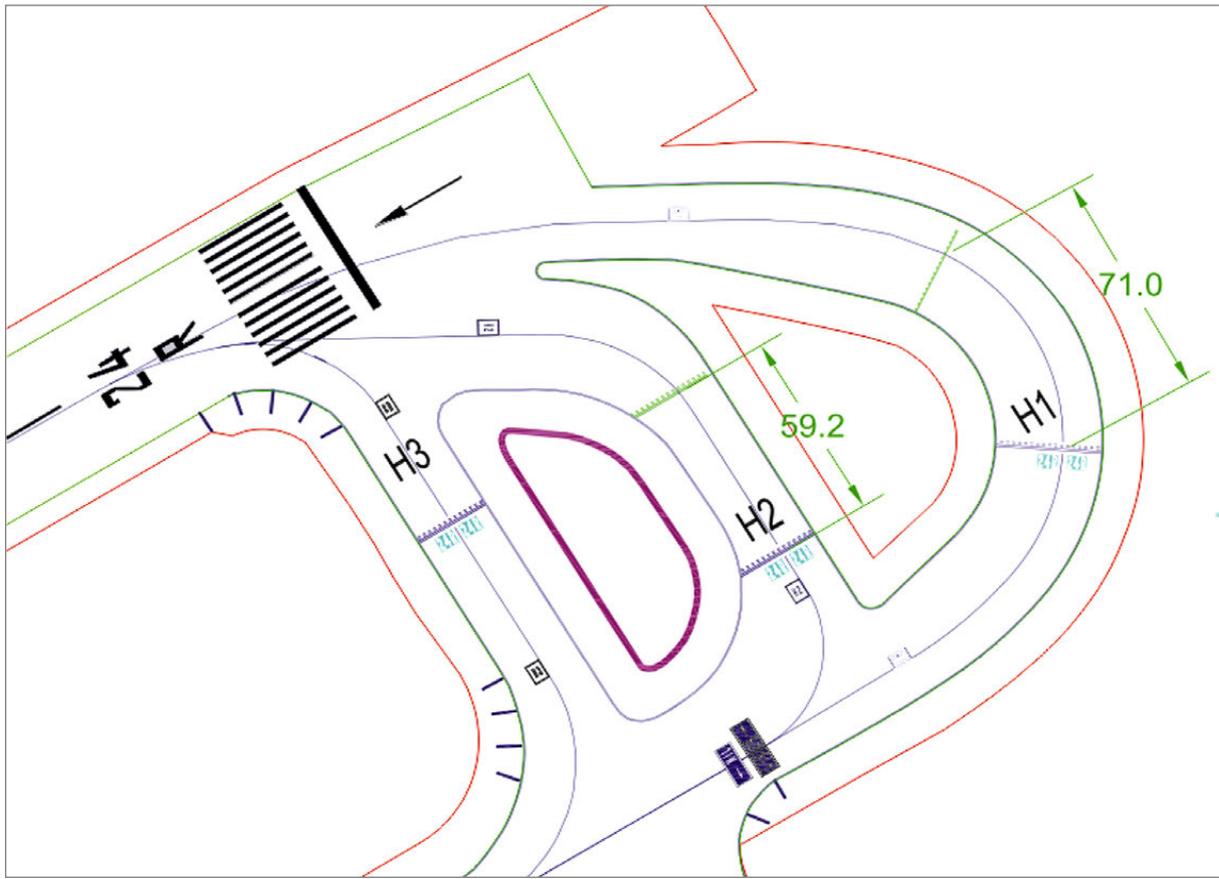
This is why the option adopted was to move the H-1 and H-2 holding points back 71 m and 59.2 m, respectively, to prevent penetrations into the approach surface (see Figure 2). No timeline was set for this though. This would result in reducing the distance between said holding points and the centerline of the "North" taxiway to an "unacceptable" level.

Figure 2. Setback of the H-1 and H-2 holding points

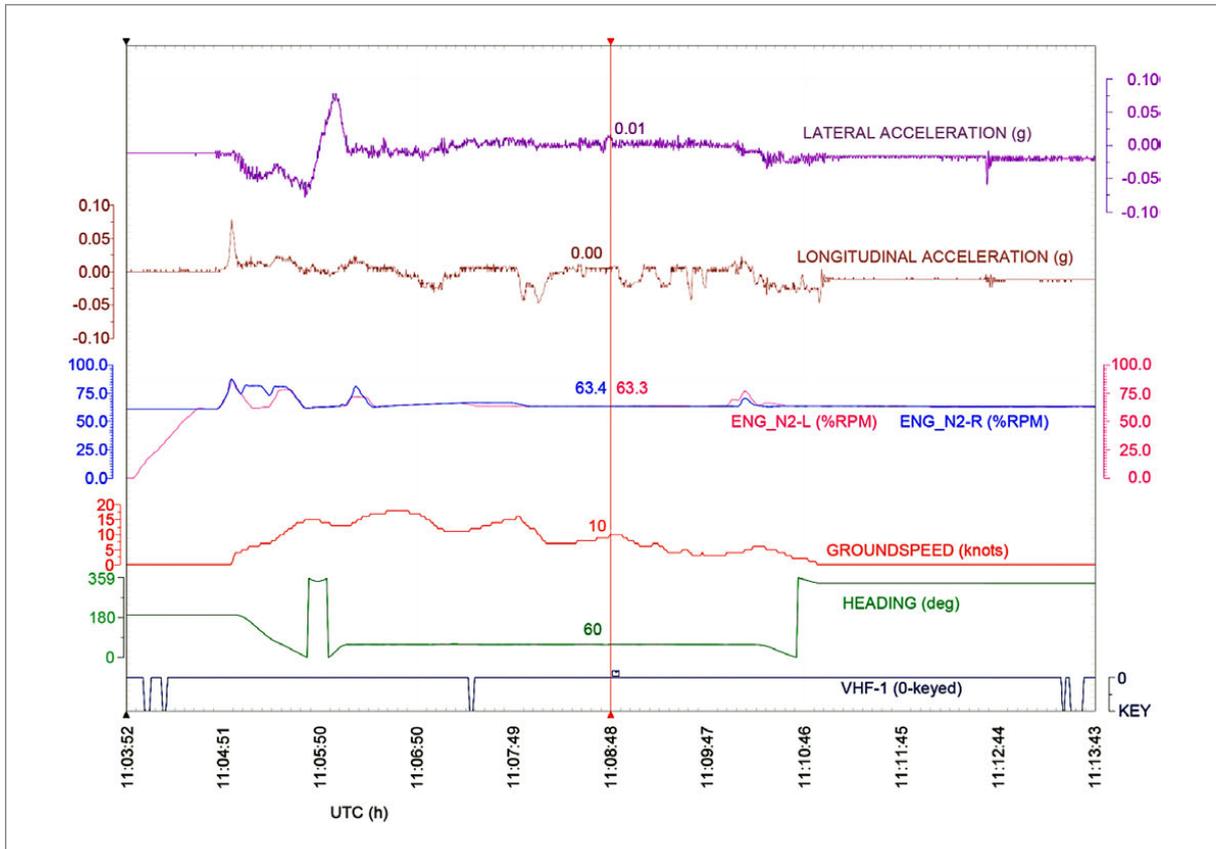
The graph in Figure 3 shows that at 11:12:37, there was a small variation in both acceleration values, though slightly greater in the lateral acceleration, possibly due to the collision between the two aircraft.

Figure 3. Trend in lateral and longitudinal accelerations, engine N2, ground speed, heading and keying of mike switch for the Airbus A320, registration EC-LAJ

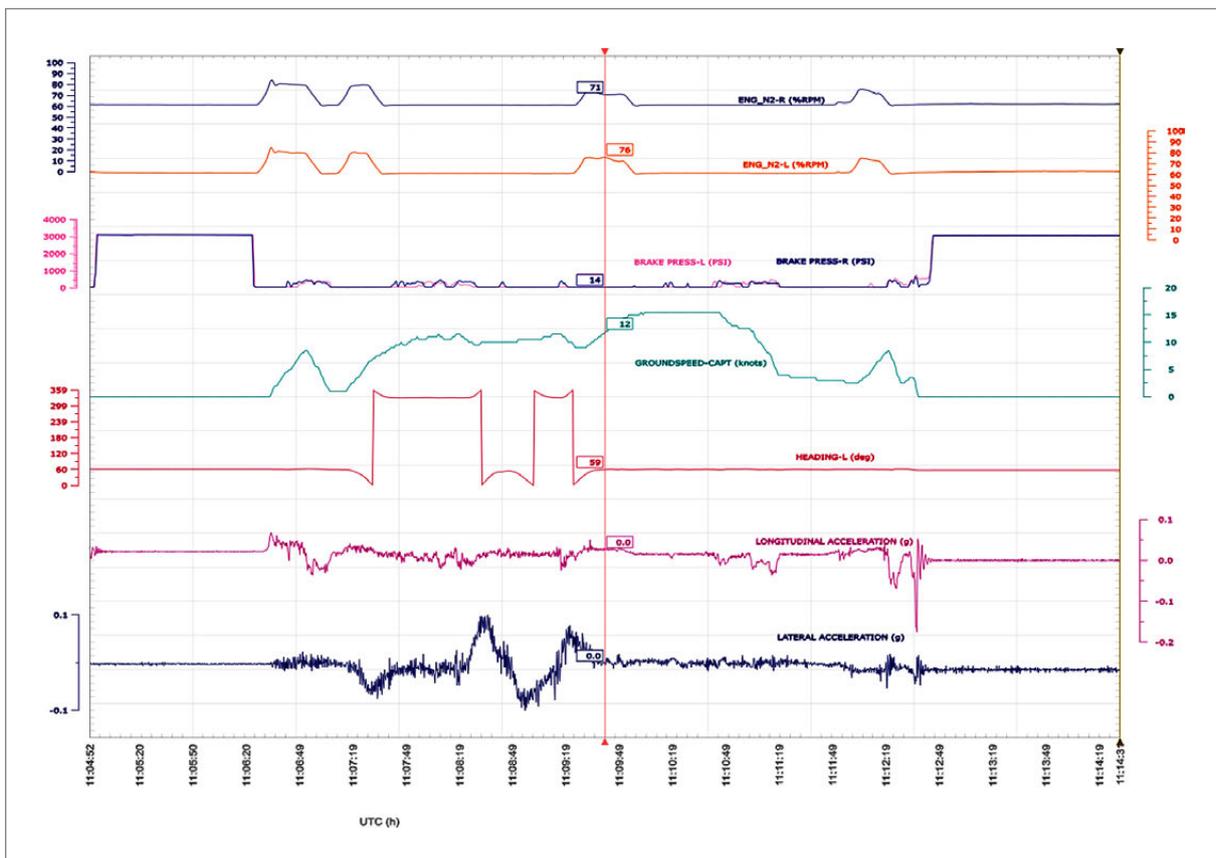
As the graph shows, the aircraft started moving at 11:06:30 UTC. The turn onto the "North" taxiway, which is the last turn to the right, was started at 11:09:19 and completed at 11:09:40. It started moving along this taxiway (heading 060), increasing in speed to a maximum of 15 kt. From 11:10:40 on, the captain applied the brakes and the aircraft started to slow, reaching a speed of 3 kt by 11:11:20 UTC.

Figure 4. Trend in engine N2, brake pressure, ground speed, heading and longitudinal and lateral accelerations for the Boeing B737, registration LN-RRH

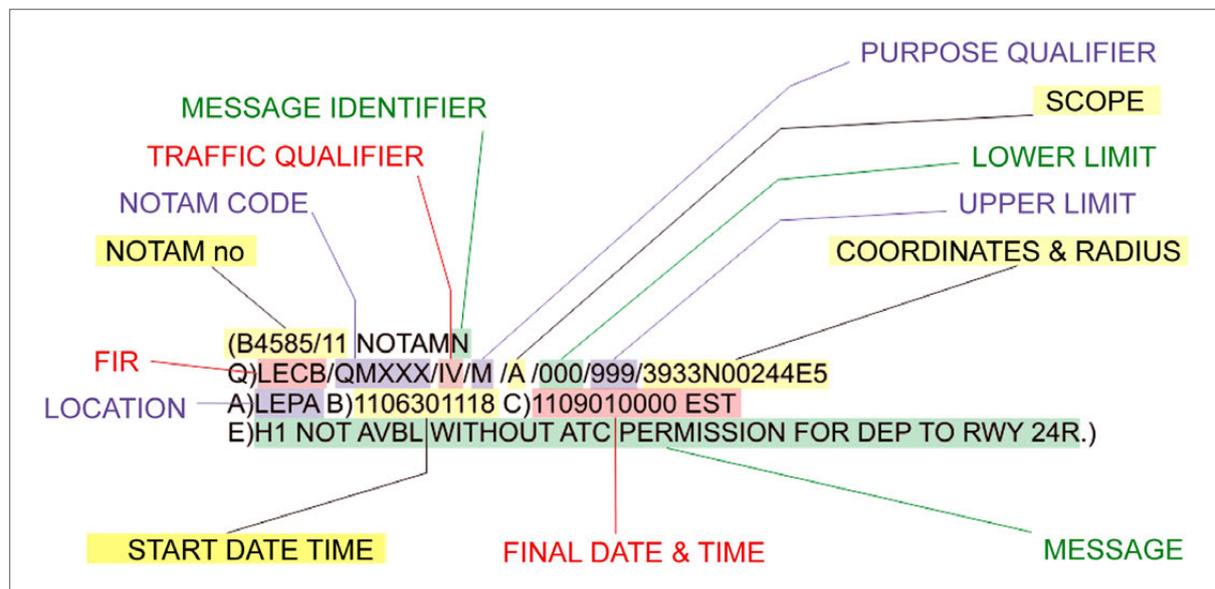
Figure 6 shows the first NOTAM that was issued concerning taxiing restrictions at the Palma de Mallorca Airport. Each of the fields that comprise a NOTAM is identified. An explanation of each follows.

Figure 6. Identification of the fields in a NOTAM
