DATA SUMMARY

Date and time	Tuesday, 27 September 2011; 16:44 h¹
Site	Vicinity of the Seville Airport (LEZL) (Spain)

Registration	EC-CXP
Type and model	CESSNA 172 H "Reims"
Operator	Aeroclub de Sevilla

Type and model	TELEDYNE CONTINENTAL MOTORS TCM/RR O-300-D
Number	1

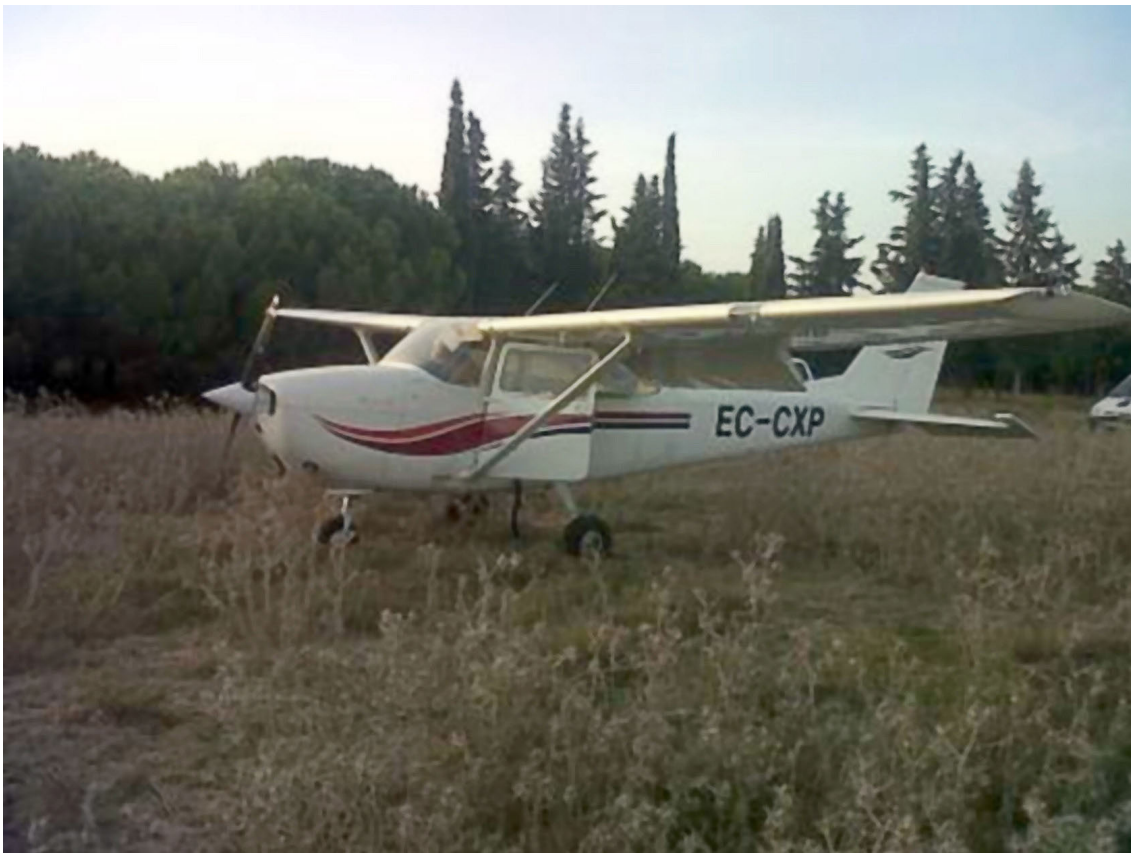
The occupants were not injured. The aircraft escaped serious damage, except for that confined to the engine.

Figure 1. View of the aircraft at the landing site

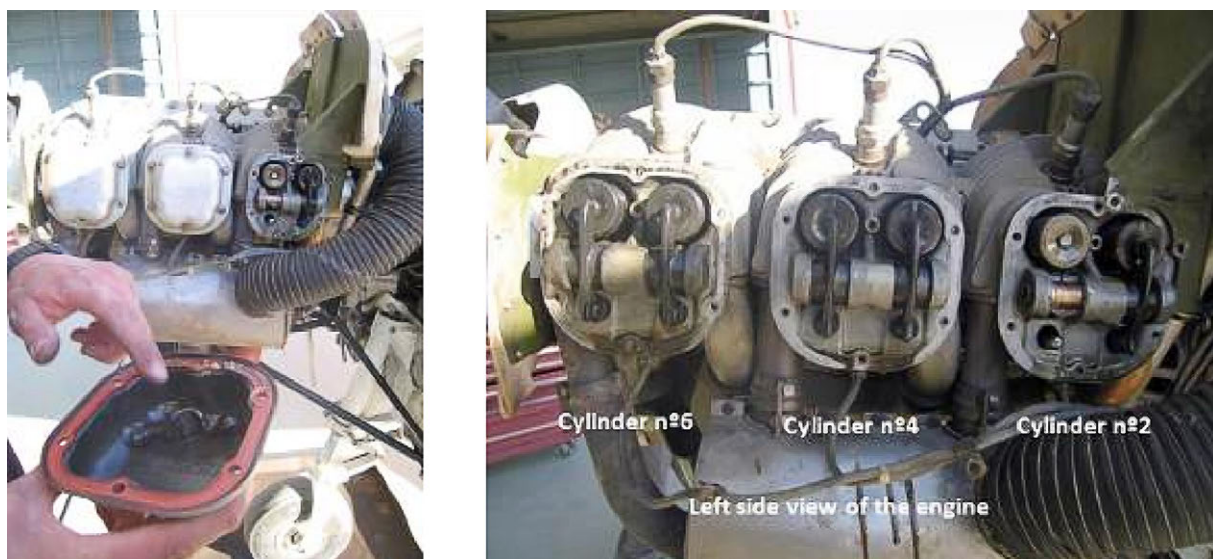
After the incident, the aircraft was subjected to an inspection. The engine was started, revealing a loud banging noise at low RPMs. The condition of the spark plugs was checked, along with the ignition harness and the intake and exhaust ports. The engine was then disassembled. The cylinder head covers, where the valves are located, were removed and the rocker arm for the number 2 cylinder exhaust valve was found to be broken in two pieces (see Figure 5).

Figure 5. Disassembled covers on cylinders 2, 4 and 6 and condition of rocker arms

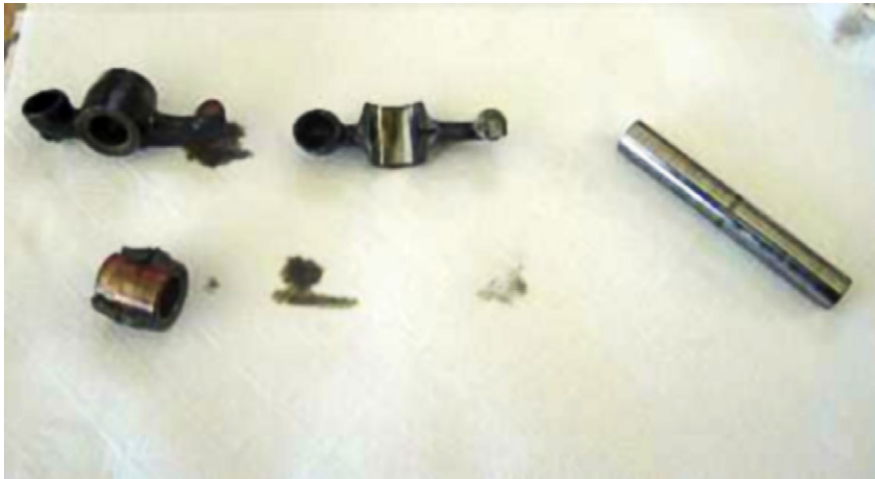
Figure 6. Rocker arms and axle from the no. 2 cylinder

Once the rocker arms on the remaining cylinders were verified to be undamaged, the inspection focused on the number 2 cylinder, which was fully disassembled. The condition of the valves, valve guides, rocker arm shaft, cylinder and piston were all checked, with no damage being noted aside from the broken rocker arm. There was oil residue and both the shafts and rocker arms seemed to be properly lubricated. The common exhaust and intake rocker arm shaft was not warped. All rocker arms had part number 35636/RR.

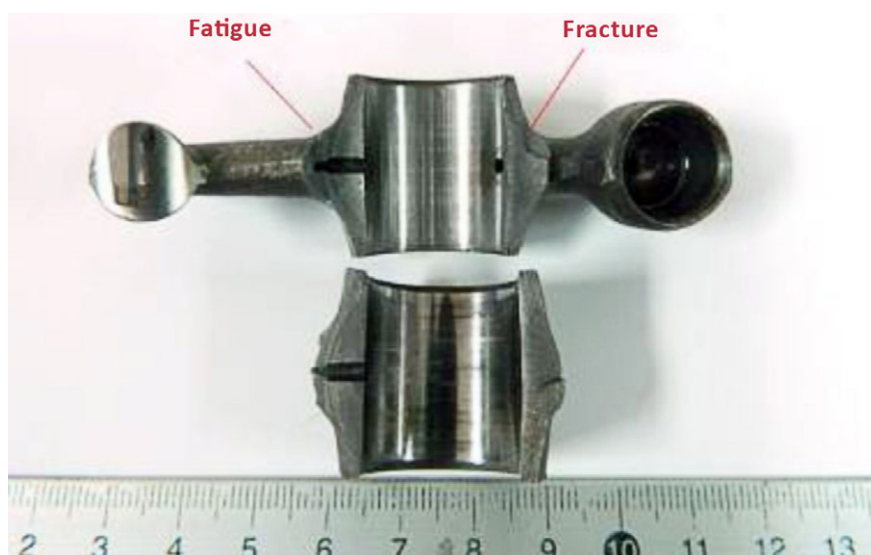
A visual inspection of the rocker arm on the no. 2 cylinder revealed it was broken, with clear fatigue and fracture zones (see Figure 7).

Figure 7. Fatigue and fracture zones on the damaged exhaust rocker arm

- Frictionless bushings: UNS C93200 tin-lead (Sn/Pb) bronze alloy with a hardness of around 95-100 HV. No significant differences or anomalies.
2. The macro- and micromorphological features exhibited by the rocker arm with the in-service fault were characteristic of a fatigue fracture that started on the outer surface on the cup side. There were no marks or signs of corrosion or wear or microstructural anomalies inherent to the material or to the manufacturing process that could have affected or initiated the in-service fracture of the piece. There was a second crack developing on the lubrication orifice on the opposite side, that of the pad. This crack was progressing from the inner surface on the rocker arm that was in contact with the bushing.

The incident took place because the rocker arm that actuates the no. 2 cylinder exhaust valve fractured, which stopped opening this valve, thus preventing the exhaust gas in the cylinder from escaping. This caused the engine to function abnormally. The crew decided to return to the airport but since they were losing altitude, they decided to make an off-field landing.

- REC 06/14.** It is recommended that Continental (type certificate holder for Rolls Royce engines) undertake a study of this case to determine the type of in-service failure that occurred and assess the need to inform the owners that could have obsolete rocker arms installed in their engines to replace them.

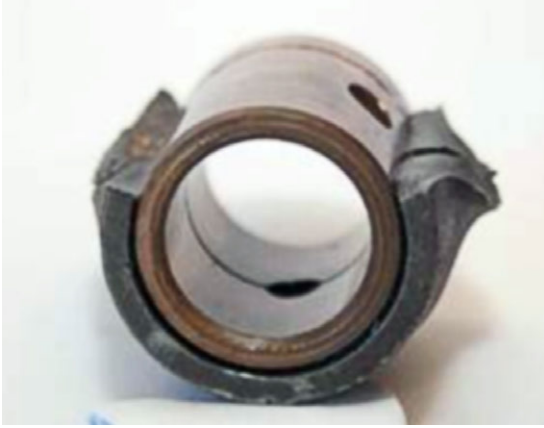
In addition, it was noted that the lubrication orifices on the bushing were not aligned with their associated channels in the rocker arm (see Figure 8).

Figure 8. Misalignment of the lubrication orifices

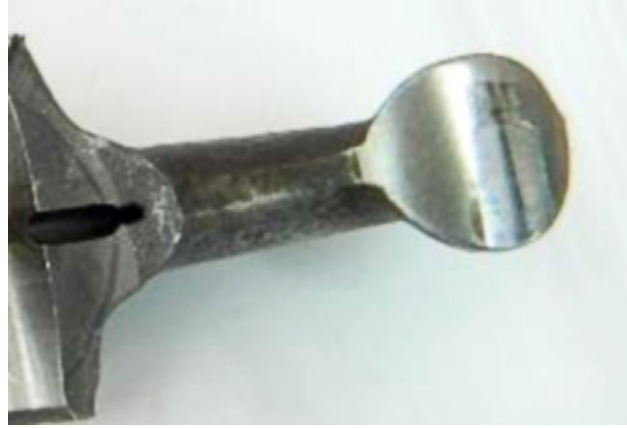
The pad on the rocker arm had two flat spots caused by contact (see Figure 9).

Figure 9. Flat spots on the pad of the damaged exhaust rocker arm
