DATA SUMMARY

Date and time	Saturday, 3 December 2011; 15:00 local time
Site	Lillo Aerodrome (Toledo, Spain)

Registration	D-EGSK
Type and model	ROBIN DR-300/180R
Operator	Aeroclub de Toledo

REPORT

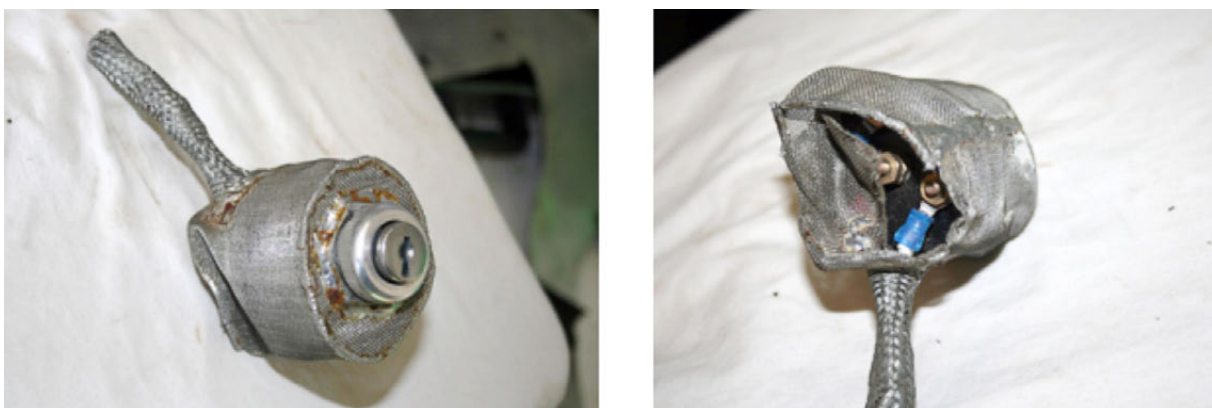
Figure 1. The aircraft's ignition switch

During the investigation into the engine stoppage, this device was inspected and found to be protected with a metal screen¹ that covered its entire surface (see Figure 1). The internals were dirty and showed signs of wear. According to the documentation from the last 100-hr check done on the aircraft, this device had been inspected.

¹ Inspectors had access to another aircraft of the same model that had the same metal screen covering its ignition switch. If this screen is installed and its bottom part bent in any way, one or both magnetos could be grounded, resulting in the stoppage of the engine.

This information was conveyed to the Bureau d'Enquêtes et d'Analyses on 27 December 2011, which resulted in the manufacturer issuing a mandatory service bulletin, No. 120102 (see Appendix 1), dated 25 January 2012, with instructions regarding the corrective actions to take with the device.

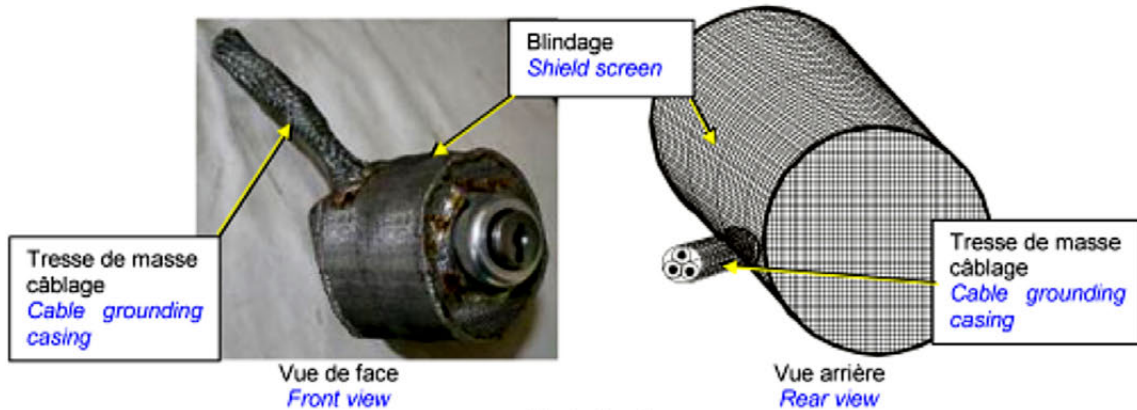
Illustration 1
Exemple de montage concerné – *Example of concerned installation*

If, for any reason, the shielding metal screen protecting the magneto switch is distorted, the switch terminals may be grounded which leads to an engine shutdown.

Avant 1985, les sélecteurs magnétos étaient munis d'un blindage.

Visually inspect the magneto switch at the rear side of the lower instrument panel to check if the switch is fitted or not with a screen shield (casing).

When there is a screen shield, refer to following §3.

- Remove the switch.*
- Cut the cable shield casing*
- Remove the screen shield from the switch*
- On the cables grounding casing, put some tin at the cut area to make sure it cannot fray and ground the terminals.*
- Install a piece of heat shrink tubing over the cable shield casing.*

- Replace the magneto switch with a new one*
- In this case, cut and tin the cables grounding casing to make sure it will neither fray nor ground the terminals.*
- Install a piece of heat shrink tubing over the cable shield casing.*
