**DATA SUMMARY**

Date and time	<b>Sunday, 20 November 2011; 12:50 local time<sup>1</sup></b>
Site	<b>Vicinity of point BRICK, Canaries TMA (Spain)</b>

Registration	<b>OH-LBR</b>	<b>G-TCBA</b>
Type and model	<b>BOEING B757-2Q8</b>	<b>BOEING B757-28A</b>
Operator	<b>Finnair</b>	<b>Thomas Cook Airlines</b>

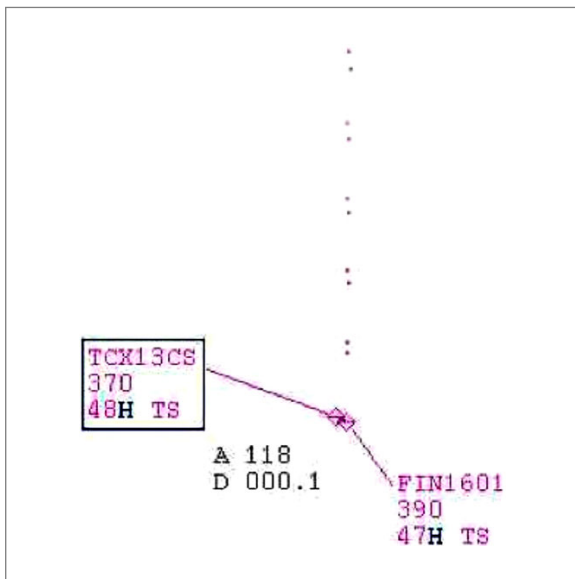
Figure 3. Radar display 12:48:09

At 12:48:09, the labels were still properly correlated (see Figure 3). One second later, after aircraft TCX13CS requested to descend, the radar label for aircraft TCX13CS showed it to be at flight level 405 and the one for aircraft FIN1601 at flight level 390 (see Figure 4).

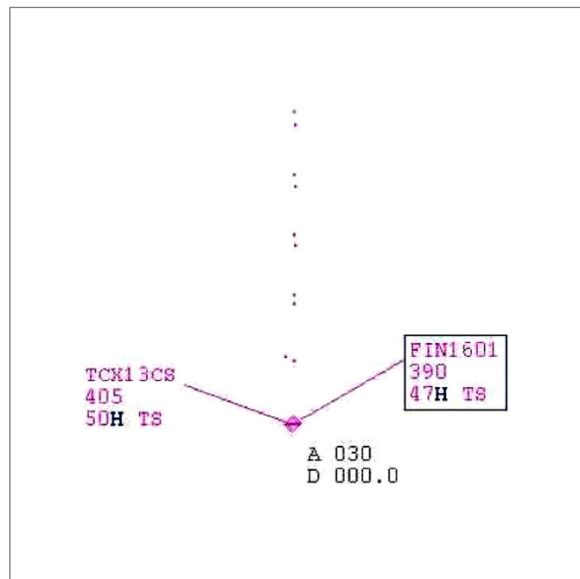
Figure 4. Radar display 12:48:10

Based on the report submitted by Aena, an incident occurred that seems to fit the characteristics of garbling sometimes seen in non-Mode S radars when the oblique distances between each aircraft and the respective radars are very similar.

Given this similarity in the distance, an overlap occurred in the reply received by the radars from the aircraft, resulting in new tracks appearing on the screen and in the label for aircraft TCX13CS splitting from the corresponding aircraft symbol.

**REC 100/12.** It is recommended that AENA ensure that its controllers are aware of the faults that can occur affecting the auxiliary systems used over the course of their jobs and of the way to detect and address said faults.

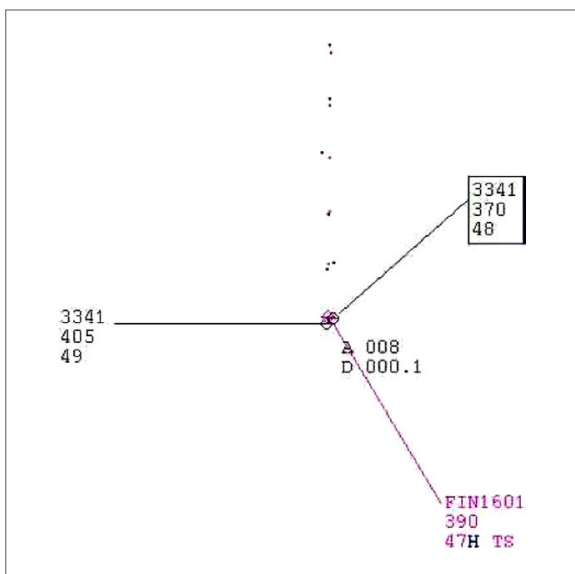
Figure 5. Radar display 12:48:20

Starting at 12:48:20, the label for aircraft TCX13CS disappeared and two labels for transponder code 3341 appeared, one at flight level 405 and another at flight level 370 (see Figure 5).

The sector NWW controller's situational awareness was incorrect. Moreover, he did not detect the problem with the radar display when aircraft TCX13CS requested to descend, since its label showed that it was maintaining flight level 405. Flight levels for aircraft in cruise flight end in "0". He did not detect the fault later either, since when he provided the aforementioned instructions to aircraft FIN1601, the screen displayed the label for aircraft FIN1601 along with two others with the (uncorrelated) transponder code 3341, one showing a flight level of 405 and the other 370.

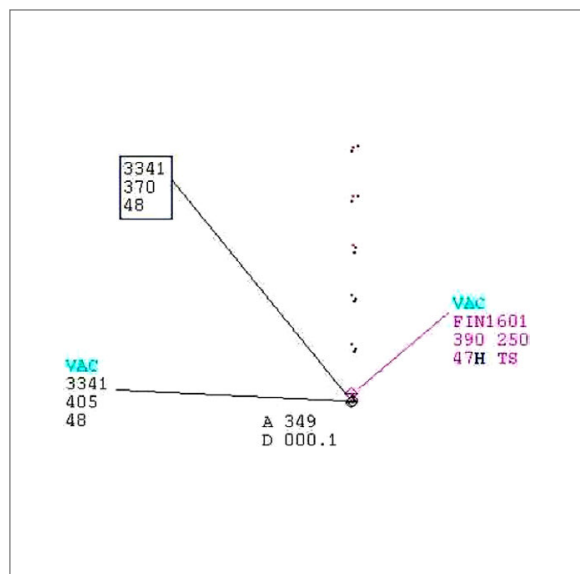
Figure 6. Radar display 12:48:41

At 12:48:41, the two labels with code 3341 were still being displayed. In the “authorized flight level” field for the label for aircraft FIN1601, the controller had entered 250 (see Figure 6).

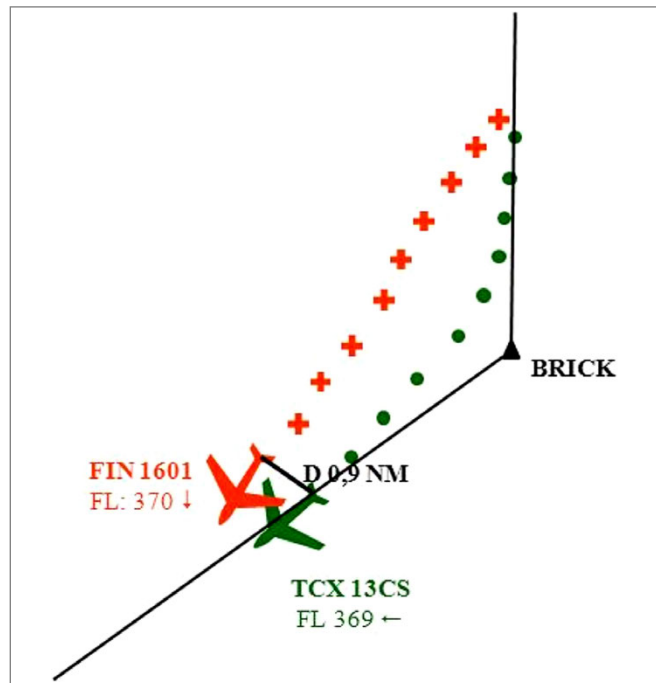
Figure 7. Diagram of the approaching aircraft

Time	Flight level FIN 1601	Flight level TCX 13CS	Vertical distance (ft)	Horizontal distance (NM)
12:49:45	375	370	500	0.8
12:49:50	373	370	300	0.7
12:49:55	370	369	100	0.9
12:50:00	364	369	500	0.9

Figure 7 shows a diagram of the separation based on radar data. The final point corresponds to the closest point of approach between the aircraft.
