DATA SUMMARY

Date and time	Saturday, 12 November 2011; 15:56 UTC¹
Site	Tenerife South – Reina Sofía Airport (Spain)

Registration	G-LSAI	EC-JMR
Type and model	BOEING B-757-21B	AIRBUS A321/B3
Operator	JET2	Iberia LAE, S.A.

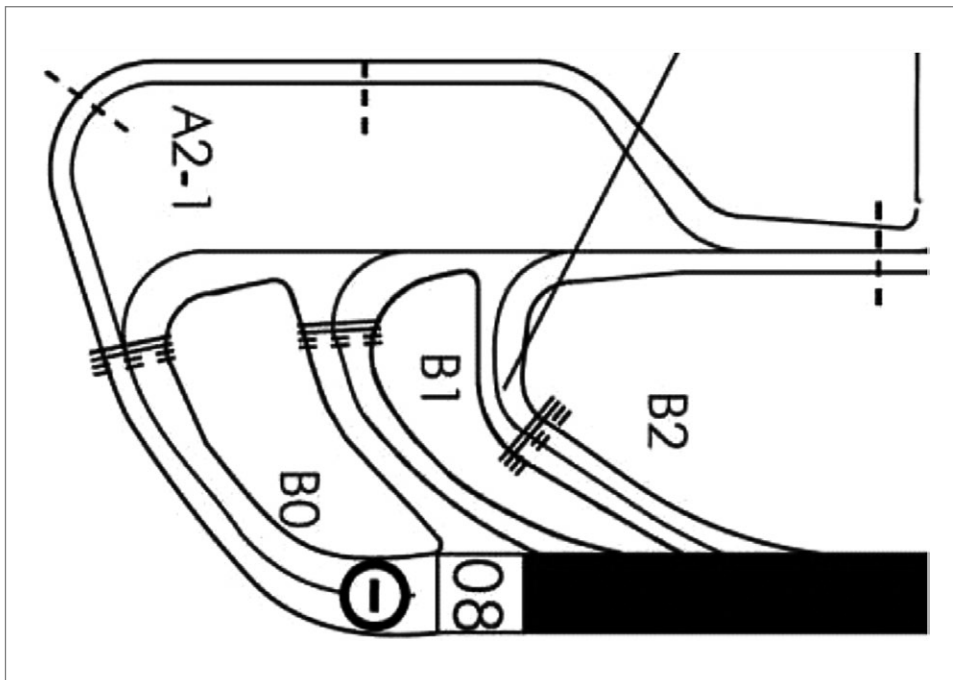
Figure 1. Entrances to the runway 08 threshold

The Tenerife South Airport has a single asphalt runway (08/26) measuring 3,200 × 45 m. There is a taxiway (called "T") parallel to the runway that has three accesses to the runway 08 threshold: B2, B1 and B0 (Figure 1). The control tower is some 500 m north of the runway's geometric center and approximately 1.5 km away from the 08 threshold.

The departing aircraft has to taxi to the runway threshold from whatever its location is at the time it is given the clearance. In the case of the Tenerife South Airport, the view from the tower of the taxiway in the vicinity of the threshold does not allow for an accurate estimate of the distance between a given aircraft and the three possible entrances to the threshold (B0, B1, B2). The controller has no additional resources (such as SMR) to aid in this regard.

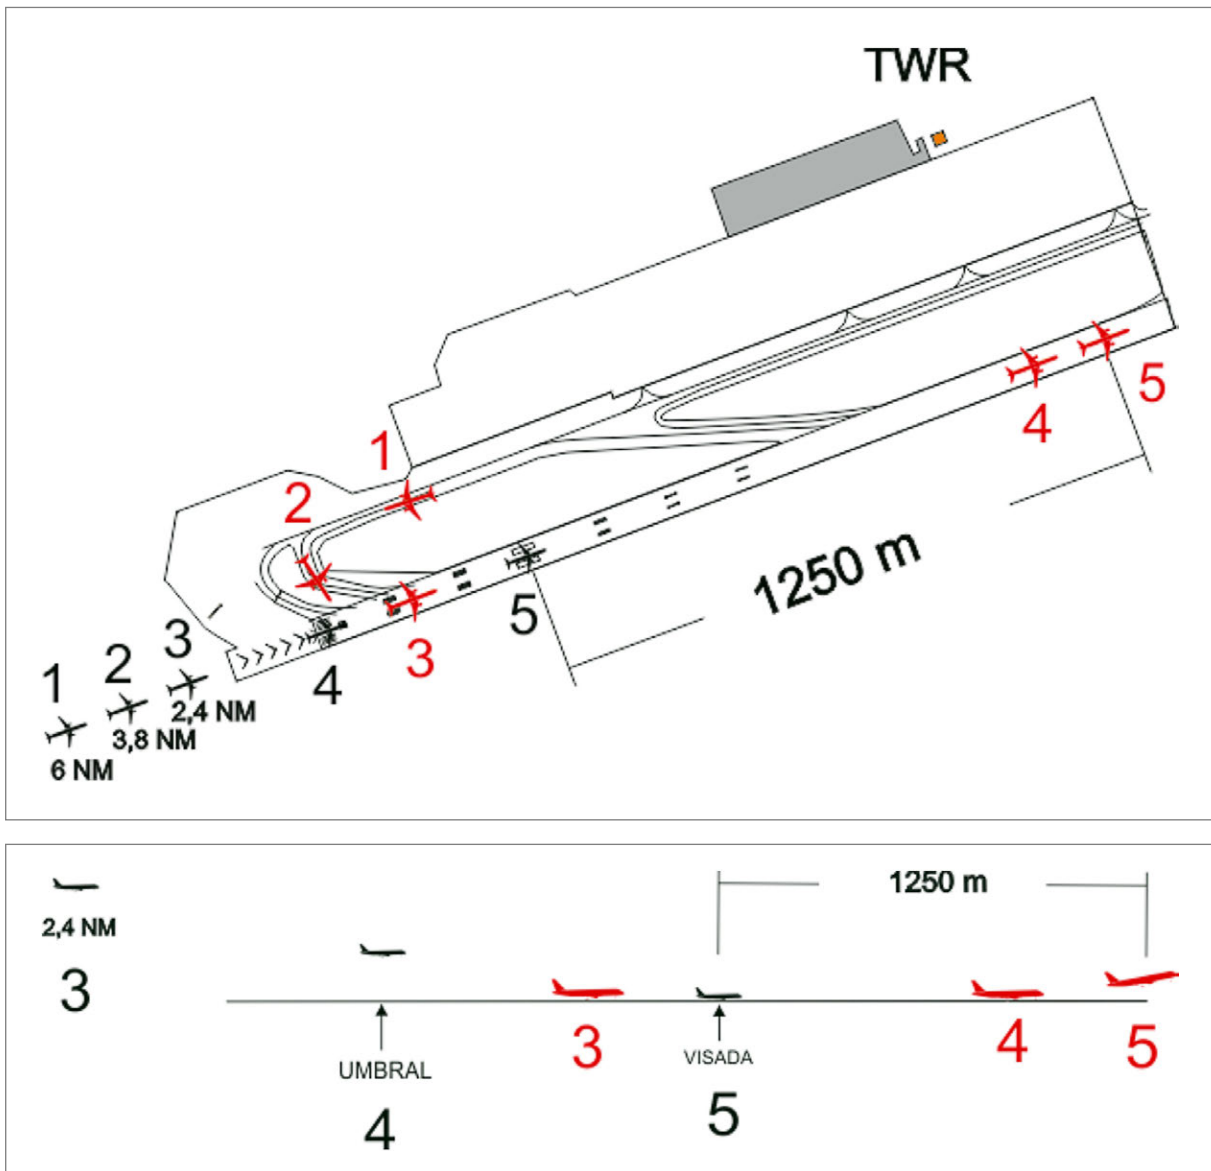
Figure 2. Relative positions of the two aircraft

- When the controller cleared aircraft EXS518 for immediate takeoff, the aircraft was approximately 300 m away from the RWY 08 hold point on B1 and aircraft IBE3415 was some 6 NM away from the runway on final at a ground speed (GS) of 232 kt. The wind was from the NW at around 10 kt (point 1).

- Aircraft EXS518 did not stop at any point after receiving its takeoff clearance, taxiing at speeds that varied between 20 kt on the taxiway after receiving the clearance, 15 kt when entering the runway via B1 and 8 kt during the last turn to line up with the runway centerline.

- 35 s after receiving the clearance, it reached the hold point, by which time the approaching aircraft was 3.8 NM away from the threshold at a GS of 210 kt (point 2).

- 25 s later, with the approaching aircraft 2.4 NM away from the threshold at a GS of 188 kt, EXS518 entered the runway (point 3), lined up and started its takeoff run, traveling some 1,350 m until it started its rotation with an IAS of 145 kt (point 4).

- At that moment aircraft IBE3415 was flying over the runway threshold. It landed five seconds later, just as the departing aircraft became airborne. At that time the separation between the two aircraft was at its minimum, 1,250 m (point 5).

- The profile of IBE3415 during the last 6 NM of the approach matched that of a “decelerated approach”, with the initial extension of the flaps being delayed until the final approach point (FAP), located 5.7 NM away from the threshold, and the final extension taking place at 1000 ft. The IAS decreased constantly throughout the descent, from 215 kt at the FAP to 155 kt above the threshold. The aircraft’s configuration at the point of contact was the so-called CONF3.

The incident was caused by the improper handling of the immediate takeoff clearance by ATC. The distance between the aircraft cleared to take off and the runway threshold on the one hand, and ATC's failure to adjust the speed of the incoming aircraft on the other, resulted in a reduction in the separation such that aircraft IBE3415 touched down on the runway just as aircraft EXS518 became airborne.

REC 07/13. It is recommended that AENA ensures that the personnel in their control towers have specific procedures and training to manage immediate departure clearances with an airplane on approach, considering the following factors: type or airplane on approach, position and ground speed at the time of the clearance, position of the departing aircraft in the maneuvering area at that instant, local wind conditions and the possibility that once the clearance is issued, a situation might foreseeably arise that reduces separation below minimums.
