DATA SUMMARY

Date and time	Wednesday, 23 May 2012; 17:05 h¹
Site	Valle de Hecho, in the municipality of Borau (Huesca, Spain)

Registration	G-CKAW
Type and model	DG 500 ELAN ORION
Operator	Midland Gliding Club

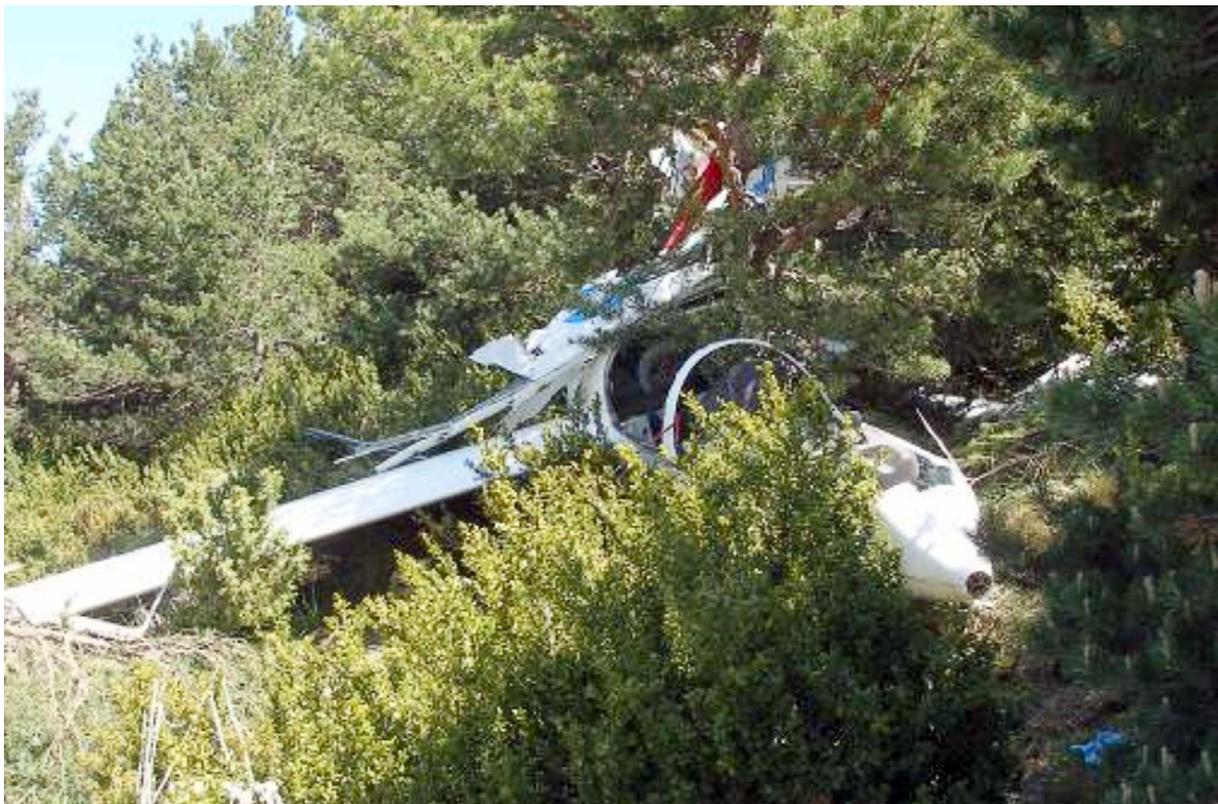
Figure 1. Photograph of the aircraft

The glider fell on a wooded hillside at an elevation of 1,353 m and struck several trees that cushioned the impact. The aircraft was destroyed. The debris field was compact, with the front part of the fuselage facing south. The cockpit was the only part that did not suffer significant damage. The surrounding trees exhibited signs of a mostly vertical flight path.

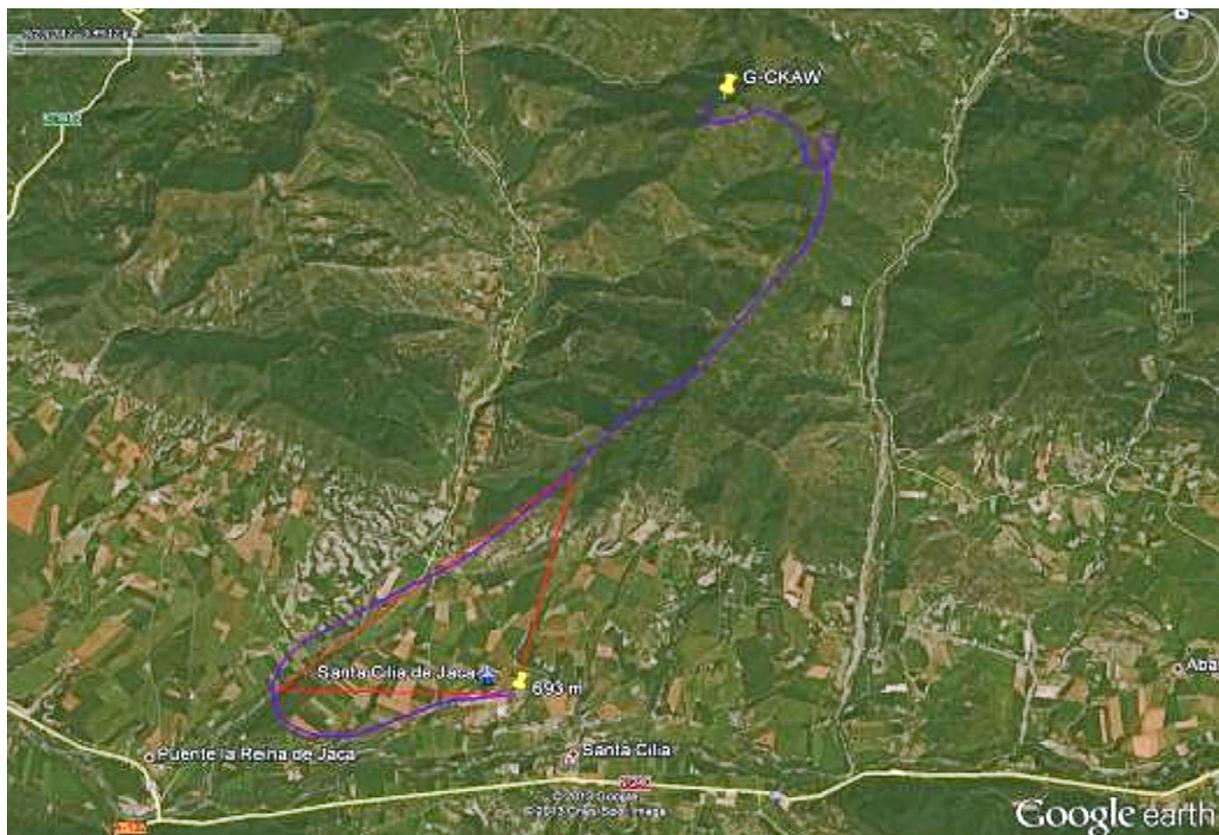
Figure 2. Flight path

The instructor also had with him a portable GPS unit that was undamaged and that recorded position and altitude information, allowing investigators to reconstruct the flight path, as shown in Figure 2⁴.

The last information was recorded with the aircraft at an altitude of 1,371 m.
