DATA SUMMARY

Date and time	Saturday, 9 June 2012; 12:15 local time
Site	Igualada Aerodrome (Barcelona, Spain)

Registration	EC-GGF
Type and model	PIPER PA-23-250 Aztec E
Operator	Private

On Saturday, 9 June 2012 at 12:15¹, a Piper PA-23-250 aircraft, registration EC-GGF, suffered a runway excursion and broke its left landing gear during the landing run at runway 17 of the Igualada Aerodrome (Barcelona).

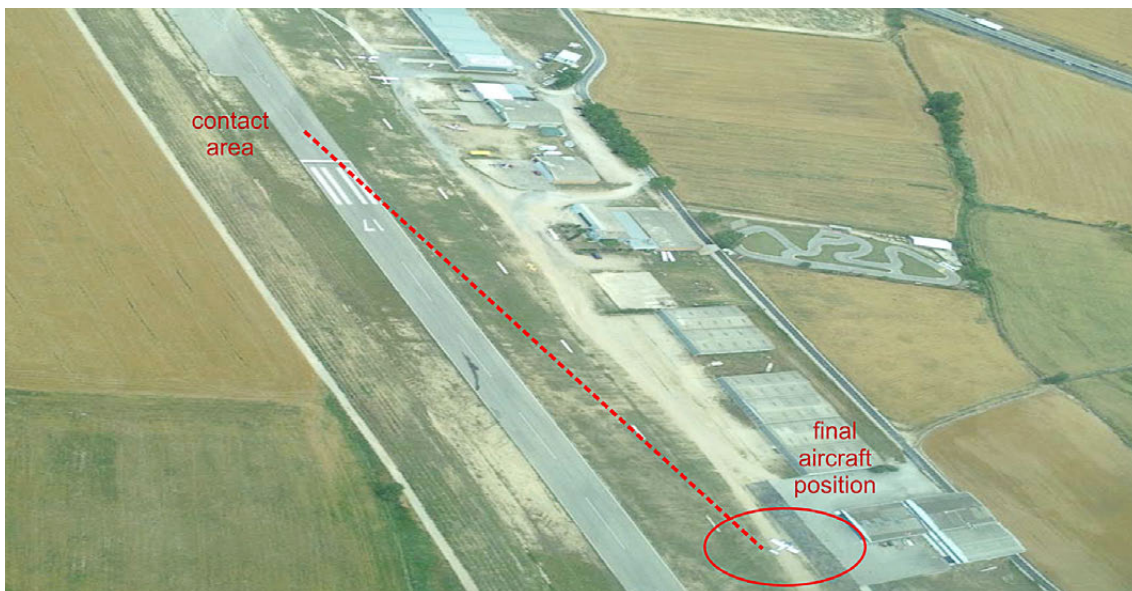
Figure 1. Final position and contact area

The aircraft made contact with the runway just before the threshold (Figure 1). The initial marks identified belonged to the left gear. The part of the landing run on the runway showed marks left by the left propeller, a continuous longitudinal line in the direction of motion and tracks from the left tire. The tracks from the right tire appeared further forward and showed signs of braking. The aircraft travelled about 70 m on the runway in practically a straight line at a 25° left angle with respect to the centerline. The rest of the trajectory was also straight but on the runway shoulder, which had a dirt surface. The marks on the ground showed that the aircraft pivoted left at the end of the landing run, coming to a stop on a heading of approximately 040° (Figure 1).

The marks left on the runway by the left propeller, the tire and the unbroken line left by the fork assembly indicate that the left gear collapsed upon touching the ground. The propeller can only make contact with the ground if the distance between the wing and the ground is reduced, which only occurs if the gear is unable to maintain its normal position. Moreover, the abrasion on the underside of the wheel support and the evident friction marks on the asphalt indicate that the contact was with the runway. In order for this area to be in contact with the asphalt, the fork assembly must have rotated left and the strut shifted backward. In other words, the damage confirms that the gear collapsed shortly after landing.

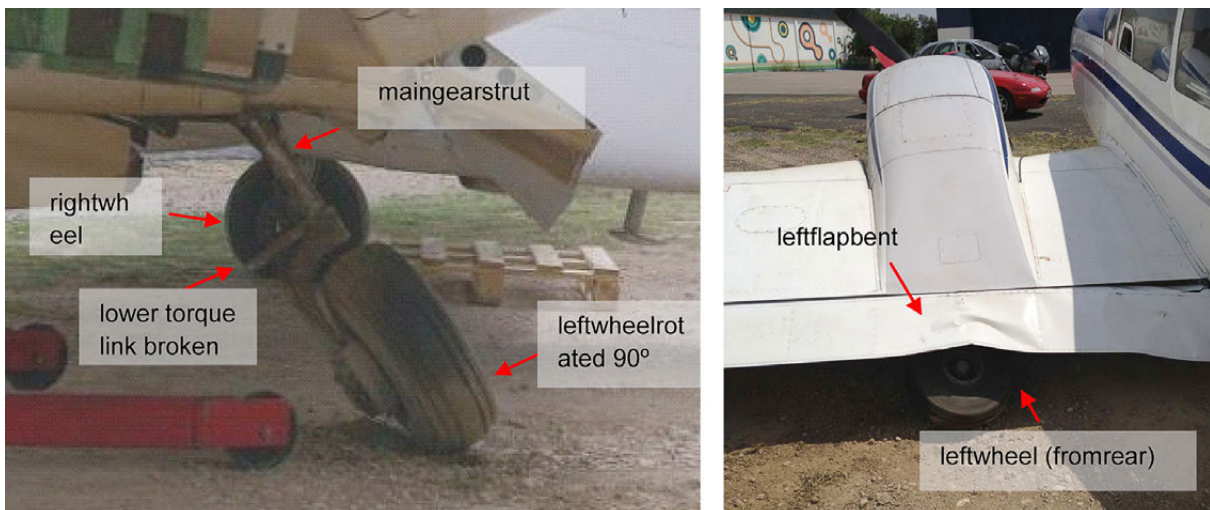
Figure 3. Gear seen from the tip (left) and trailing edge on the left wing (right)

The aircraft's left wing exhibited scratches along its underside near the tip, specifically, on the outboard hinge support for the left aileron. This part did not have any soil fragments in it, meaning the contact had been with the runway. The tips of the left propeller blades had been damaged by contact with the ground. The left flap had been bent by the action of the gear folding backwards.

The gear was configured and damaged as follows (Figure 3):

- The main gear drag link was in the down and locked position.
- The drag link fitting support was in its normal position and attached to the structure.
- The fitting support reinforcement was bent. This was because the main gear strut had rotated approximately 90° back with respect to its down and locked position and was contacting and bending this reinforcement.
- The rear gear door was bent due to the backward movement of the main gear strut.
- The main gear strut was cracked and missing components. Specifically, the projection where the main gear drag link is attached had completely separated from the strut and was joined to the main gear drag link (see Section 1.5.3).

- The fork assembly was twisted 90° left (as seen from the back) with respect to the piston tube and was touching the ground (Figure 3 shows the left wheel perpendicular with respect to the right). A part of the bottom of the fork assembly had been abraded due to friction.
- The lower torque link had detached from the upper torque link (the lower link can be seen in Figure 3).
- The strut had lost all of its hydraulic fluid.

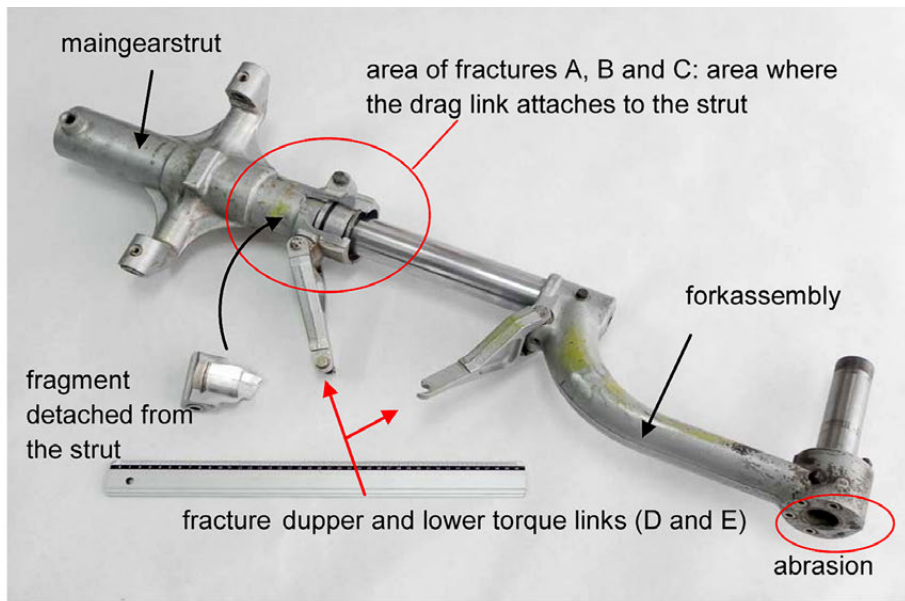
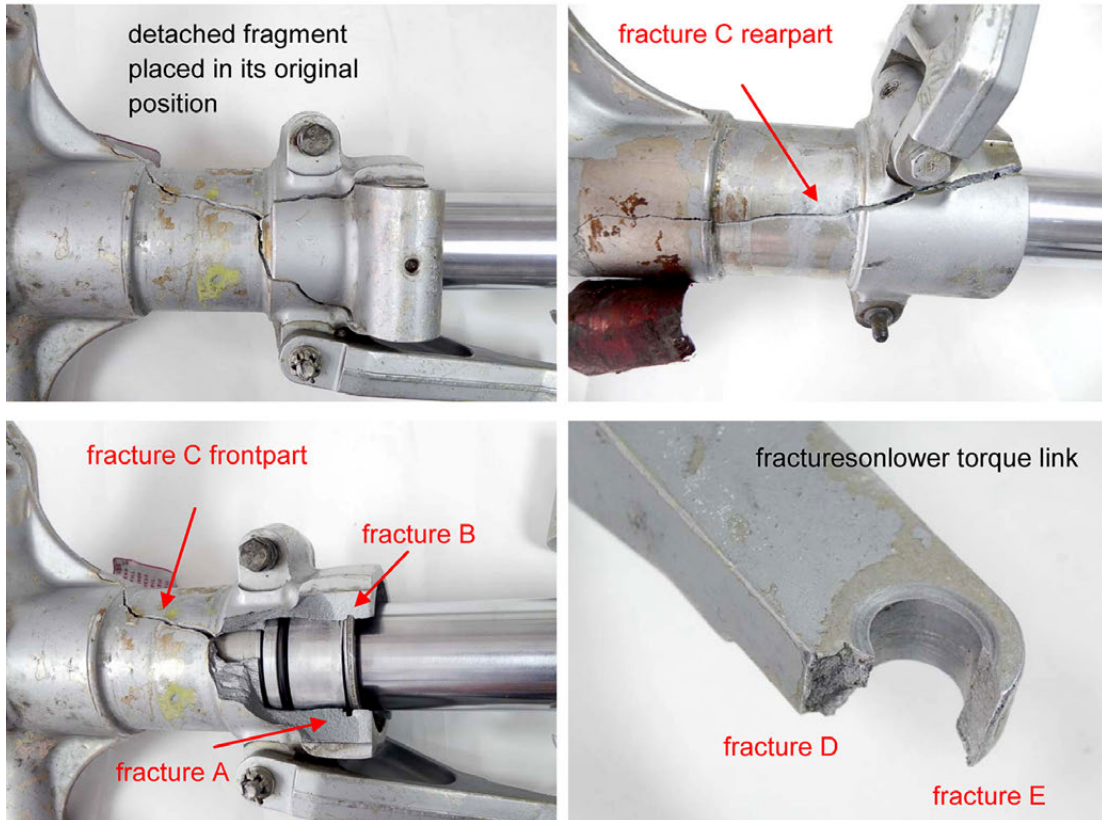
Figure 4. Fractures on the left main gear on aircraft EC-GGF

The main gear strut and the strut fragment that had detached and remained joined to the main gear drag link were sent to a laboratory for analysis. The following fractures were identified (Figure 4):

- Two fractures (A and B) on the strut that had managed to completely separate the projection where it attaches to the main gear drag link.
- Fractures A and B joined at a point, after which fracture C continued to the other end of the strut.
- The torque link exhibited two fractures where the lower torque link hinges (fractures D and E).

The analyses ruled out microstructural defects or heterogeneities at the fault initiation area that could have caused the material to break.

The fracture analyses concluded that fractures A and B started jointly and were the main fractures. The other three (C, D and E) originated as a result of the first two.

Once the initial fractures A and B (Section 1.5.3, Figures 4 and 5) grew to the point where they caused the projection to detach from the strut, crack C developed as a continuation of cracks A and B toward the opposite direction of the strut, causing the torque link to fracture. While fractures A and B had developed some time in the past, they grew until they joined and caused part of the strut to detach instantaneously upon landing, at which time fractures C, D and E also developed. The investigation could not determine whether the collapse of the part took place as a result of the cracks reaching a critical size (at which point the part breaks), meaning the part would have fractured even under the load of a normal landing. The three eyewitnesses to the incident, regarded as qualified in the matter, agreed that the landing was hard, in which case the forces of the landing would only have accelerated the growth process of an already existing crack. In other words, the gear would have failed eventually, and the hard landing, if it occurred, accelerated the failure but did not cause it.

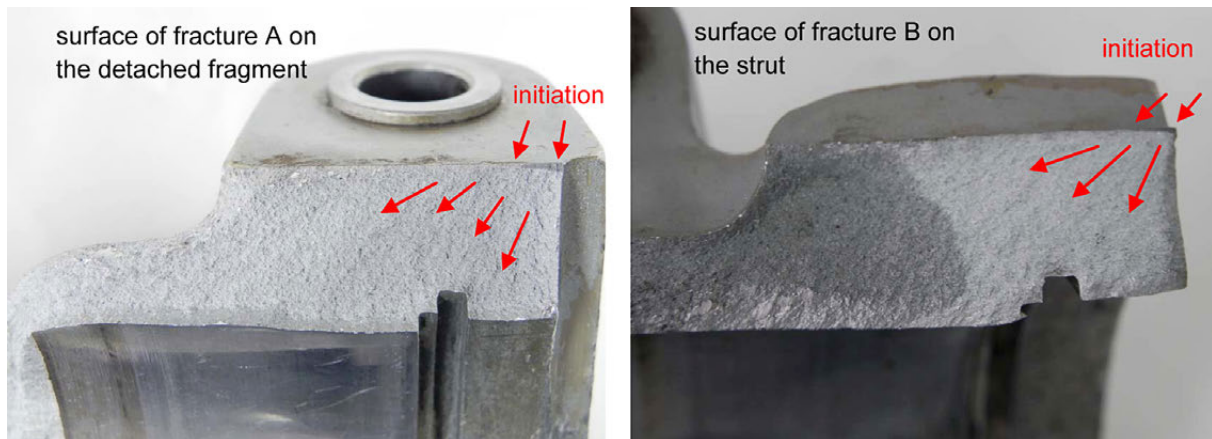
Figure 5. Close-up of fractures A and B

Fractures A and B (Figure 5) started on the piece's outer surface and resulted from a fatigue incubation process in the transition area between the cylindrical body of the

strut and the projection for attaching the main gear drag link. The initial fracture surfaces were rusted, meaning the aircraft operated for a long time with these cracks on the gear. The rust prevented the identification of any fractographic features involved with the start of the failure that could have indicated any other potential mechanism besides fatigue that might have contributed to the initiation of the cracks by fatigue. In any case, the presence of several microcracks near the fracture, exhibiting features typical of fatigue, and the absence of flaws in the material, indicate that the main crack also started as the result of a fatigue mechanism.

Both the microcracks and the fractures had initiated in places where the geometry of the piece and its changing cross section promoted the accumulation of stress.

The laboratory was unable to determine if the weakening caused by the cracks was enough to cause the break during a landing under normal conditions, but the crack would eventually have advanced to the point where the gear would have undergone a complete failure under normal loading. The crack was invisible to the naked eye. This type of crack is often mistaken for a scratch. The only way to detect them is through non-destructive testing using liquid penetrants. Once the laboratory findings were received, the right gear on aircraft EC-GGF was subjected to a liquid penetrant test and found to be free from cracks.

The gear failure started in the projection on the strut where the main gear drag link attaches; specifically, on the fragment that detached from the strut. The cyclic stresses that occur during landing operations must have resulted in the incubation of fatigue cracks in this area. As these cracks grew, the component gradually weakened, leading to further stress build up until the material's strength in this area was exceeded, causing the component to fail.

The fact that there was rust around the area where the cracks started confirms that the fatigue process had been present for a long time, though exactly how long the aircraft had been in operation with that problem could not be determined. The cracks would not have been visually detectable during the prescribed maintenance inspections. The way to detect this type of defect is through non-destructive testing using liquid penetrants.
