Registration	SE-DST
Type and model	British Aerospace AVRO 146 Series RJ100
Operator	Malmö Aviation AB

On Friday, 6 July 2012, a British Aerospace 146 aircraft, registration SE-DST, took off from the Malmö/Sturup (ESMS) Airport in Sweden at 15:45 en route to Palma de Mallorca (LEPA) in Spain. There were 101 passengers, 2 flight crew and 3 flight attendants onboard.

Figure 1. Instrument panel and location of the first officer's PFD

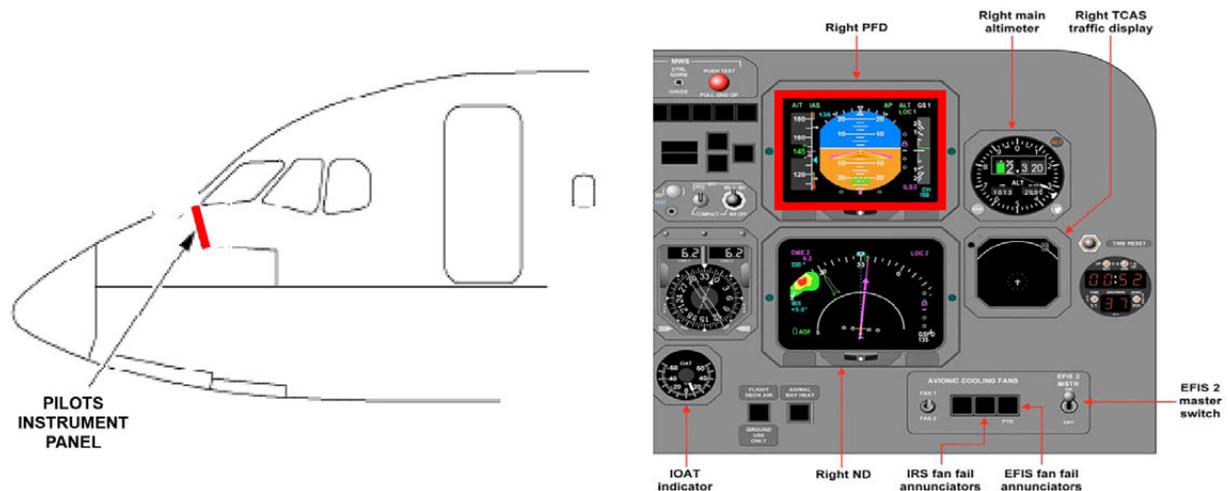
While descending into the Palma de Mallorca Airport, the first officer's upper² EFIS³ display, the PFD (primary flight display), went blank (figure 1). The first officer selected the lower EFIS display, the ND (navigation display), to compact mode⁴. The first officer then noticed a smell of electrical smoke, after which the presence of smoke was confirmed. They turned off the first officer's EFIS system and donned their oxygen masks. They declared an emergency and were given landing priority. During the remainder of the descent, the smoke cleared and the crew removed their oxygen masks. Neither the smell nor the smoke entered the passenger cabin.

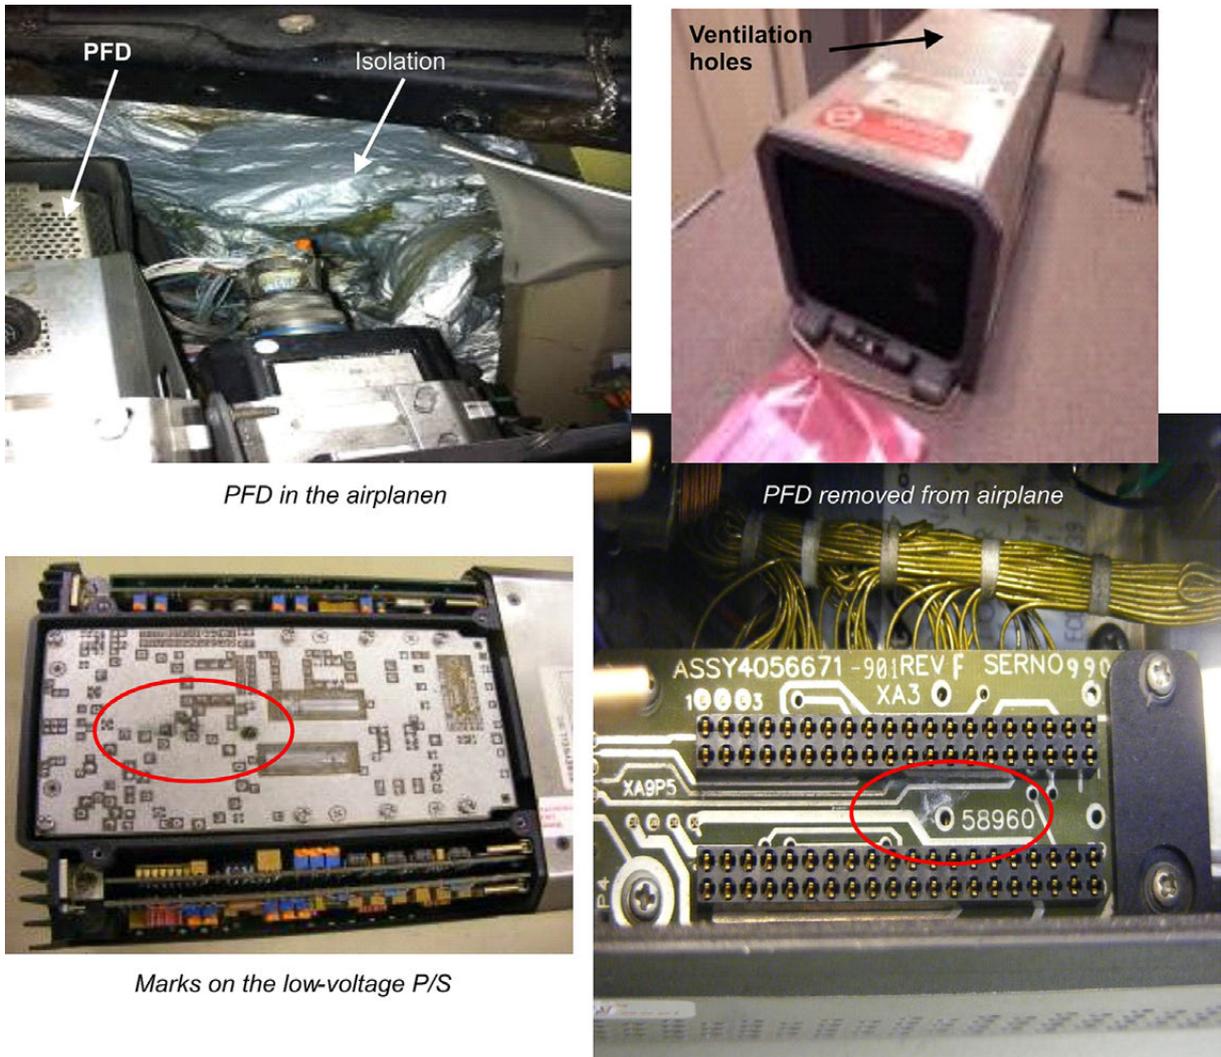
- The first officer’s PFD showed signs of smoke around the ventilation holes at the top of the unit (figure 2).
- The isolation blankets on the PFD were not properly adjusted (figure 2).
- The units next to the PFD were not affected.
- The disassembly of the PFD revealed that:
 - When the top cover was removed, there were stains left behind by water, corrosion and arcing on several connectors at the top of the low-voltage power supply (figure 2).

Figure 2. First officer’s PFD

- There were water marks on one of the connector boards (figure 2).
- The circuit boards were removed but no corrosion was found on any of them.
- No additional water marks were found in the rest of the unit.

The presence of marks from smoke, water, corrosion and arcing on the PFD after it was removed confirmed that the smoke and electrical fire smell had been caused by a short circuit in this unit due to the presence of water in it. The not properly adjustment of the isolation blankets must have allowed the water that condenses on these blankets to drip on the equipment.

The incident onboard aircraft SE-DST was likely caused by the presence of water in the first officer's PFD unit due to the improper placement of an isolation blanket that allowed condensed water to drip onto the unit.

In addition to the revised SB, the manufacturer modified the maintenance instructions for installing and removing the EFIS displays, AMM 34.27.11, to include a check of the condition of the isolation blankets after the EFIS displays are installed or removed⁹.

- It implemented SB 25-433-61091A fleet wide.
- It started tracking and identifying recurring events to prevent future incidents.
- It introduced periodic checks to verify the proper position of the isolation blankets.
- It encouraged the use of emergency checklists.

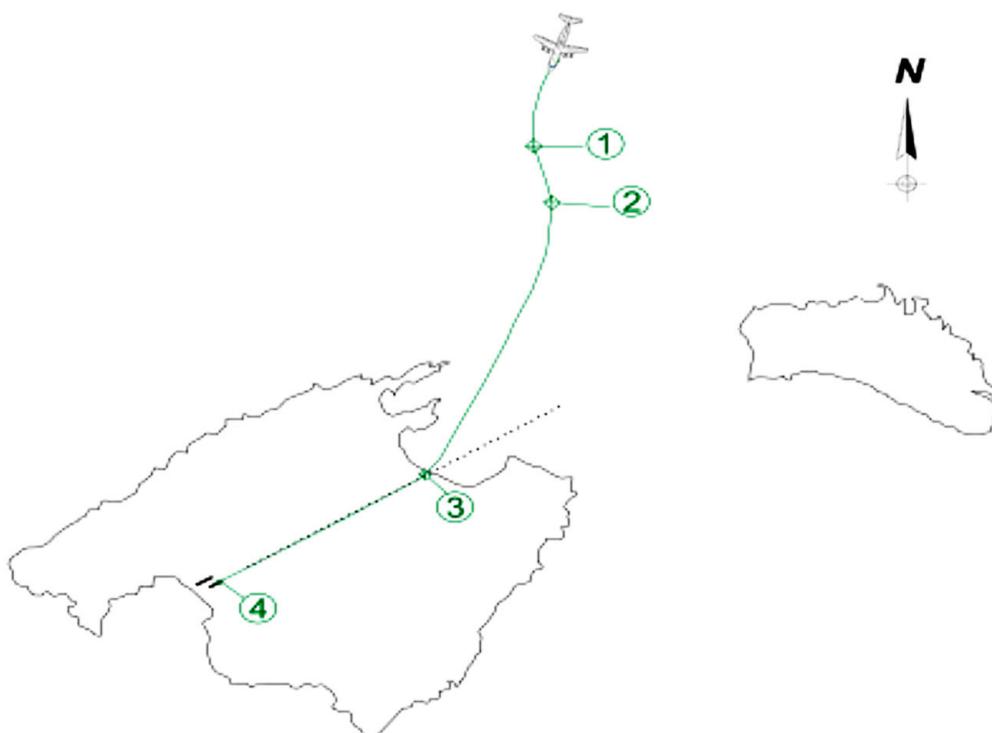
The ACC continued calling the aircraft, which at 18:47:40 (point 2 in figure 3) managed to issue a clear message and declare an emergency due to smoke in the cockpit. There were no further problems with the clarity of the transmissions.

Figure 3. Flight path of the aircraft following the emergency

At 18:53:42 they intercepted the 24L localizer (point 3 in figure 3).

At 19:00 (point 4 in figure 3) the aircraft landed normally on runway 24L. It left the runway via taxiway H-7 and while taxiing to its assigned parking stand (154), the crew reported that they did not need assistance from the firefighters.
