SAFETY INVESTIGATION REPORT

REPORT NO.: 23/2012

MT Haldoz

Cargo spill In the port of Tarragona 03 February 2012

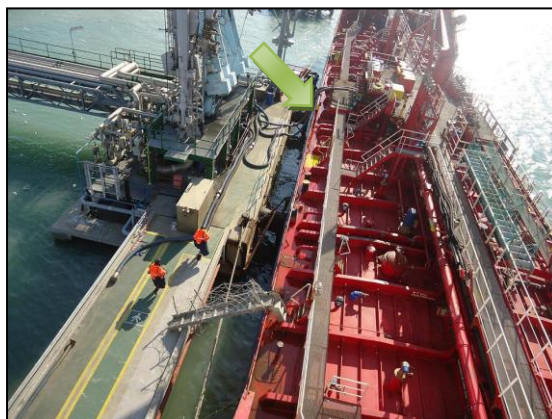
At 0830, a hose was connected for the loading of Styrene monomer, whilst a cargo hose for the loading of the first parcel of Polyol F4811 was connected at 0945 (Figure 4). With both hoses in place, a pre-loading checklist was completed at 0947, in accordance with the company's requirements as laid down in its safety management system manual.

Figure 4: *Haldoz* alongside during the pre-loading operations (arrow shows loading manifold)

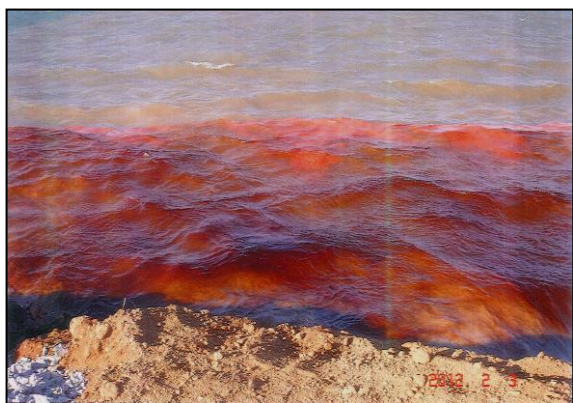
During their visit on board, the harbour authorities observed a substance around the vessel, which was red in colour (Figure 5). By 1139, the first seagulls were reported dead, whilst a number of dead fish were also sighted floating on the sea surface. At 1240, the Terminal emergency control centre reported that the total amount of spilled cargo into the harbour waters was about 100 m³.

Figure 5: Spilled Styrene monomer in the harbour waters

Oil booms were deployed in the area and the Terminal authorities also ensured that six mobile shore reception facilities were made available for the collection of the spilled cargo and contaminated water.
