**DATA SUMMARY**

Date and time	<b>Sunday, 27 October 2013; at 15:18 local time</b>
Site	<b>Malaga Airport (Spain)</b>

Registration	<b>CS-TMU</b>	<b>N111HY</b>
Type and model	<b>BEECHCRAFT 1900 D</b>	<b>ROCKWELL COMMANDER</b>
Operator	<b>TAP</b>	<b>Private</b>

**REPORT**

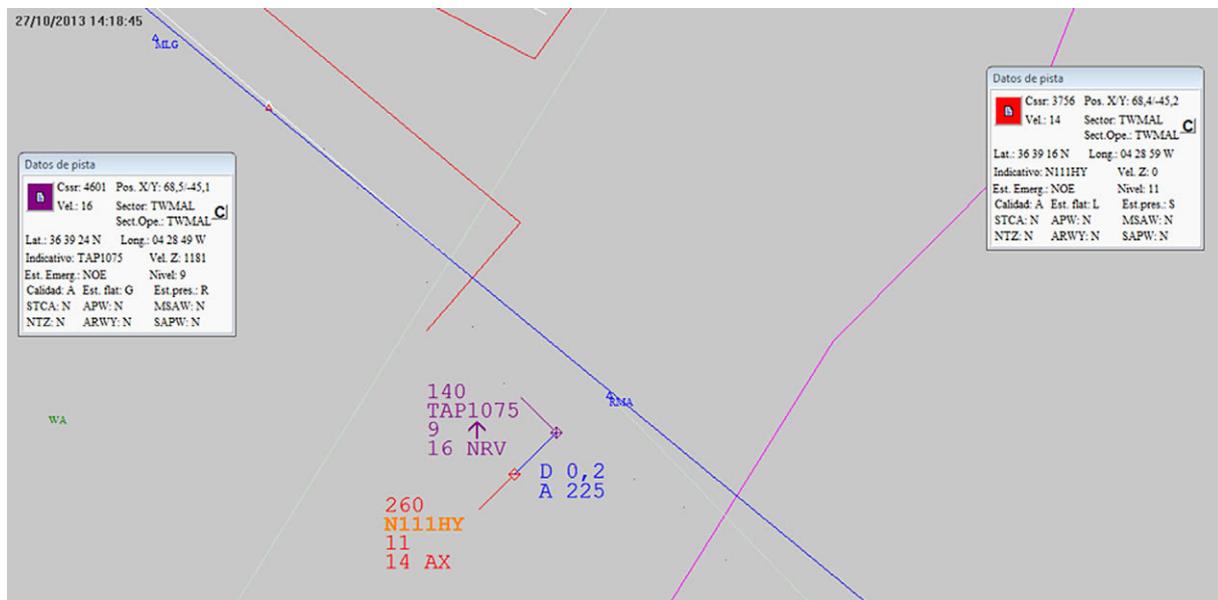
ATC warned the private flight of its proximity to the other aircraft, after which the first aircraft turned 180° to the left, the two aircraft being separated by 0.2 NM horizontally and by 225 ft. vertically, with the Rockwell Commander above and to the left of the Beechcraft, which did not have to take any evasive actions and continued climbing normally.

Figure 1. Aircraft on radar screen at point of minimum separation

By 14:18:40 the separation between the two aircraft had dropped to 0.4 NM horizontally and 225 ft. vertically. Airplane TAP1075 reported traffic ahead to the tower. The controller replied that he was aware of it, that the traffic had not been cleared to cross the active runway and that he assumed the pilot of the other aircraft was not going to cross the runway. The controller apologized and the crew of TAP1075 told him they were not going to report the event but to please be careful as it could be dangerous.
