Report A-046/2013

Accident on 20 December
2013, involving a Bell 212
aircraft, registration EC-IFA,
operated by INAER,
in Chera (Valencia, Spain)

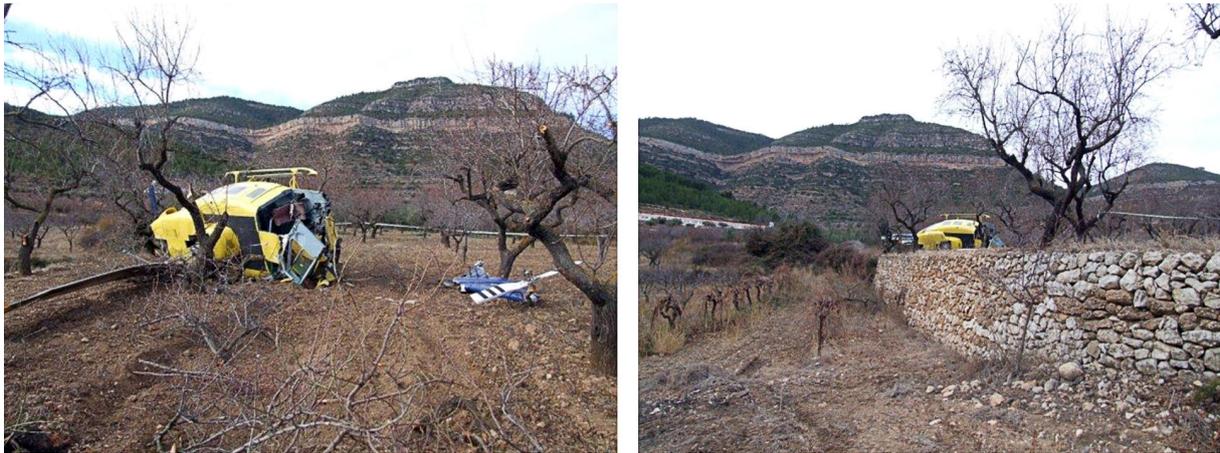
The helicopter was destroyed. The nose was heavily damaged, as were the main rotor blades. Part of the tail cone had detached, along with the tail rotor.

Figure 1. Helicopter after the accident

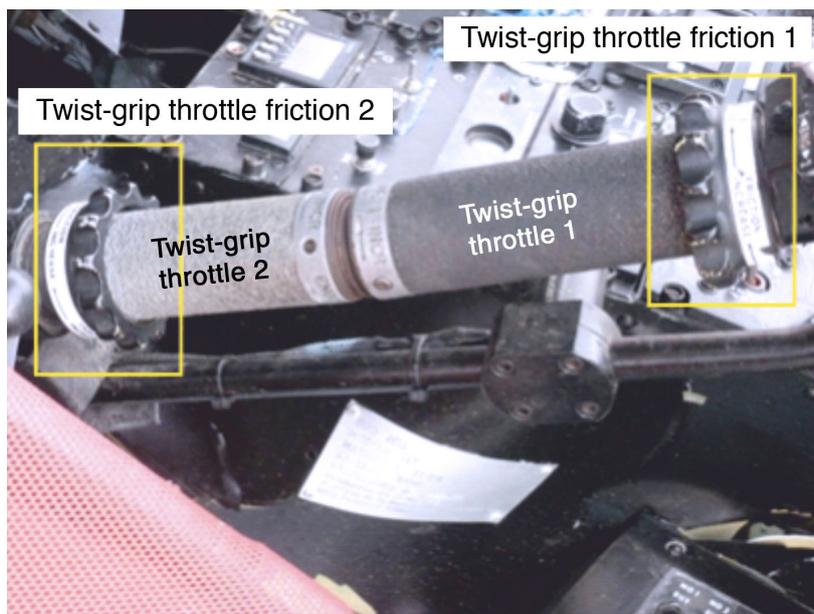
Figure 2. Collective stick and grip throttles

One explanation for the loss of power that the running engine should have been able to provide is the pilot's possible and unintentional input to the grip throttle for said engine. The pilot stated that he released the friction on both grips, meaning that when he later closed the throttle for the number 2 engine, he might have moved the one for the number 1 engine as well.

The fact that the grip throttle for the running engine might have been accidentally twisted while closing off the throttle for the number 2 engine means that the operating limits for the number 1 engine would have been lowered. As a result, any subsequent movement of the collective lever to demand more power would not achieve its objective, as its N1 would have been limited to 90% of its rated value.

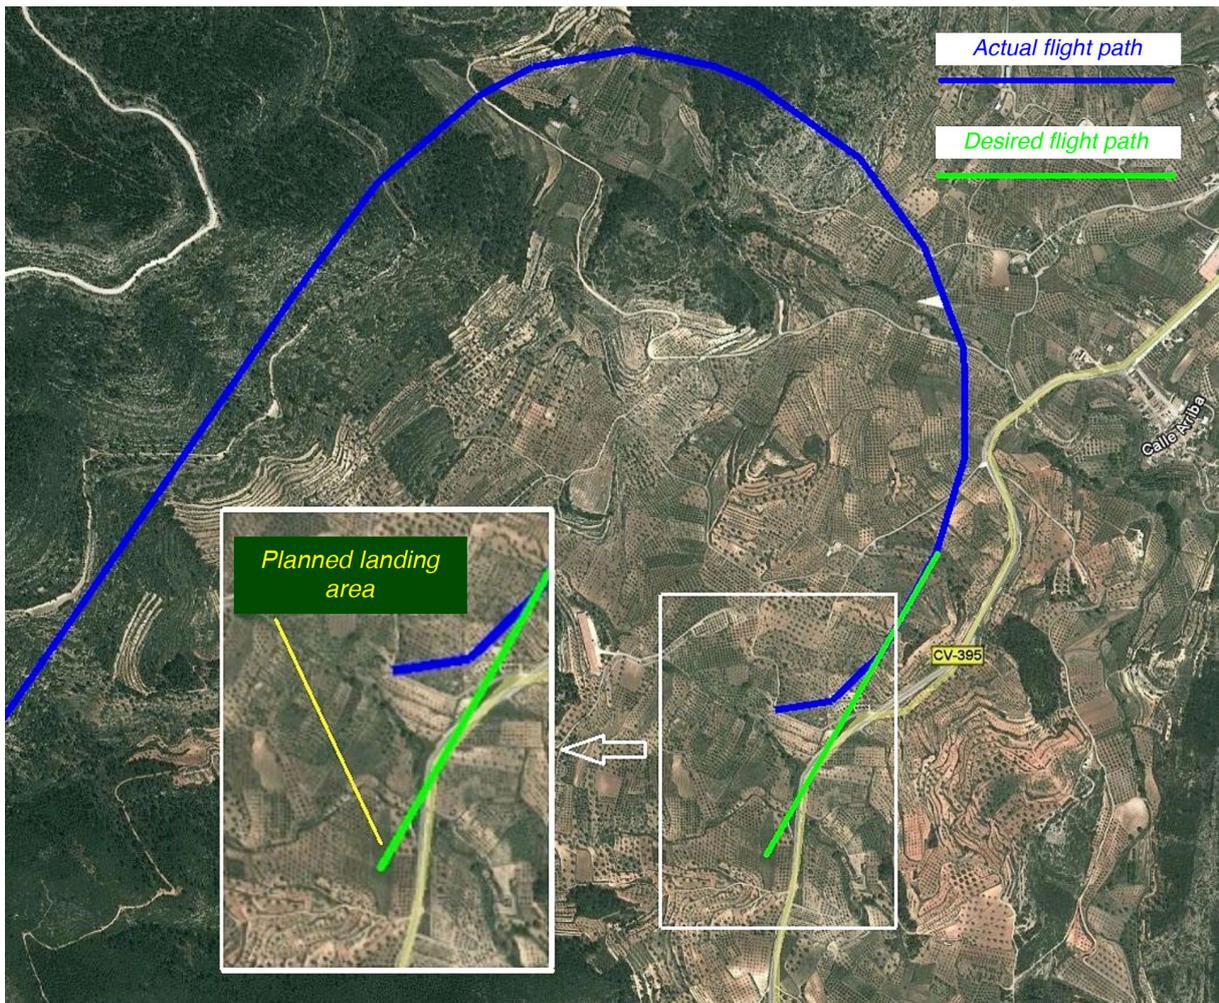
While making the approach to the chosen landing area, the pilot was unable to stay on course and he was forced to land in a different spot, where the helicopter impacted the ground.

Figure 3. Close up of final flight path

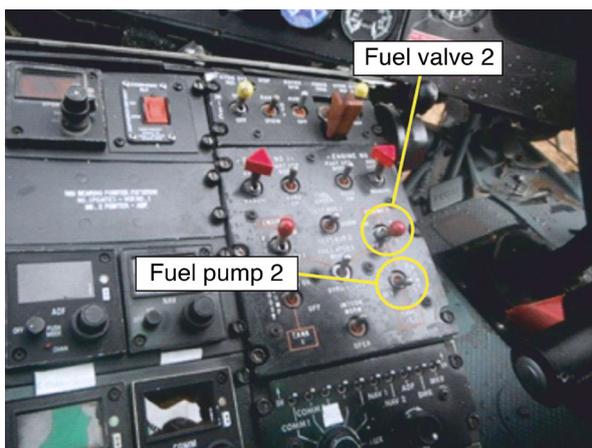
During the inspection of the cockpit, it was noted that the fire detection lever for the number 2 engine had been pulled, that the fuel valve and pump switches were OFF and that the engine's instrument readings were at zero. It was also noted that the fire detection lever for the number 1 engine had been pulled and that the instrument readings for that engine indicative values above zero.

Figure 4. Fuel panel

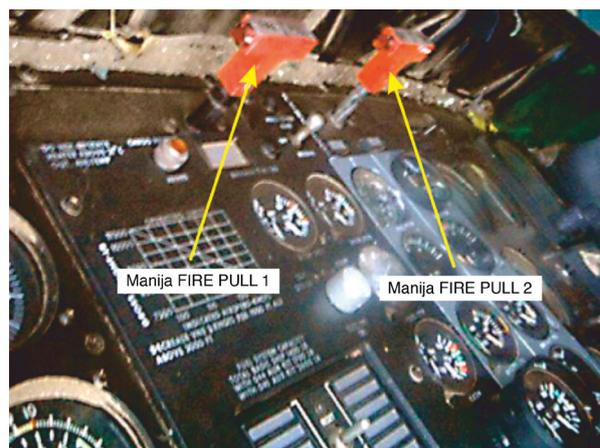
Figure 5. Fire detection levers
