CIAIAC

Report A-009/2014

Accident on 25 May 2014,
involving an Air Tractor
AT-802 aircraft, registration
EC-LCA, while fighting a fire
in the vicinity of Serón
(Almería, Spain)

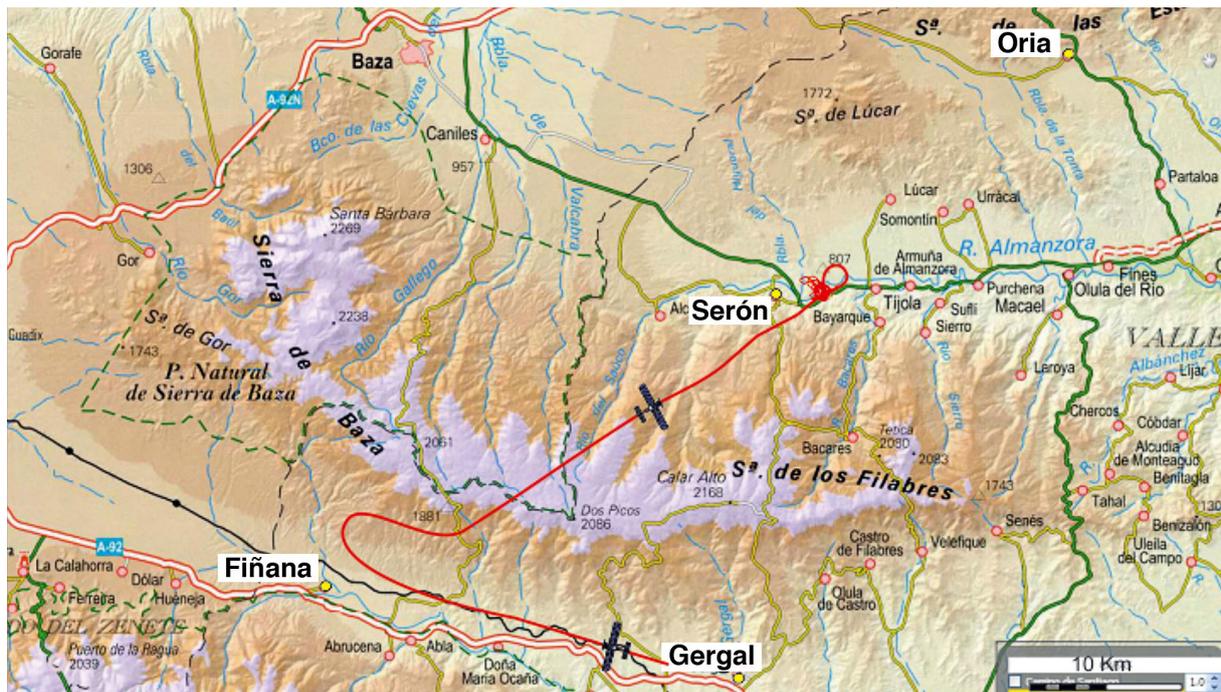
Subsequently the aircraft was observed away from the area of the fire but flying toward it and making an unexpected water drop near a hillside that was more than one kilometer

Figure 1. Aircraft's flight path and site of the accident

away from the fire. As it made the drop, the aircraft made a sharp turn and banked hard to the right, causing the aircraft to impact the terrain.

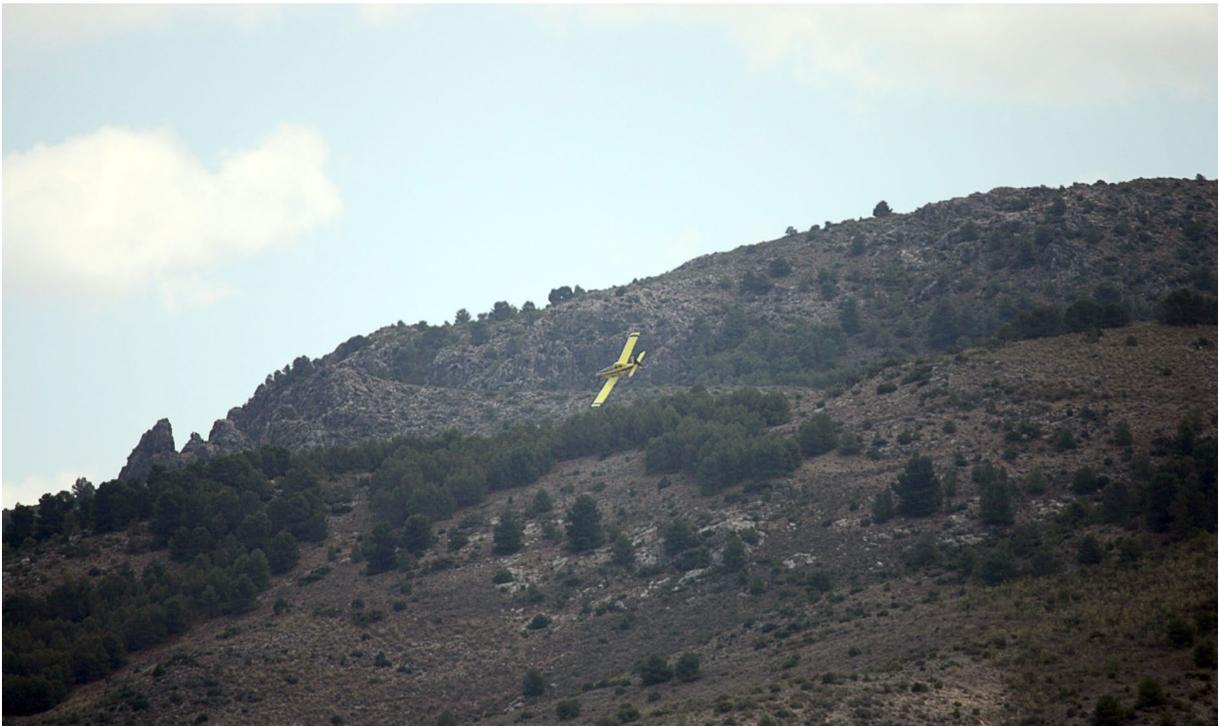
According to the eyewitness, the pilot was unable to locate the fire site. The TOP instructed him to fly over the area and that he, along with other members of the brigade, would lead him to the fire. Although the pilot was able to locate them when he flew over the area, when he flew back to make the drop he was unable to find the drop point, resulting in the process being repeated three times (the graphs in Appendix 1 show the path taken by the aircraft as it attempted to locate the fire, and Fig. 2 shows how these attempts to locate the fire were being executed). It was then that the eyewitness told the pilot to abort the operation and return to base. Thinking that the aircraft had flown away, he was surprised to see it appear once more, downhill from

Figure 2. Aircraft as the pilot attempts to locate the fire prior to the accident

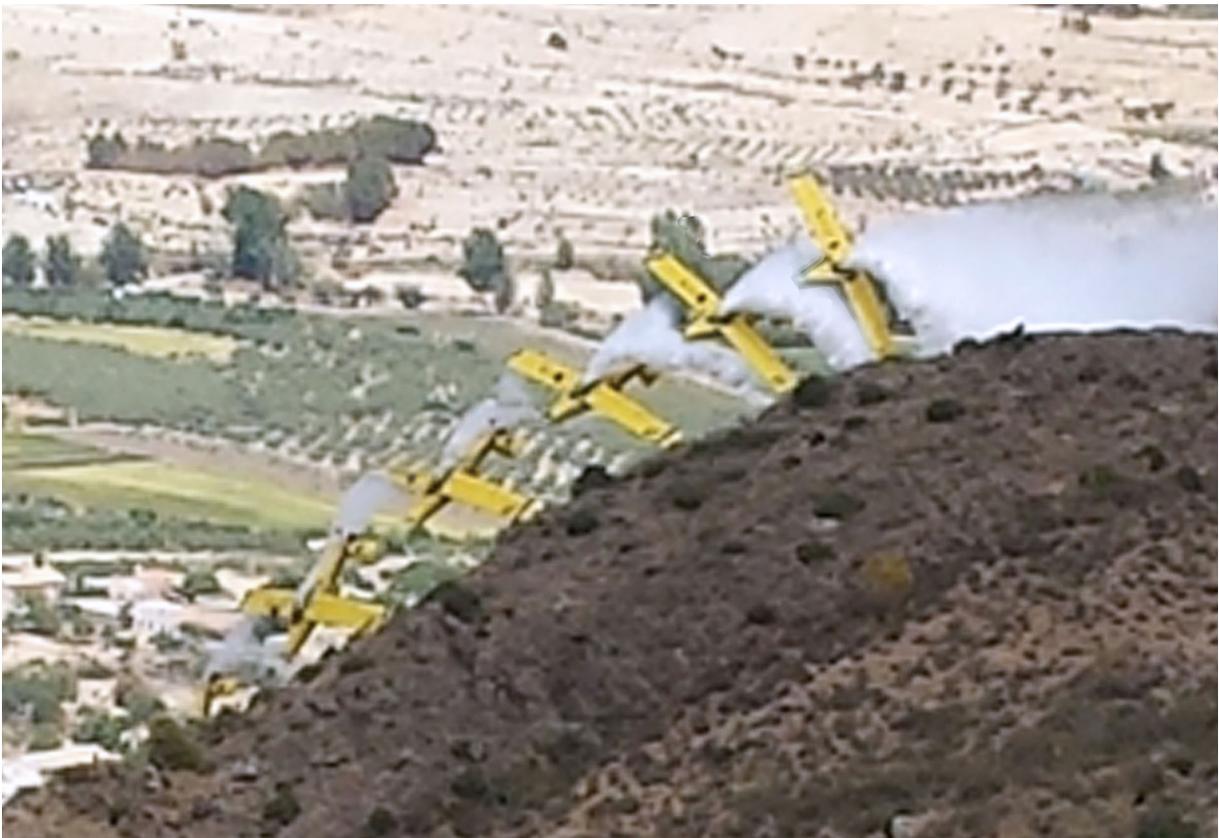
Figure 3. Sequence of photographs taken by eyewitnesses

his position and flying near the mountain toward their position. They then saw the aircraft turn and bank sharply to the right, even reaching an inverted position, while making the drop. Immediately after this the aircraft disappeared from view and they saw the fire and column of smoke after the impact.

Below is a sequence of six photographs taken from the fire brigade's position showing how the water drop was made with the airplane practically inverted, and how it made a sharp right turn causing it to roll and descend almost vertically. This resulted in some of the water falling on top of the aircraft after the impact.

As the aforementioned images show, at one point the aircraft was making a sharp turn to the right while at the same time making the drop. This happened more than one kilometer away from the site of the fire, meaning the drop was not made with the intention of putting out the fire. It also made no sense to make the drop there to return to the base, since according to the company's Operations Manual, the drop has to be made in a specified area near the base. The images available show that before completing the drop, the aircraft was already at an angle in excess of 90° and going into an inverted position.

As the images show, the aircraft was turning just as it was making the drop. This means that in addition to the above conditions, the aircraft also experienced a sudden increase in lift, which in this case served to push the aircraft toward the terrain. This means that as the aircraft started to roll, it sank to the ground.

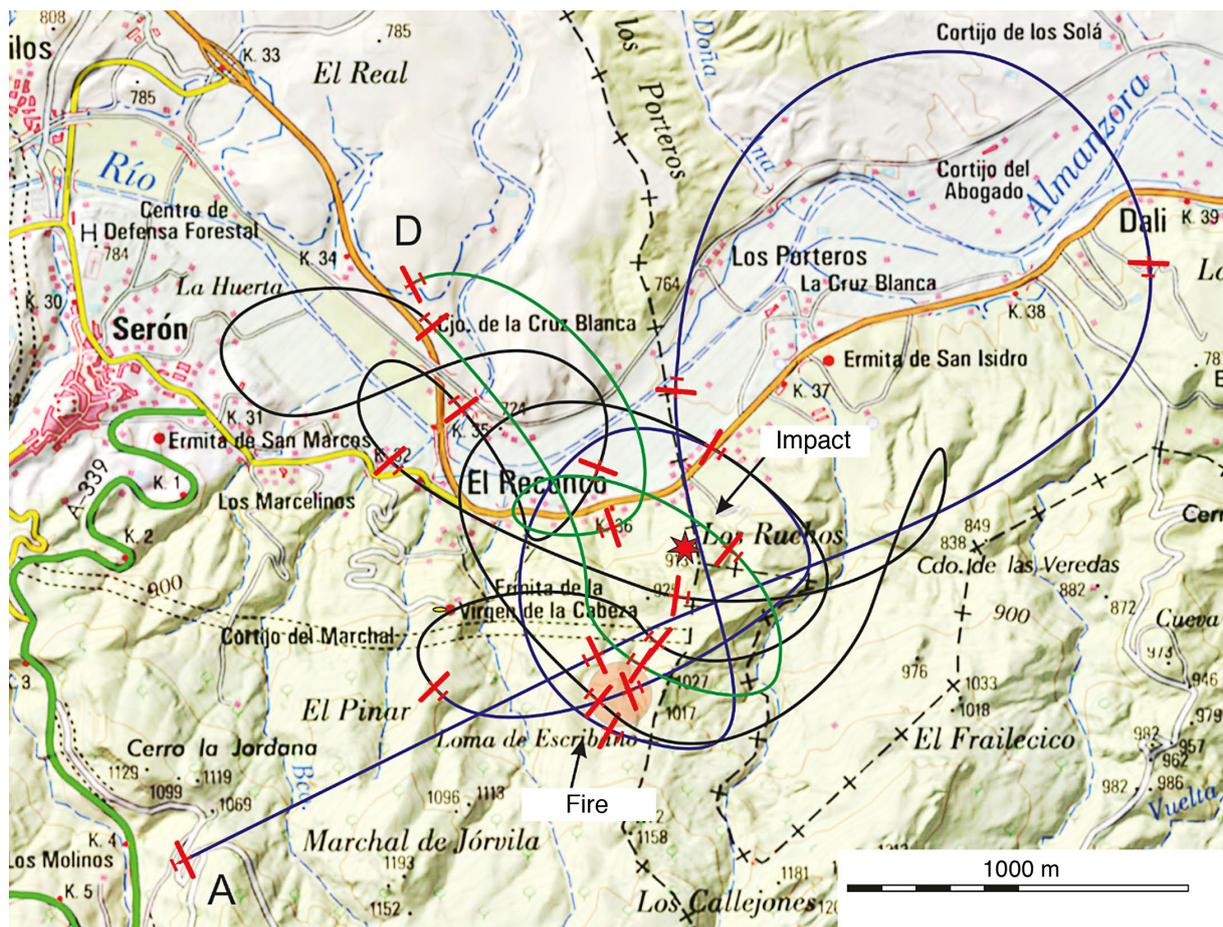
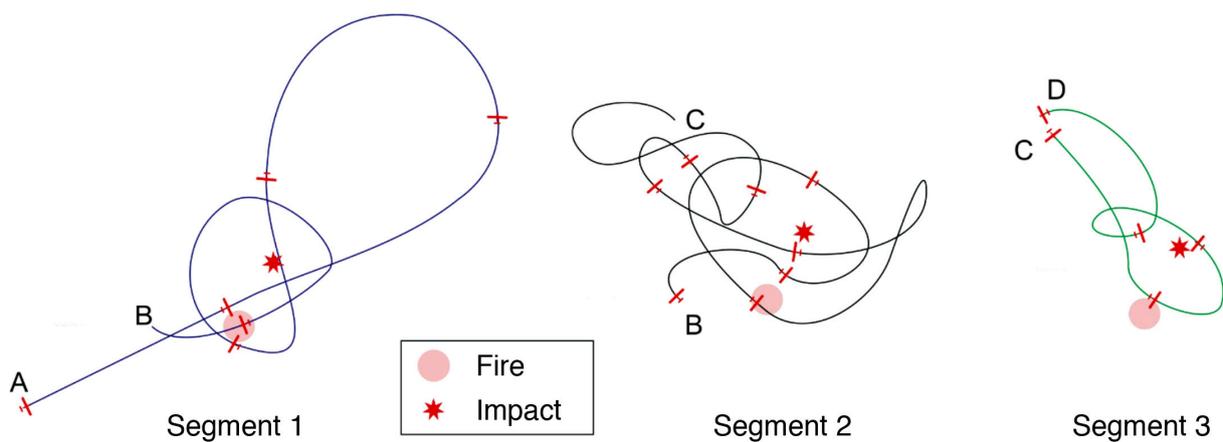
APPENDIX 1
**Flight path while trying
to locate the fire**

Due to the complexity of the flight path before the accident, it has been divided into three different segments to make it easier to follow:
