Report IN-027/2014

Incident involving a Boeing B737 aircraft, registration EI-EBC, operated by Ryanair, and a Boeing B737 aircraft, registration G-GDFR, operated by Jet2.com, at the Malaga-Costa del Sol Airport (Spain) on 17 September 2014

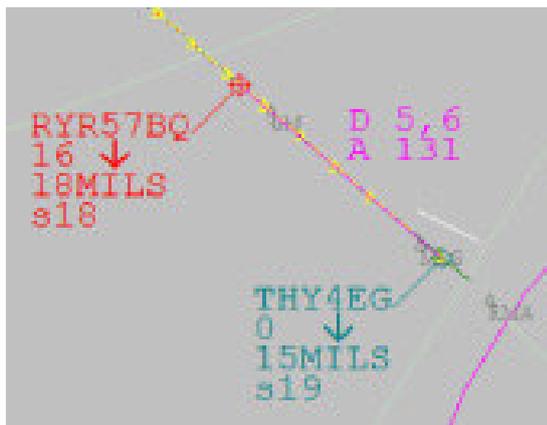
Figure 1: Position of aircraft RYR57BQ and THY4EG at 11:18:18

Based on the data from this system, at 11:18:18 aircraft RYR57BQ was a little over 5 NM away from the runway 13 threshold and descending. At that time, the LCL had not yet cleared EXS21PM to take off from this same runway, since THY4EG was still on it following its landing maneuver.

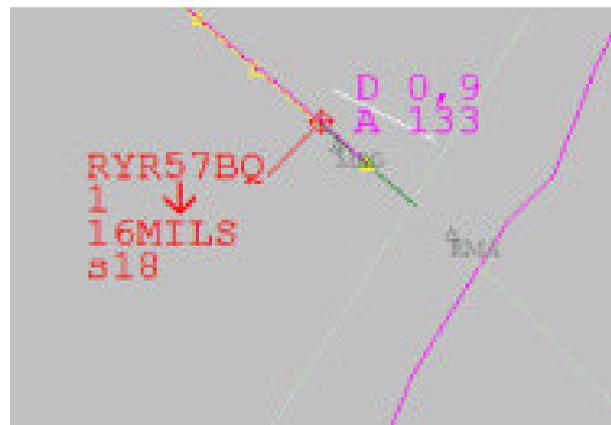
Figure 2: Position of aircraft RYR57BQ at 11:20:03

RYR57BQ continued to approach the runway until, at 11:20:03, this aircraft was cleared to land, by which time it was already over the runway threshold within 100 ft of the ground and descending.

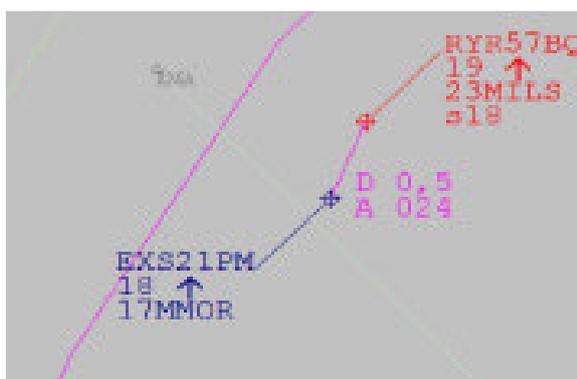
Figure 3: Position of the aircraft at 11:21:05

At 11:21:05, when EXS21PM also started turning to heading north, the horizontal separation between the two aircraft reached its minimum value of 0.5 NM. Their vertical separation at the time was 100 ft.

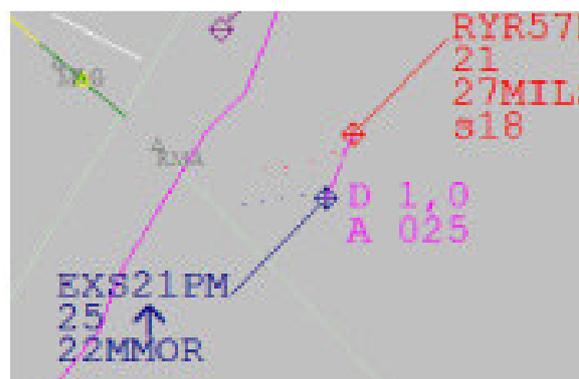
Figure 4: Position of the aircraft at 11:21:29

By 11:21:29, aircraft EXS21PM was turning to heading south, while RYR57BQ was turning to the north. By that time, the horizontal separation between them had increased to 1 NM and the vertical separation to 400 ft and the LCL had transferred RYR57BQ to the departures (APP) frequency.

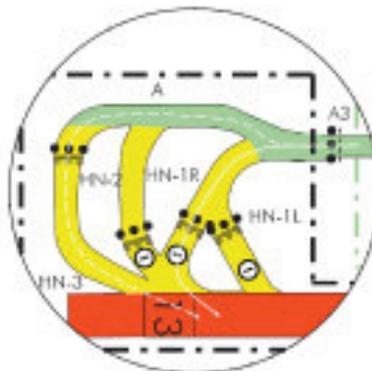
Figure 6: Access taxiways to runway 13

Unless the ground (GMC) controller specifies otherwise, access to runway 13 with a single aircraft in operation will preferentially be via HN-3. HN-1R will not be used unless instructed by GMC (information contained in the Aeronautical Information Publication (AIP)). See Figure 6.

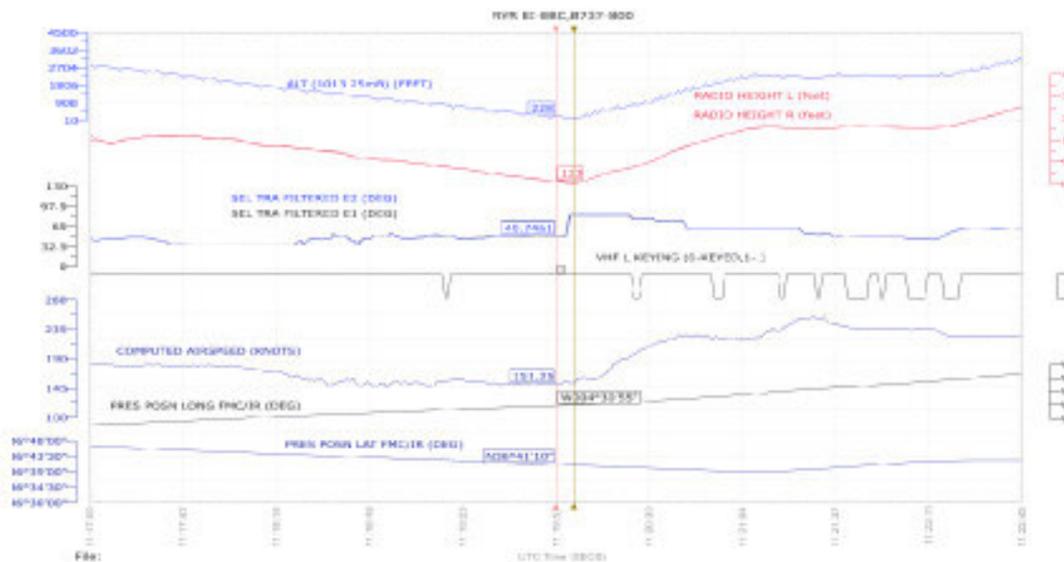
Figure 7: Data for aircraft RYR57BQ

The FDR submitted by the operator for its reading was a Honeywell solid-state model, part number 980-4700-042. The data revealed the instant, 11:20:06, at which RYR57BQ started its go-around maneuver as it went from a descent to a climb attitude. Prior to this instant, the radio altimeter was recording descending values to an altitude of 38 ft, after which the recorded values started to increase. The airspeed also increased substantially after this time, as did the RPMs recorded by the engine tachometer.

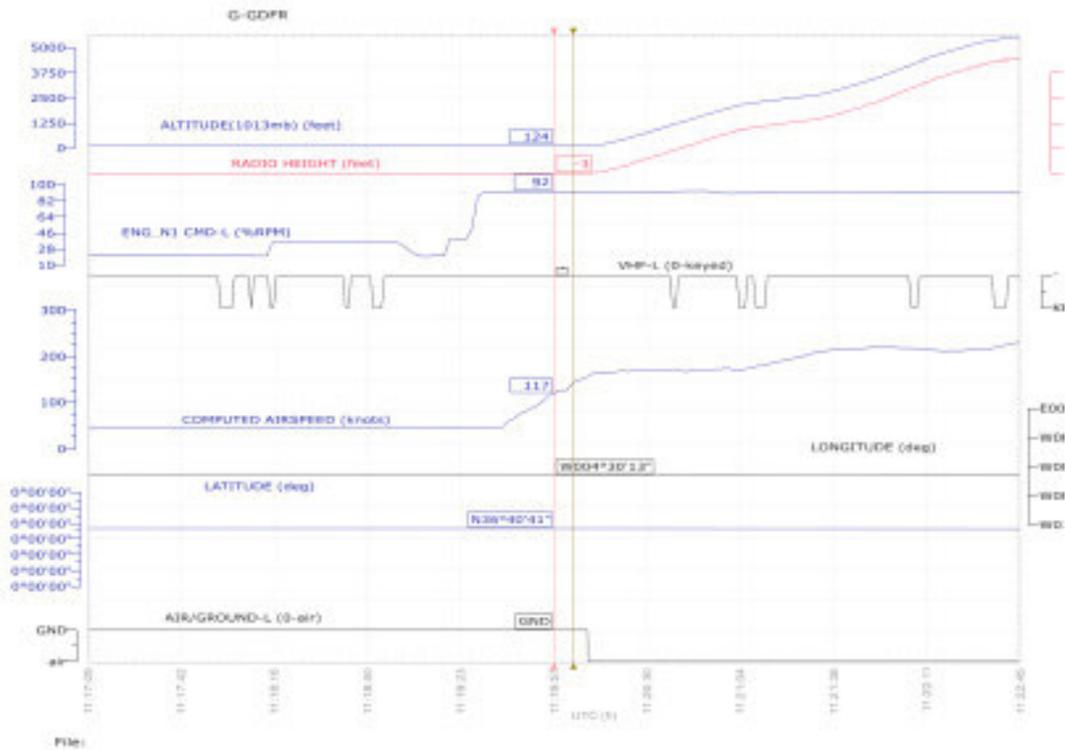
Figure 8: Data for aircraft EXS21PM

The aircraft was airborne at 11:20:10. Based on radio altimeter data, it was then that it started recording positive and increasing altitude values.

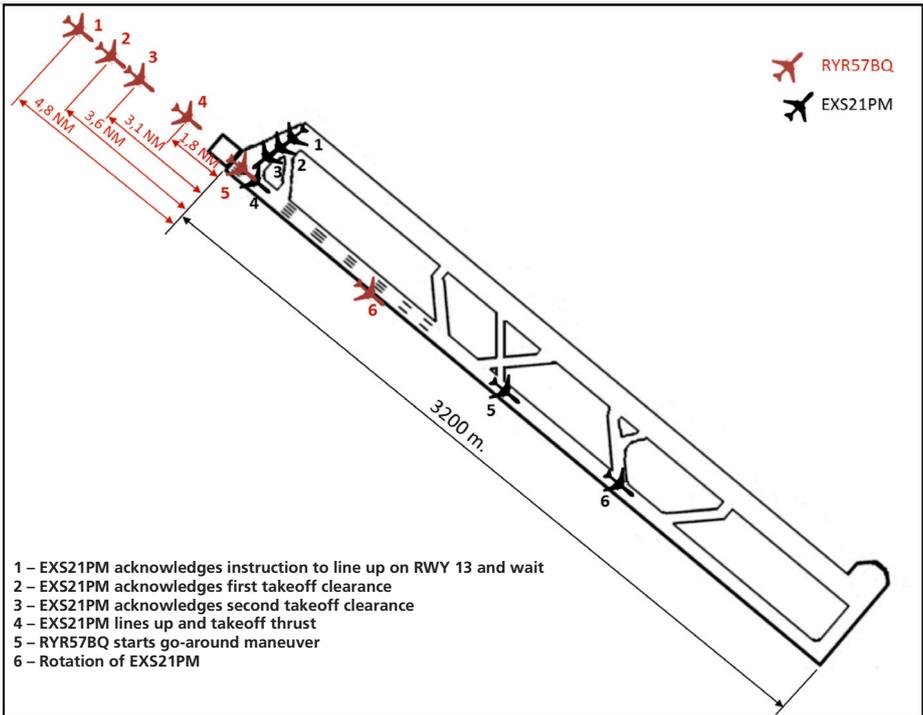
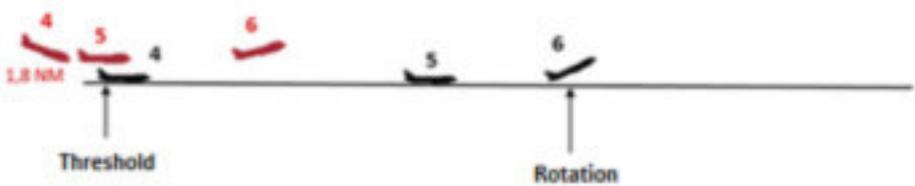
Figure 9: Positions of the two aircraft

- By the time aircraft RYR57BQ was over the runway threshold, at which point it started the go-around maneuver, EXS21PM was on its takeoff run, 1312 m away from the runway threshold (position 5).

- Aircraft EXS21PM rotated and took off some 1952 m away from the runway threshold, by which time RYR57BQ was already flying over the runway, and separated horizontally from EXS21PM by fewer than 0.4 NM (position 6).

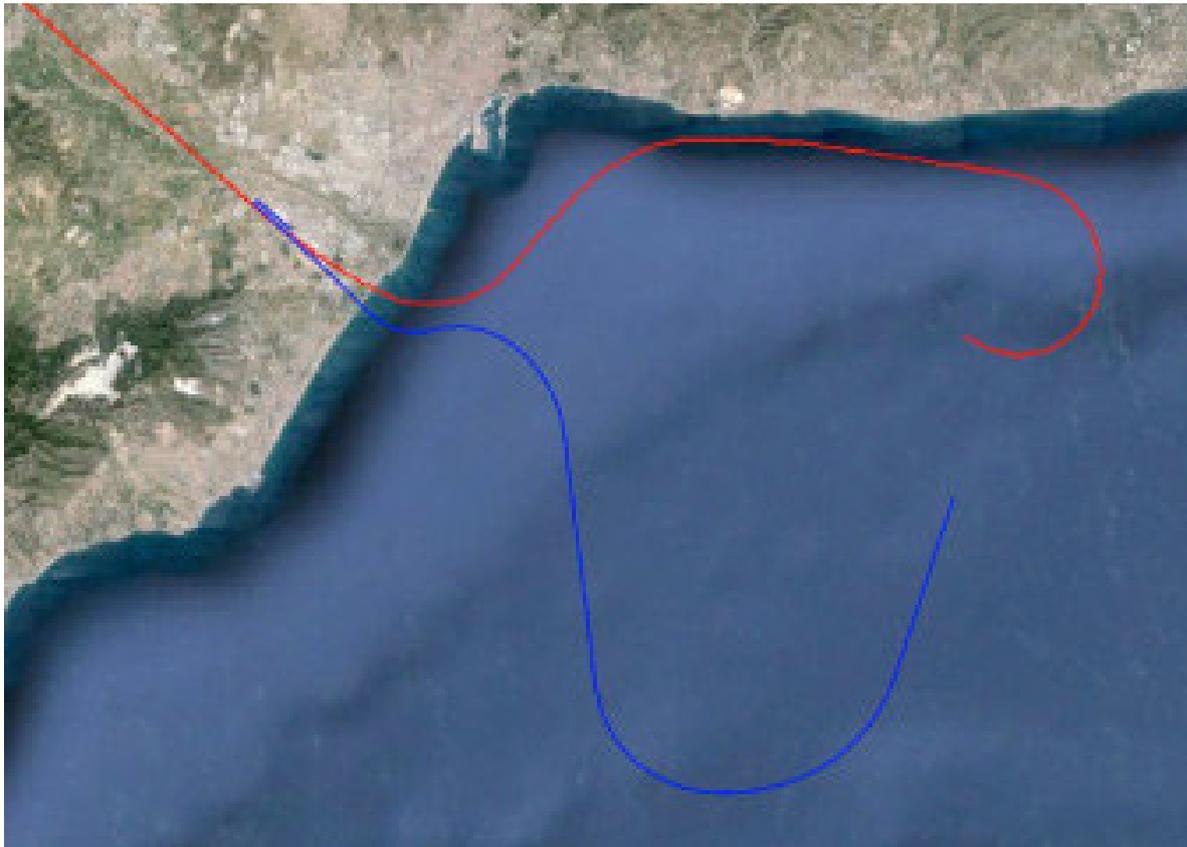
Figure 12: Aircraft flight paths

When the crew of EXS21PM noticed that the maneuver of RYR57BQ, and resulting from the instruction given to them by the LCL, put RYR57BQ in conflict with EXS21PM, they disengaged the autopilot and turned right to avoid the other aircraft. They then verified the direction of their turn with the LCL, who amended his instruction from turn north to turn south. At that time, the distance between the two aircraft was reduced to 0.5 NM and 100 ft.
