## Report A-028/2014

Accident involving an Airbus A319-111 aircraft, registration G-EZIX, operated by EasyJet, in the Madrid FIR at FL150 on 21 September 2014

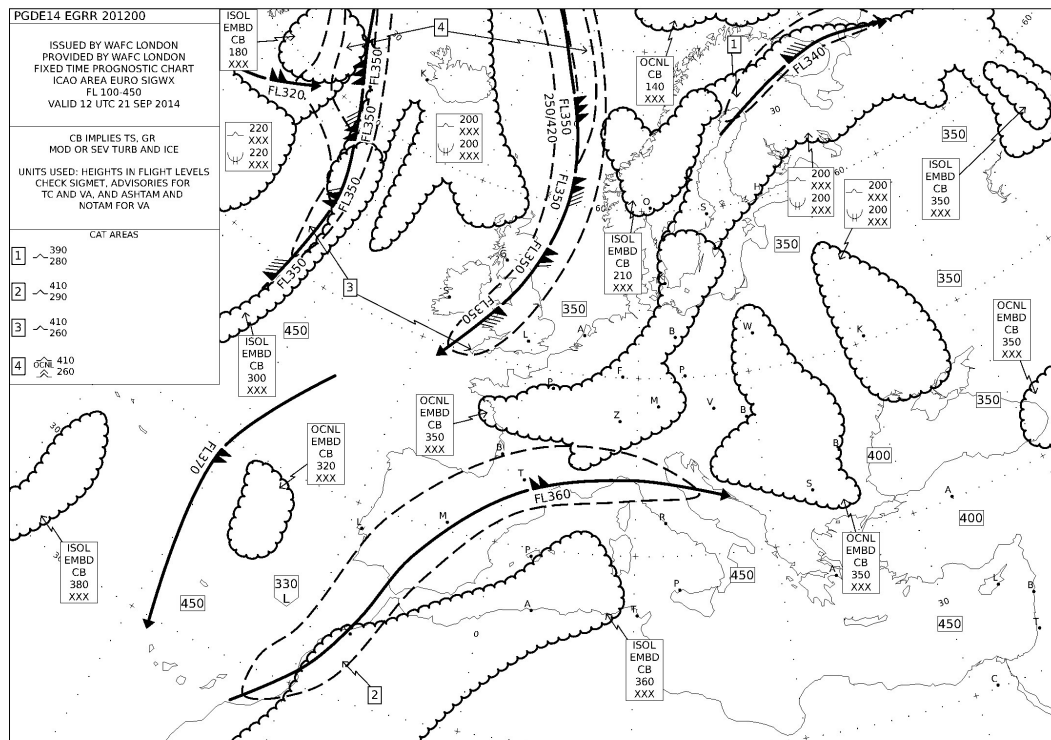
**Figure 1.** Significant weather map between FL100-450

Figure 1 shows the map forecast for 12:00 UTC from FL 100 to 450. This map calls for moderate turbulence between FL 290 and 410 in the LEMD approach area.

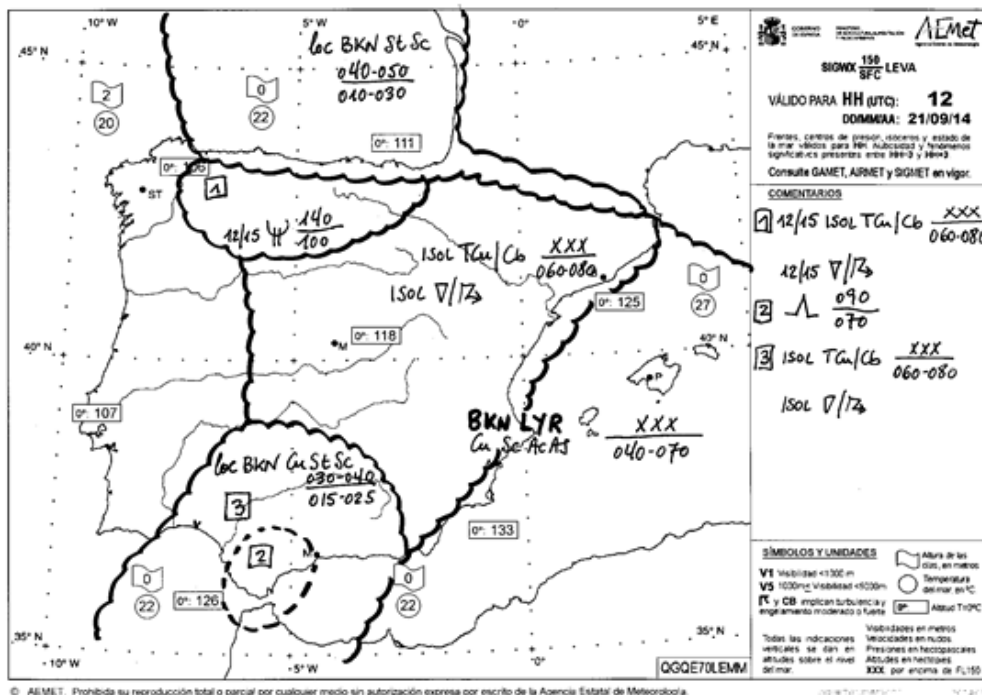
Figure 2. Significant map

The significant map from the surface to FL150 at 12:00 UTC showed: Figure 2

Isolated showers and storms,

Isolated cumulus and towering cumulus clouds with bases between FL 060-080 and tops above FL150.

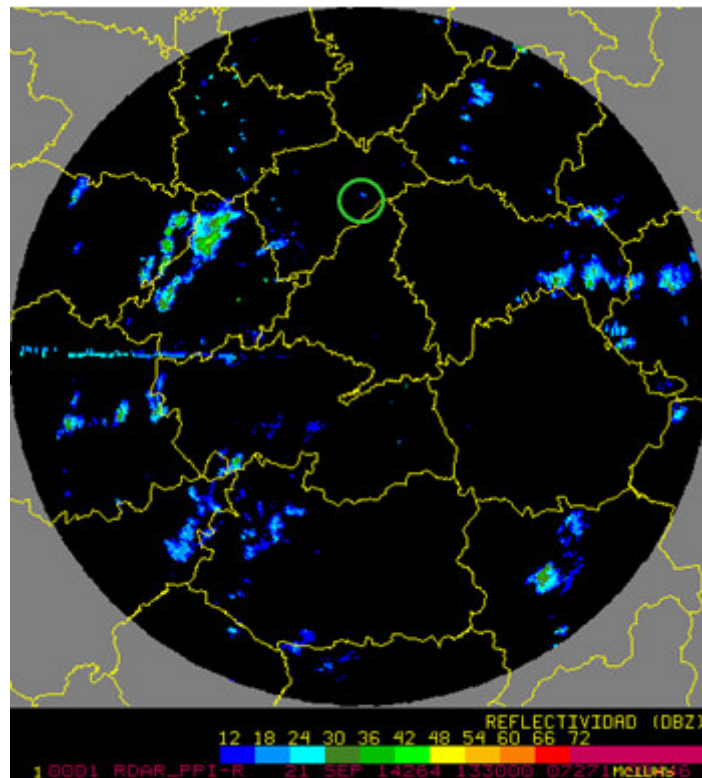
**Figure 3.** Weather radar image

Figure 3 shows the reflectivity weather radar image associated with the precipitation in the hours before 13:30 UTC. The area that the aircraft was flying through when it encountered the turbulence is circled in green.

The weather information gathered by investigators shows a storm cell in the area where the turbulence occurred, Figure 3. Spain's aviation weather service had also published a significant low-level weather chart that called for the presence of cumulus and towering cumulus clouds. This significant chart was not part of the information used to plan the flight, though it is made available to all operators in general.

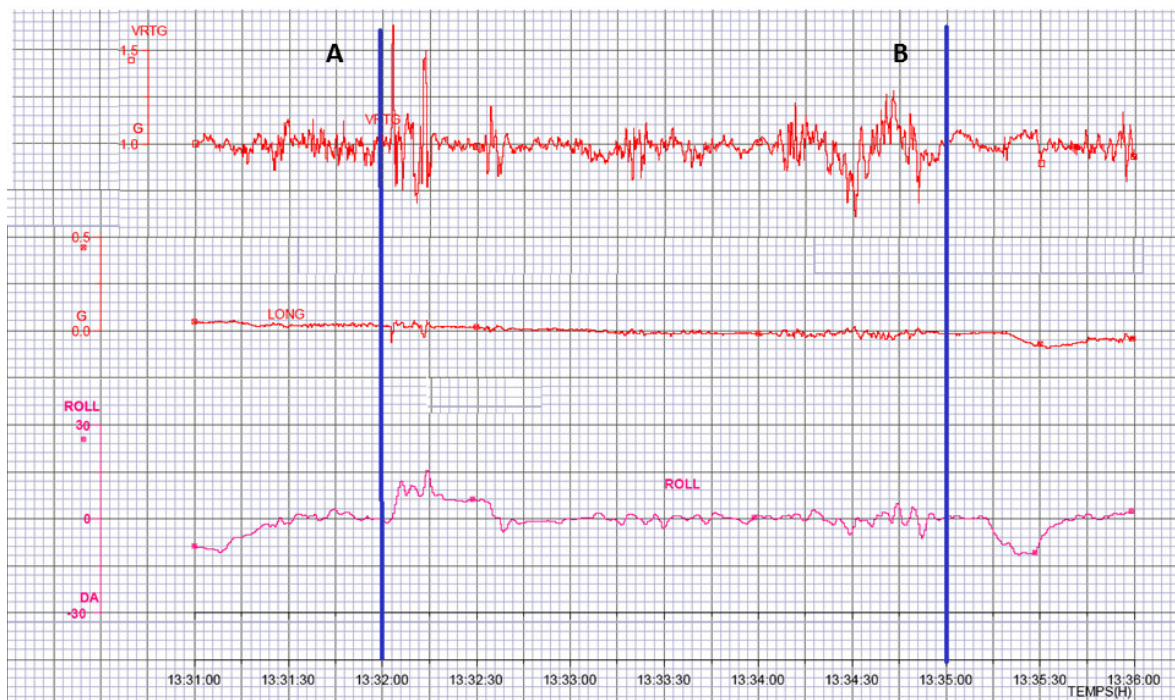
Figure 4. Graph of values recorded

In Figure 4, the segment between points A and B shows the vertical acceleration, longitudinal acceleration and bank angle values recorded during the turbulence. In this segment, the aircraft descended some 2,700 ft from 14084 ft at around 2,000 ft/min. This rate quickly slowed to 480 ft/min, with instantaneous values of between 0 and 24 ft/min. Once below 12,000 ft (FL120), the descent rate again rose to normal values, though instantaneous vertical acceleration values of up to 48 ft/s were recorded in the seconds that followed.

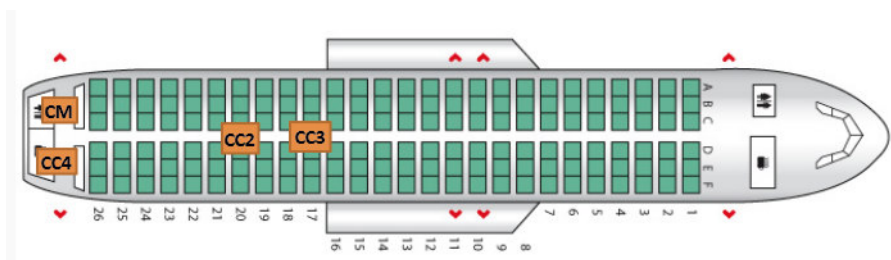
Figure 5. Positions of FAs

Their locations when the turbulence began were as follows, Figure 5:

CM: Aft lavatory

CC2: Row 20

CC3: Near the middle of the aircraft

CC4: Aft galley

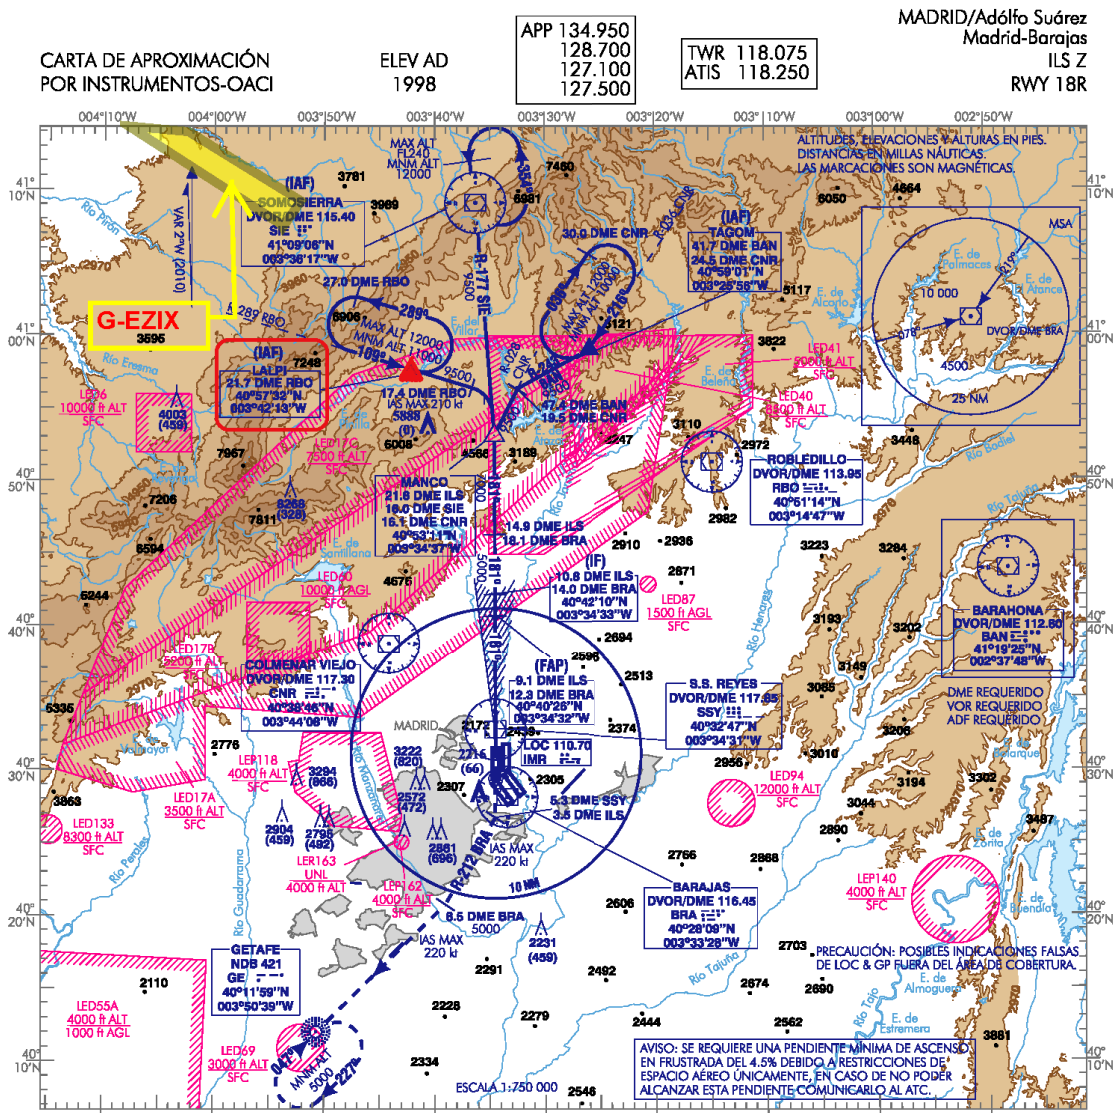
Figure 6. Location of the area of turbulence

The yellow-shaded area in Figure 6 shows the final part of the area of turbulence, as the airplane was flying to point LALPI, the IAF for the instrument approach to runway 18R at LEMD.

The figure also shows a mountain chain that runs across the flight path taken by the aircraft, some peaks of which rise to elevations just over 2,000 m (6,561 ft).
