Report IN-032/2014

Incident involving an Airbus A320-216 aircraft, registration EC-KCU (operated by Vueling), and a Boeing 737-800, registration EI-EKS (operated by Ryanair), in the vicinity of reporting point VULPE in the Seville (LEZL) TMA, Spain, on 30 October 2014

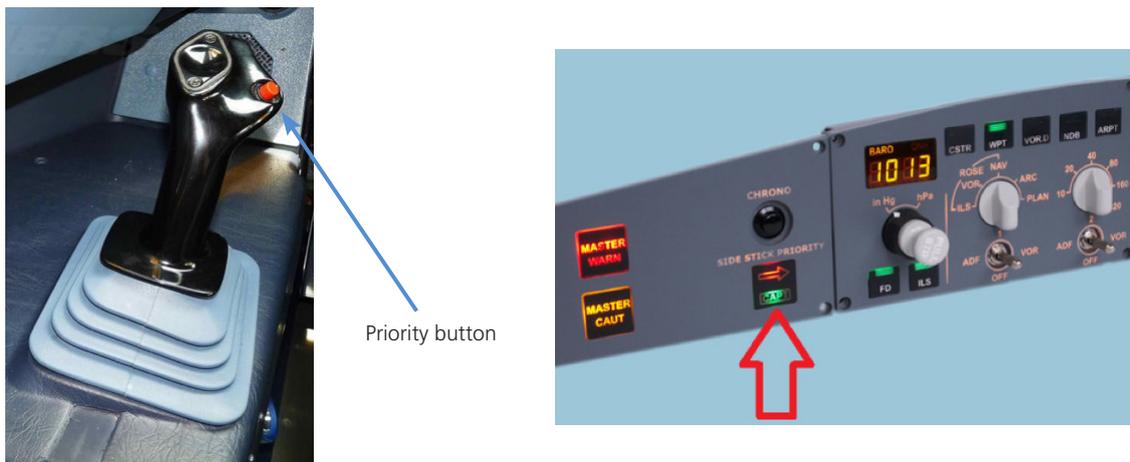
Figure 1. Sidestick on the A320 and control priority indicator

Either pilot can cancel the other pilot's actions by pressing a priority button on his control stick. The last pilot to press this button has control of the aircraft, and a light on the other pilot's instrument panel alerts him to this. The other sidestick's inputs are only cancelled while the button is pressed. A "DUAL INPUT" callout is issued by the system when both sidesticks are active.

At 20:57:33, VLG2226 was descending at a rate of 4400 ft/min. The direction of the RA then changed to "Climb, climb now", indicating a climb rate of 1500 ft/min. The FDR recorded at that instant that both pilots pulled on their sidesticks to reduce the descent rate without either of them pressing the priority button. The captain stated that at that time, the speed indicator display on the PFD refreshed to reveal that the vertical speed needle was in the red area, and far from the green area. This caused him to react rapidly to adjust the speed to that required by the TCAS, although he did not intend to take control of the aircraft. As a result of the stressful situation, he did not apply the procedure for transferring control of the aircraft, as required by the operator. This caused the aircraft to increase its vertical acceleration to 2.03 g. The "Dual input" aural was not issued since the TCAS RA aural, which takes precedence, was also sounding. Both pilots were simultaneously actuating the aircraft's control for a period of 10 seconds.

- The captain and first officer both moved the airplane's control stick without either one pressing the priority button.
- This caused the aircraft's vertical acceleration to increase to 2.03 g.

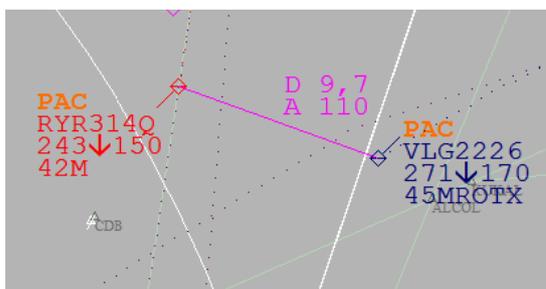
Figure 3. Aircraft positions at 20:56:23

At 20:56:23, the controller's conflict alert system was activated. In this case, it was a PAC, since the minimum radar separation distance had not been breached. The descent rate of VLG2226 was 4475 ft/min¹⁴ and the distance between the aircraft was 9.7 NM horizontally and 2800 ft vertically.

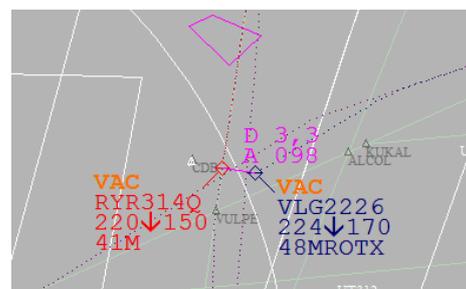
Figure 4. Aircraft positions at 20:57:23

At 20:57:23, RYR314Q was descending at 2,344 ft/min while VLG2226 was descending at 3,981 ft/min. They were separated by 3.3 NM horizontally and 400 ft vertically.

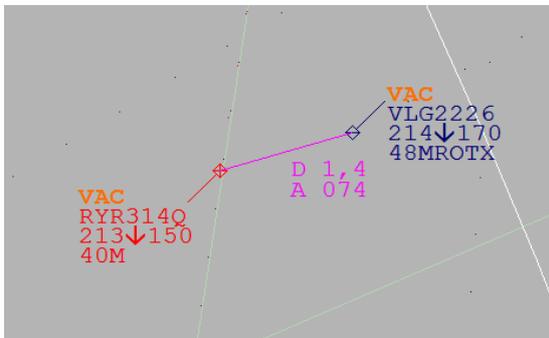
Figure 5. Aircraft positions at 20:57:43

The closest point of approach came seconds later, at 20:57:43, when they were separated by 1.4 NM horizontally and 100 ft vertically.

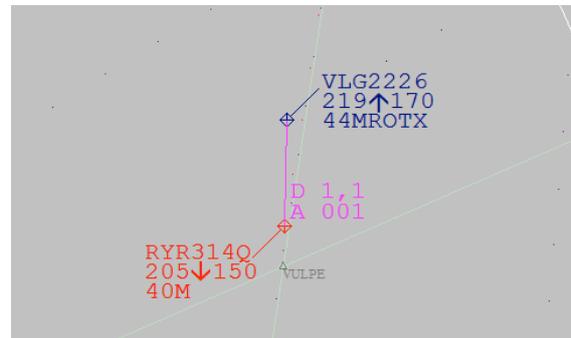
Figure 6. Aircraft positions at 20:57:58

The minimum horizontal distance between the aircraft was 0.9 NM, by which point the vertical distance had increased to 1100 ft.

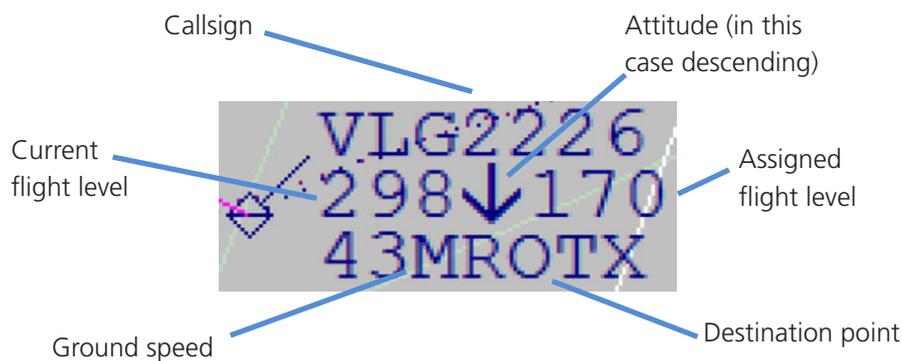
Figure 7. Radar tag shown on controller's display

There is no way for the controller to see the descent rate of aircraft.

sent by the aircraft, it is calculated after the fact by the system. ENAIRE was asked about the possibility of including descent rate data with the other information shown to the controller once the SACTA system is upgraded and mode S radars are implemented. This option was ruled out in the end because vertical speed is subject to large variations due to turbulence and to small, fast vertical motions of the aircraft. As a result, a safety recommendation is not issued in this regard to the service provider to upgrade the SACTA system to have it display this information on the controller's display as the transition to mode S radar is made.

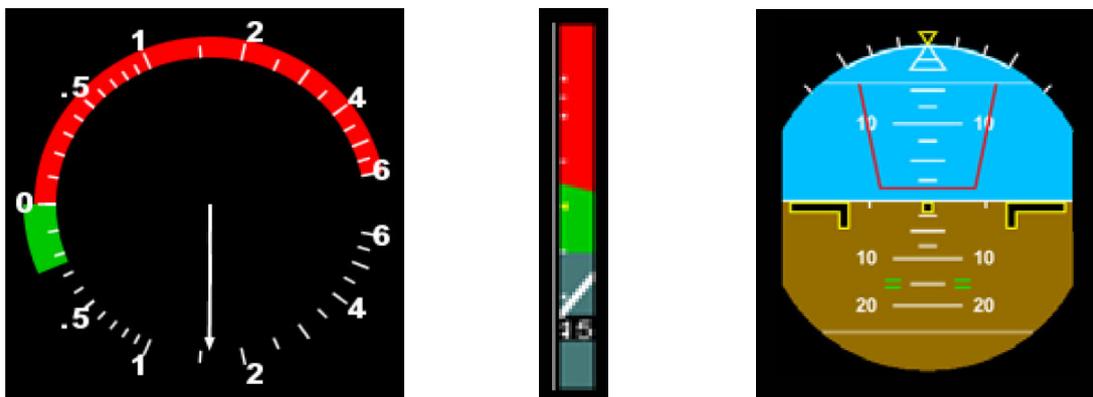
Figure 8. TCAS-VSI. From L to R: Semicircular VSI, Vertical Speed Tape and Pitch Cue

The TCAS "Adjust vertical speed" RA requires the crew to reduce the aircraft's descent or climb rate. Bulletin number 3 focused on faulty interpretations by crews of the "Adjust vertical speed" advisories, stating that this is the most frequent type of RA, meaning its instructions must be followed exactly. The bulletin noted that over just 14 months, 12 events were detected in which the crew maneuvered the aircraft in the opposite direction required by an "Adjust vertical speed" RA (other potential events were being analyzed). In the cases considered, the RA was shown

on the vertical speed tape or on the semi-circular VSI (vertical speed indicator). In one similar event, however, the RA was displayed on the pitch cue in the PFD.

The Eurocontrol ACAS Bulletin states that the RA is sometimes difficult to interpret when it is shown on the vertical speed tape. An RA shown on the PFD can be similarly difficult to interpret for a weakening RA due to the absence of a green area. It also does not inform the crew of what vertical speed is required by the RA. Many aircraft operators and pilots regard the RA displayed on the pitch cue on the PFD as the most intuitive for other RA types. This means that if the RA is shown both on the PFD and on the vertical speed tape, it can improve the crew's interpretation of RAs of the "Adjust vertical speed" type.
