Report IN-005/2015

Incident involving a Bombardier CRJ1000 (CL-600-2E25) aircraft, registration EC-LPG, operated by Air Nostrum, at the Adolfo Suárez Madrid-Barajas Airport (LEMD) on 1 February 2015

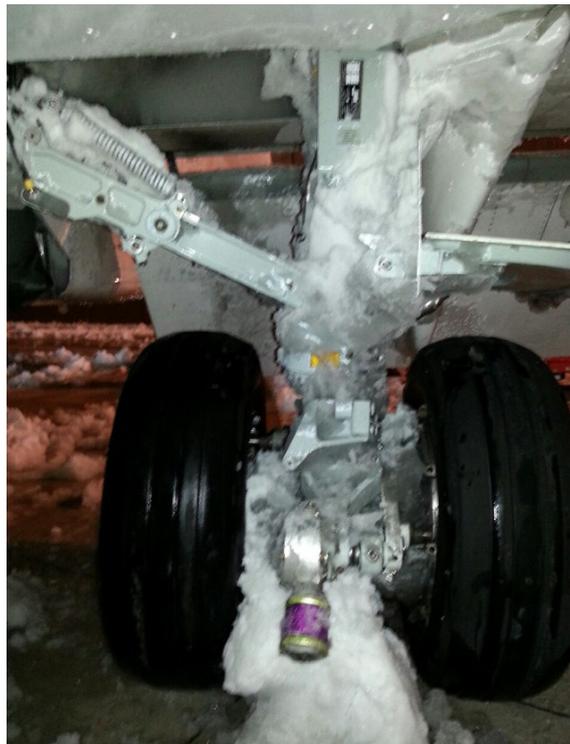
On 31 January 2015, the aircraft landed at the Pamplona Airport (LEPP) on its last flight of the day. When it arrived at the parking stand, there was a considerable amount of snow built up on the gear (see photograph 1 below). According to the maintenance technician, the snow was cleaned off manually. Some ice remained in areas that were hard to reach, but it melted over the course of the night, during which it continued to snow.

Photograph 1. Condition of the gear the night before the incident

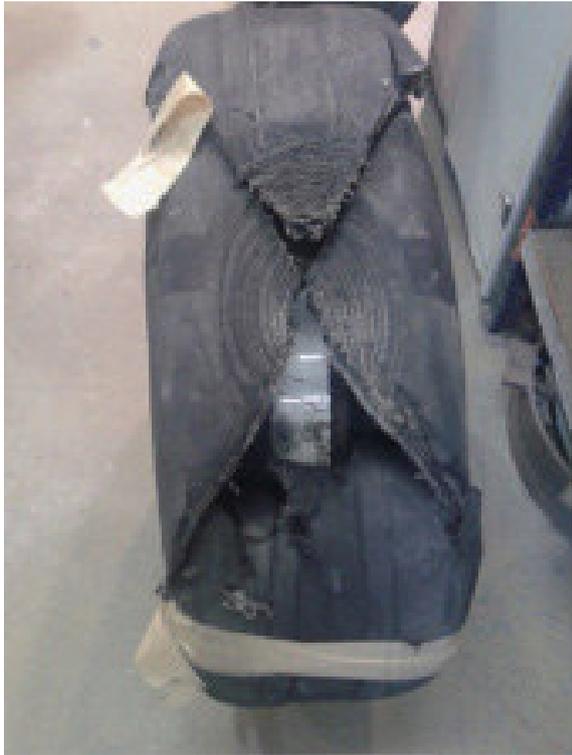
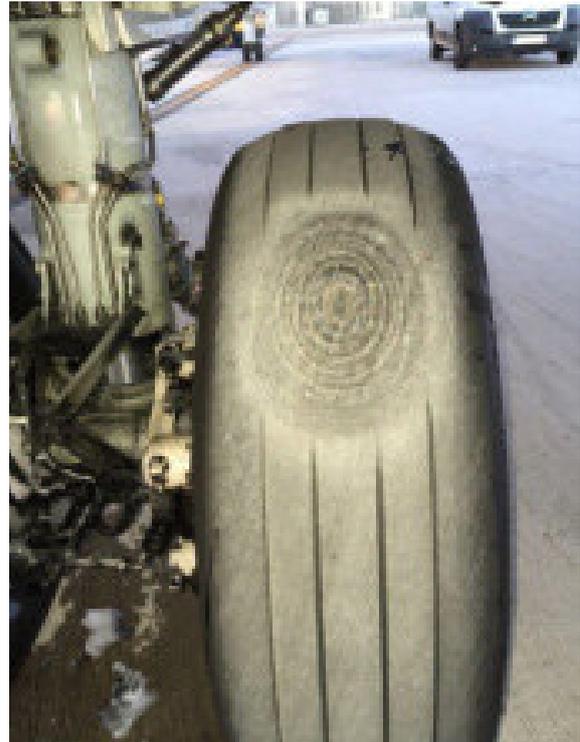
The number 1 tire showed signs of a flat spot, as did the number 4 tire, though it did not burst. The blowout of the number 1 tire damaged the inboard left flap, slightly bending part of the trailing edge upward. The gear door broke off its fittings, and one flap fairing was also damaged.

Photograph 2. Conditions of tires 1 and 4

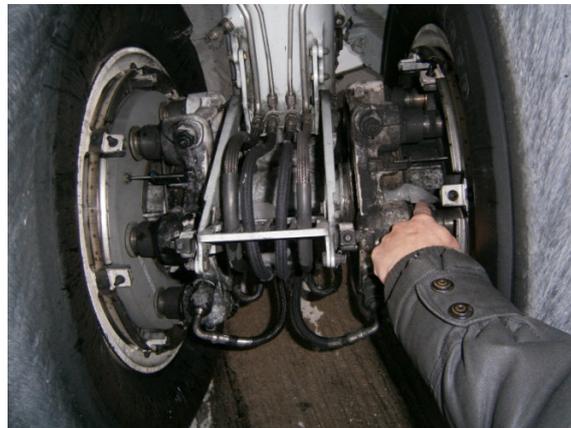
Photograph 3. Blocks of ice still adhering to the brake assemblies

The aircraft was equipped with carbon, instead of steel, brakes. The main drawback of carbon brakes over steel brakes is that due to their porosity, they can absorb large amounts of moisture. If this happens, the moisture can soak the brakes, which can then freeze if the temperature conditions are right. This situation can lock the brakes, which could potentially result in a tire blowout during the landing.

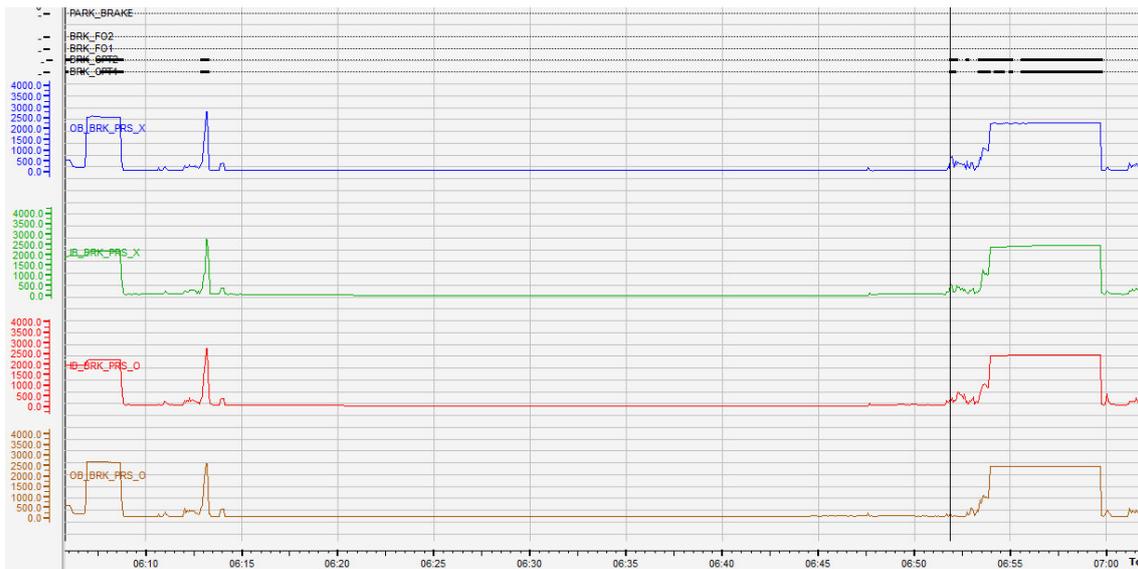
The aircraft approached runway 32L at LEMD. There were no events of an unstabilized approach. The maneuver relied on the glide slope and localizer and was carried out at an approach reference speed of 130 kt. The aircraft approached into the wind, which was from approximately 325° at 33 kts at the start of the approach, and from 315° at 13 kt at the moment of landing. The main gear touched down at 06:51:30, and the nosewheel sensor was activated three seconds later. For seven seconds following the activation of the WOW sensor, there was no pressure in the brake assemblies, i.e. the crew did not apply the brake pedals. Despite this, the number 1 and 4 wheels did not turn. Brake pressure was subsequently applied to all four wheels (06:51:38), but the brake pressure shown for wheel 1 was higher than for the other three (see braking graph below). The pressure in the number 1 brake during the landing run was confirmed to have been 734 psi. The BTMS readings for brakes number 1 and 4 were 0-2.

Figure 3. Braking graph

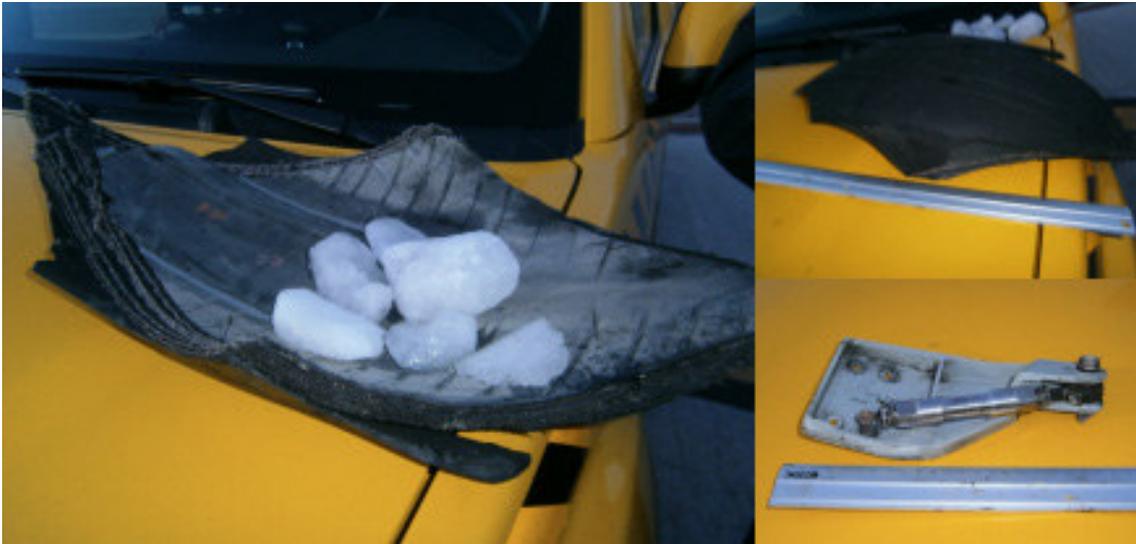
A metal piece from the main gear, a chunk of tire and three fist-sized ice fragments were found (see Photograph 6).

Photograph 6. Debris found on the runway after the landing

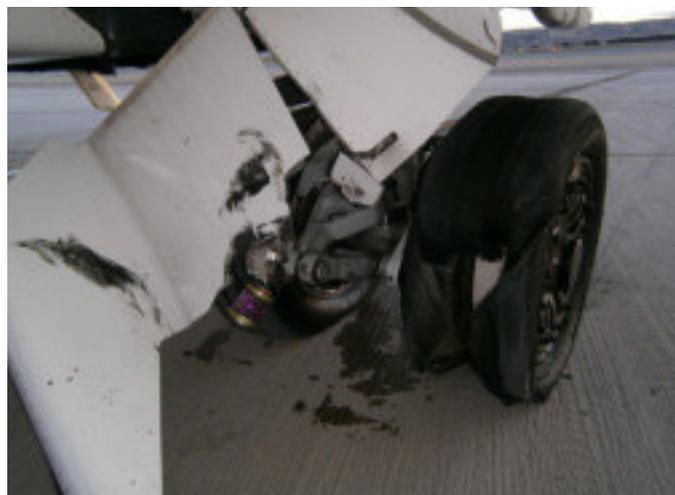
The CGA informed the RFFS of the incident, which reported to stand 5 with two vehicles. The RFFS confirmed that the number 1 wheel on the main gear had burst and part of a metal plate was loose (see Photograph 7).

Photograph 7. Landing gear after the aircraft reached the parking stand

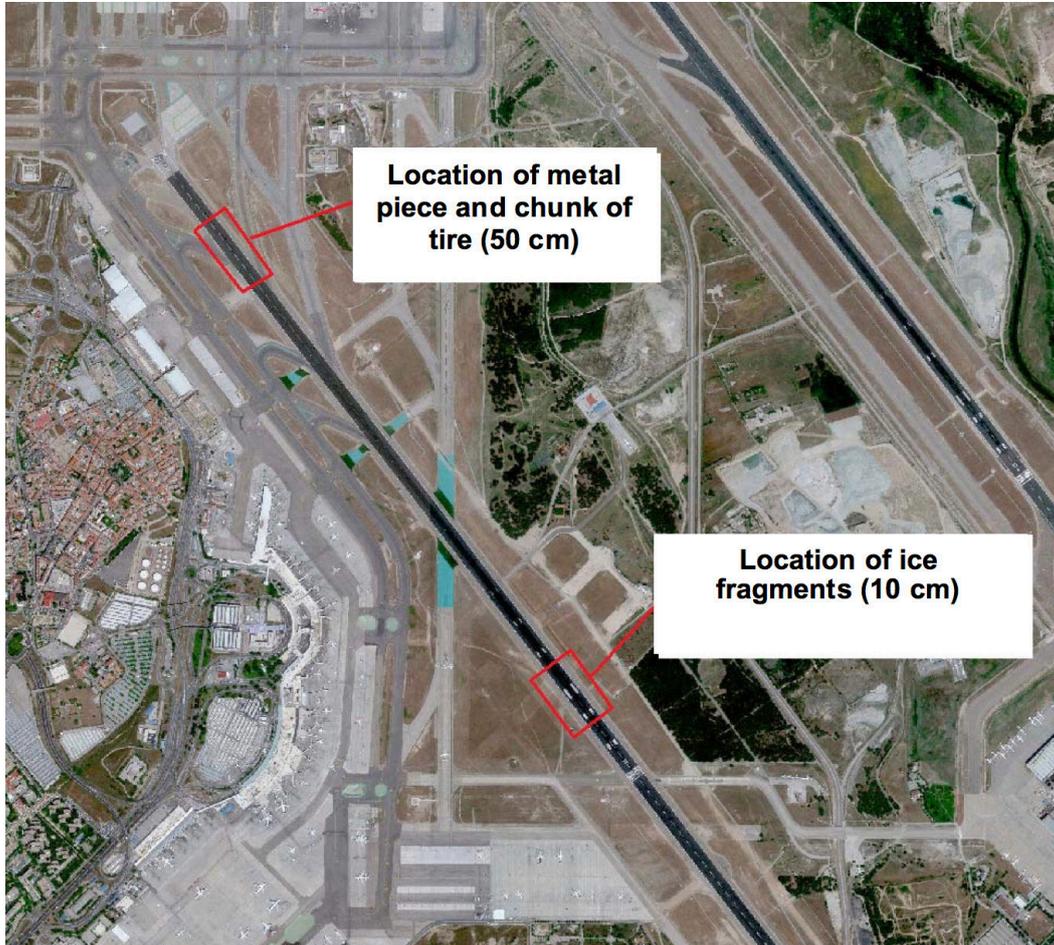
The figure below shows where the debris was found on the runway.

Figure 4. Locations of debris at LEMD
