Report A-008/2015

Accident involving an Airbus
helicopters AS 355 NP aircraft,
registration EC-KYJ, operated
by TAP Helicopters at the helipad
on the Catalonia Race Track
(Montmeló, Barcelona),
on 26 March 2015

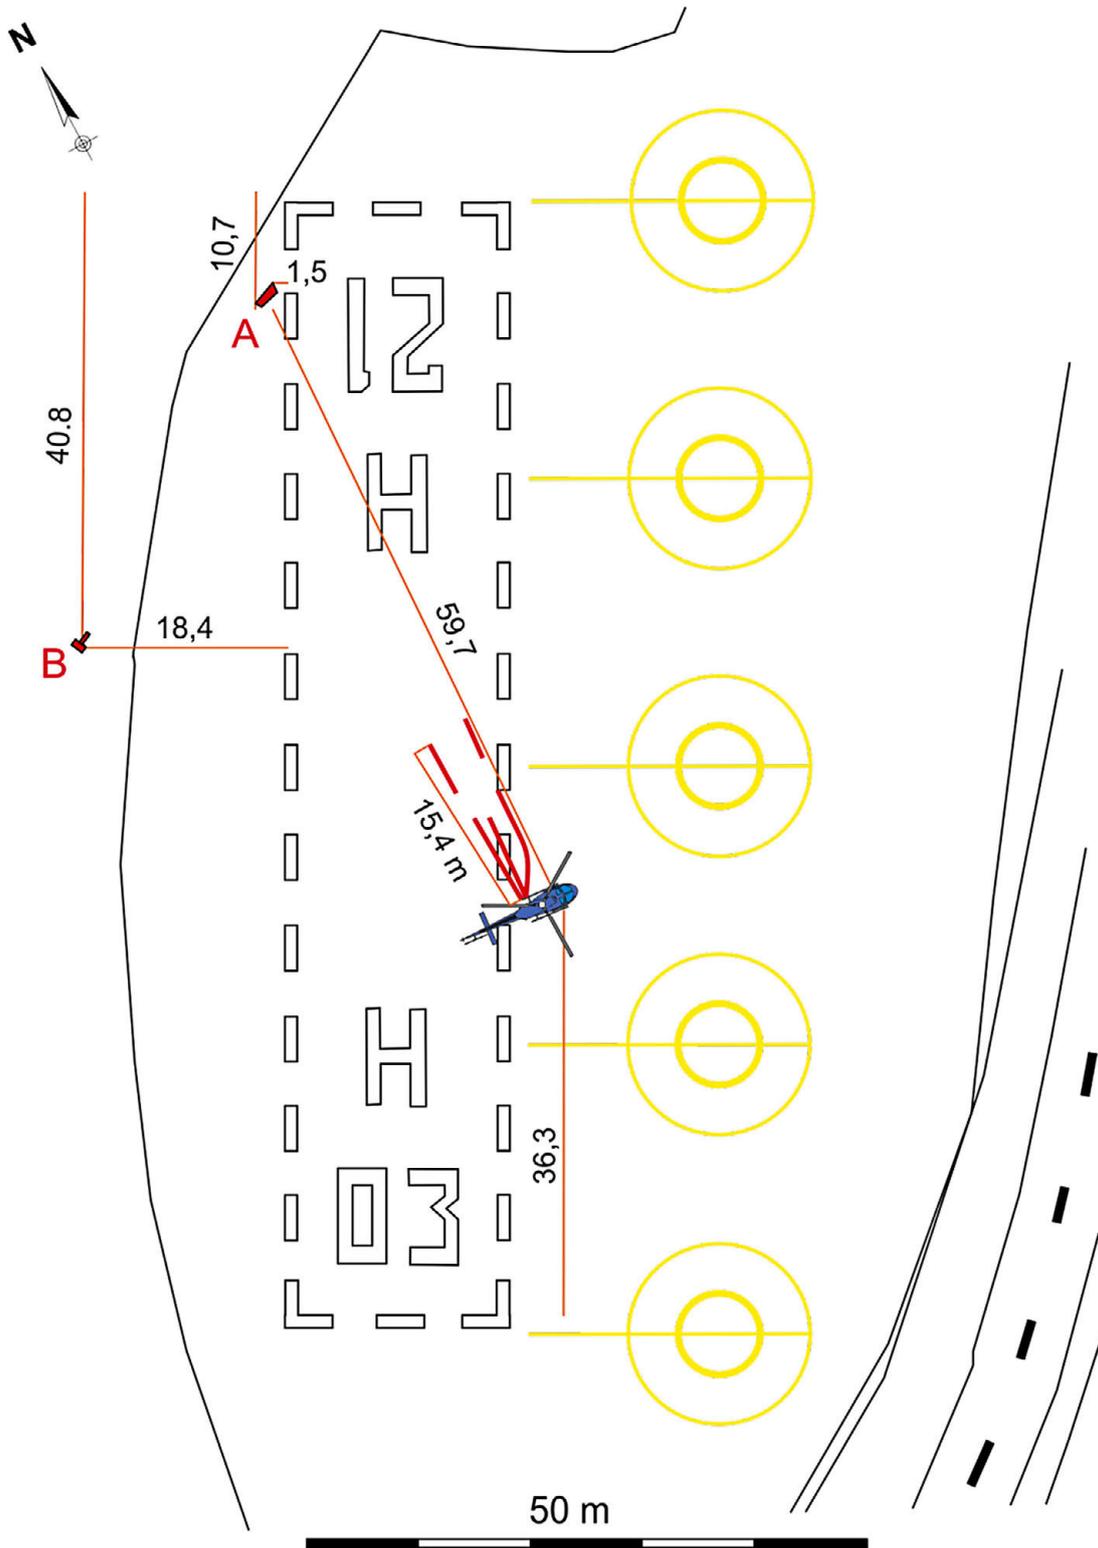
Figure 5. Sketch of the debris field

The only large pieces that detached were part of the power turbine shaft and disk for the right engine and its exhaust pipe. Also found scattered over the FATO were turbine blades and debris from the engine bearings. The skids, fairing, cockpit and the fuselage in general, as well as its mechanical components, appeared to be in fairly good condition.

The right engine was destroyed. Also damaged were the right engine covers and its firewall. The tail rotor drive shaft was sheared by the engine fragments that detached.

⁸ The nozzle was found at point A and the turbine drive shaft at point B.

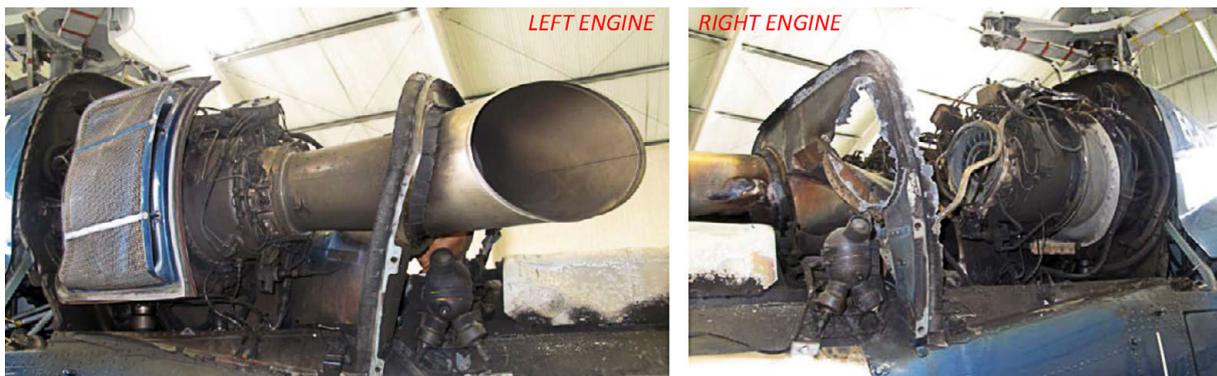
Figure 6. Condition of the engines after the accident

A preliminary visual inspection revealed that both the left engine and its housing contained a large amount of soot from the fire. The right engine and its housing had been severely damaged by the fire, and the rear section of the engine was missing. The housing side of the firewall was also heavily damaged.

Upon disassembling the right engine for a more thorough check, its components were found to be firmly attached, the oil filter was contaminated by a large amount of particles in aluminium and there were particles in the chip detector. There was a large amount of metallic debris in the rear baggage compartment.

Several holes were found in the engine compartments, especially the one for the right engine. Both engine covers also exhibited heavy damage, as did the exhaust area, especially the one for the right engine.

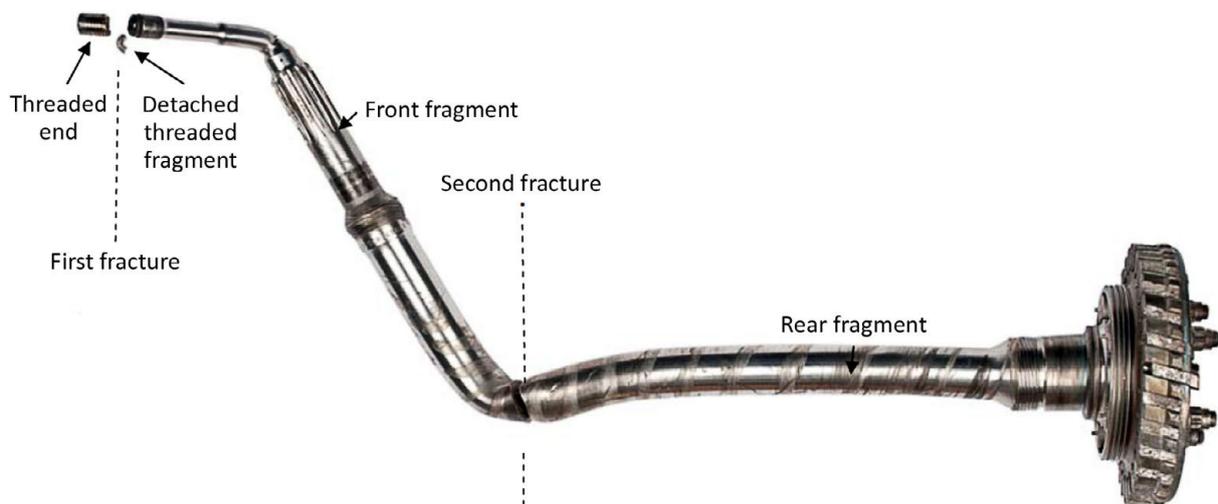
Figure 7. Identification of PT shaft fractures

The speed sensors on the power turbine were removed to access the shaft. The sensors were found to be damaged and the power turbine drive shaft was broken from the end of the threaded part, and the nut was completely destroyed.

The power turbine drive shaft and its fractures were analyzed in the laboratory. It was determined that the fracture had resulted from fatigue on the thread of the clamping screw at the front of the shaft.

The crack grew gradually over time and when it failed completely, it resulted in the release of the tightening tension on the force transmission cone which led to an axial overload of the Power Turbine (PT) trust bearing. This overload caused the destruction of the bearing and as a consequence, the loss of axial retention on the PT shaft. On power demand, the PT shaft moved backwards. When it was partly ejected, the contact between the rotating PT and the parts behind it led to the deformation and static rupture of the shaft seated on the rear bearing housing. The rear section of the PT shaft became separated from the engine. These two fractures affected the following four fragments:

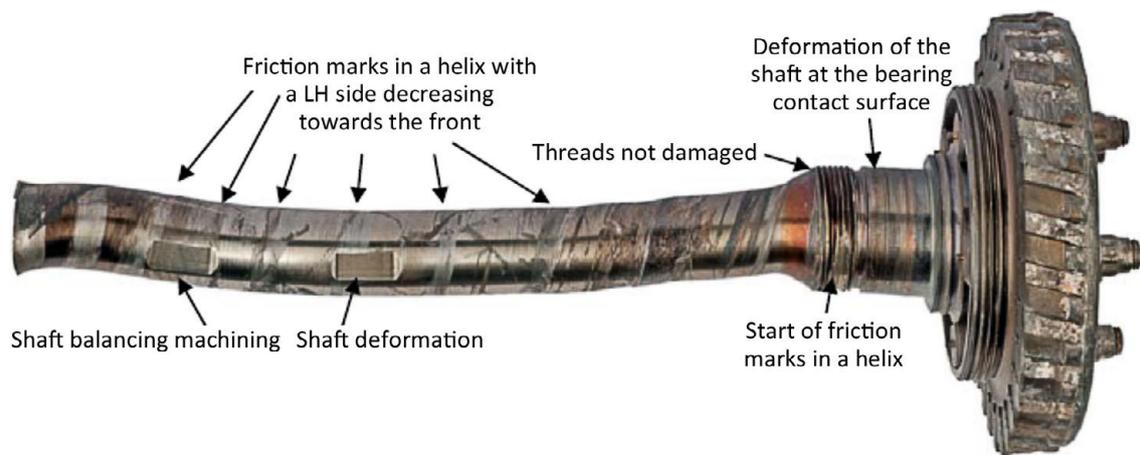
Figure 8. Damage on the PT shaft bear fragment

The rear fragment was bent mainly from the surface of the support bearing to the fracture point, and there were several helical friction marks with approximately ten instances of pitch on the LH side, varying from rear to front between 35 and 15 mm, extending from the thrust bearing tightening threading to the rupture point.

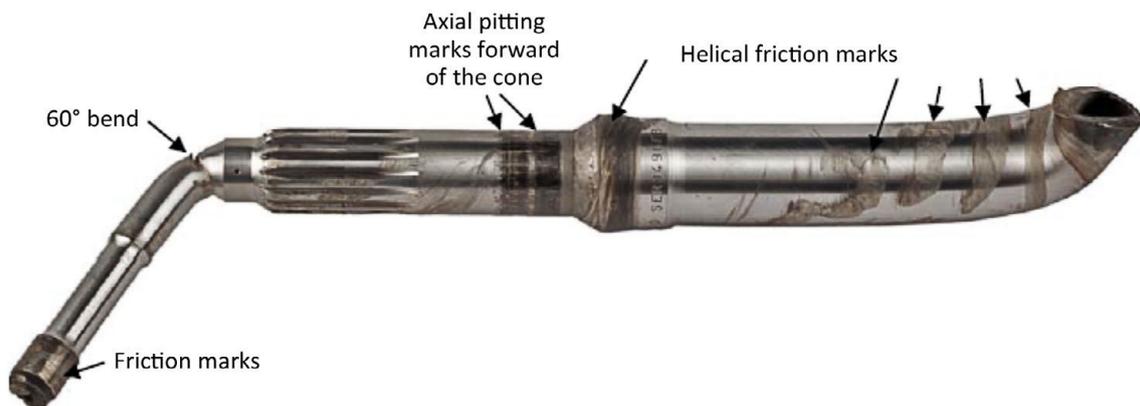
Figure 9. Damage on the front fragment of the PT shaft

The front section had a 60° bend associated with the fracture in the area where the shaft diameter changed, and a ductile fracture from excessive loading. There were also friction marks centered on the front surface of the drive gear.

It also exhibited axial pit marks between 3 mm and 17 mm in front of the drive gear cone.

There were helical friction marks with pitch of approximately 13 mm on the left side, at the point where the rear fracture occurred. These marks increased in intensity toward the surface near the drive gear cone.

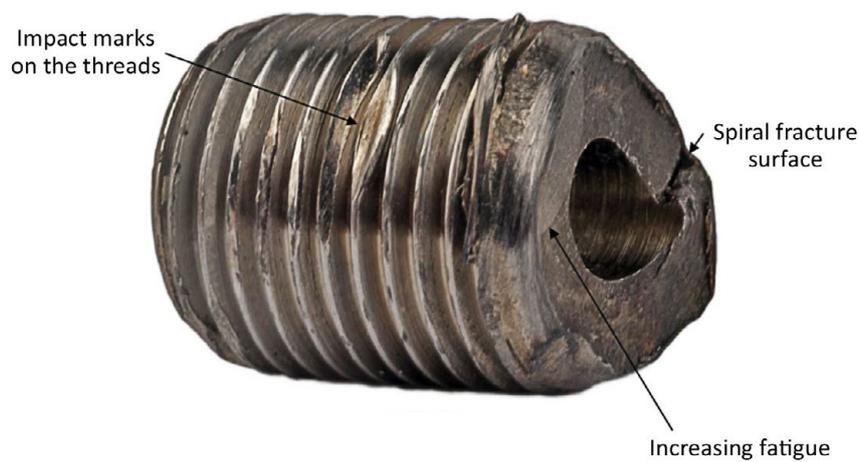
Figure 10. Damage on the threaded end of the PT shaft

At the threaded end of the forward segment there was a propeller-shaped break with pitch of approximately 1 mm on the right side, friction marks around the edges of the broken surface and signs of fatigue on the fracture surface. However, the area where the crack had started was not visible because of the friction marks around the fracture surface. There were also impact marks on the threads.

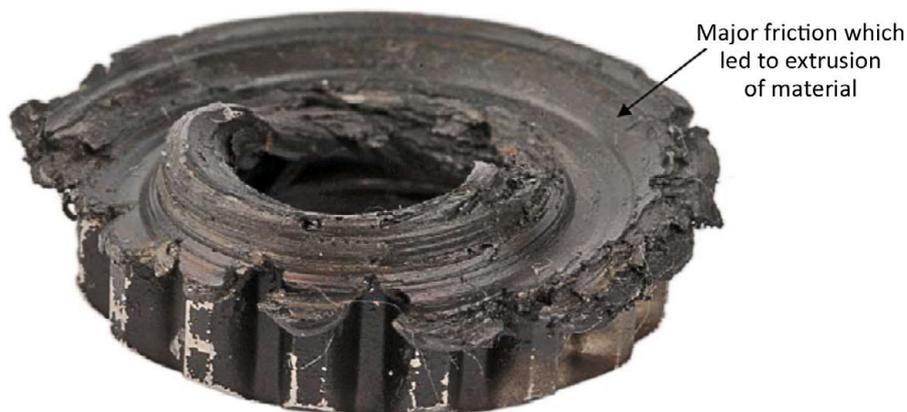
Figure 11. Drive gear tightening nut

The locknut on the gear exhibited uneven wear and extrusion on the surface in contact with the gear. The threads outside the area affected by the deformation on the locknut surface were not damaged, nor were the tips of the grooves on the side of the locknut.
