Report IN-013/2015

Incident on 28 April 2015
involving an AIRBUS 321-212,
registration F-GTAZ, operated
by Air France, and a Boeing
737-400, registration OE-IAP,
operated by TNT Airways,
at the Barcelona-El Prat
Airport (Spain)

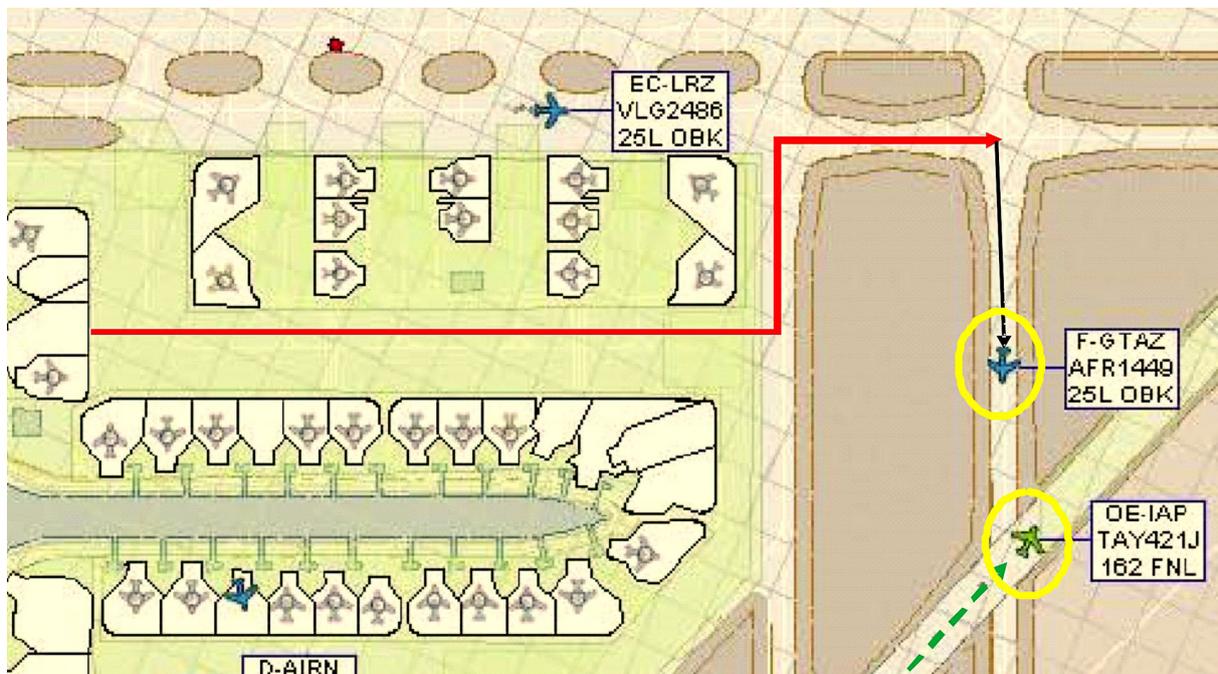
Figure 1. Moment the crossing occurred

At 06:58 it reached point D2, which is the intersection of taxiway D with runway 02, and it stopped upon seeing the stop bar lights energized. The crew contacted ATC (GND C) to confirm they were cleared to cross the runway. ATC instructed them to hold their position.

The aircraft with callsign TAY421 continued its approach and landed normally, passing in front of the other aircraft. It left runway 02 via exit taxiway V1 (the first on the left
