Report A-010/2016

Accident involving a CESSNA 172R aircraft,
registration EC-JSM,
operated by a private operator,
in Perales de Tajuña (Madrid)
on 30 March 2016

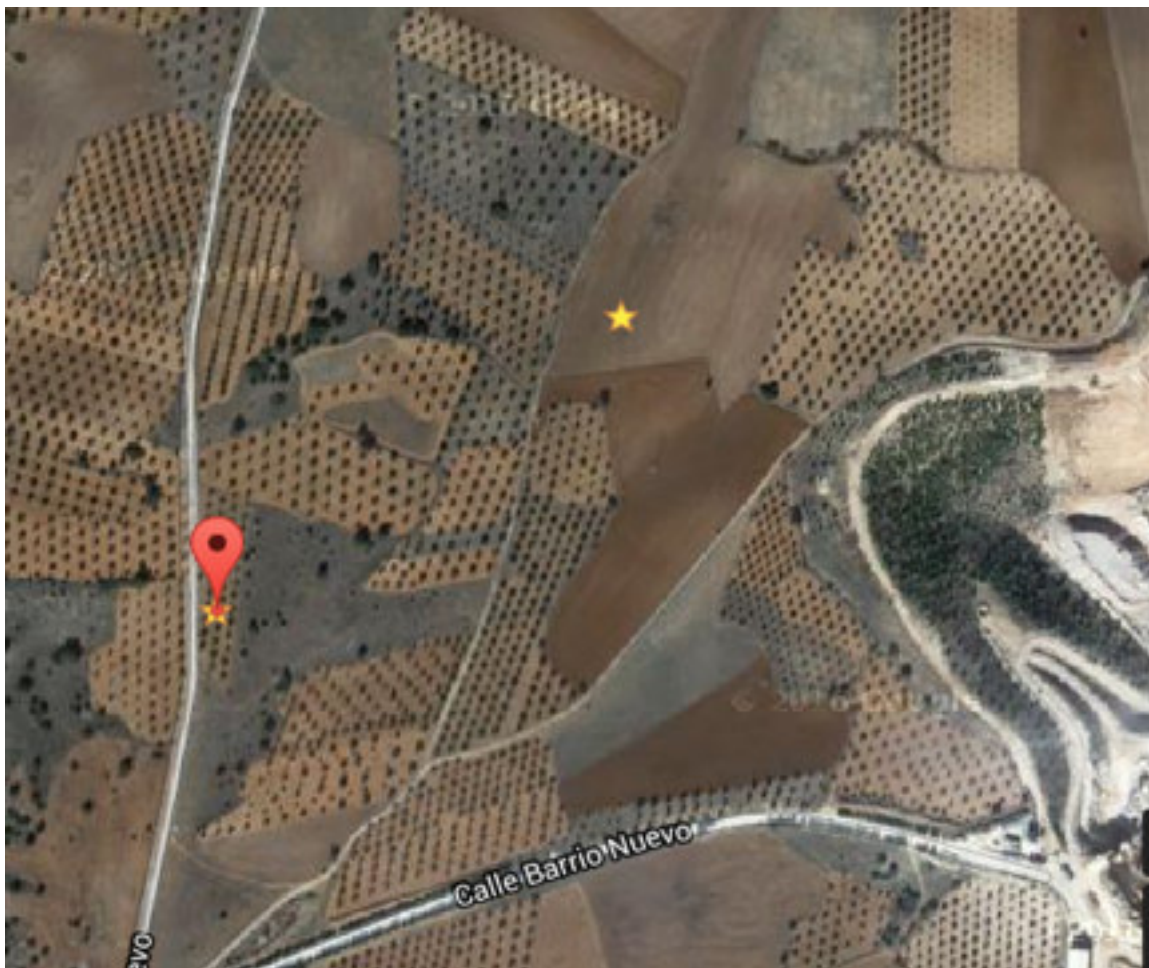
Figure 3. Location of the left wing (right star) and the main wreckage (left star)

The aircraft was completely destroyed. The aircraft wreckage was found in two areas. The debris from the left wing was found at coordinates 40° 15' 42.6" N, 3° 20' 36.7" W. The remains of the vulture were some 100 m north of this location. The rest of the aircraft was found at coordinates 40° 15' 35.3" N, 3° 20' 49.1" W, next to an olive tree that stopped the aircraft's motion. The figure below shows both of these areas:

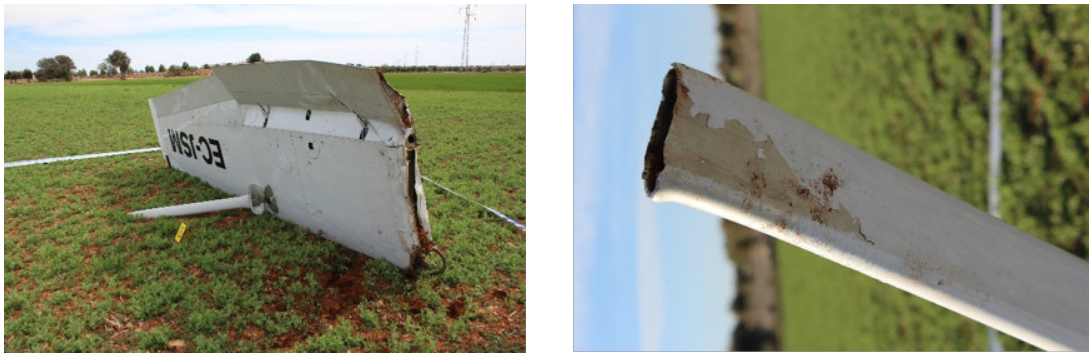
Figure 4. Left wing and strut

The photographs below show the condition of the left wing, with the photograph on the right showing the point where the griffon vulture severed the strut.

strut joins the midpoint of the front spar to the underside of the fuselage. Without the strut, the wing rotates about the points where it attaches to the fuselage and the loads placed on the wing cannot be absorbed by the fuselage. Therefore, if the strut breaks, it will cause a catastrophic failure that will result in the loss of the aircraft.

On impact, the left wing strut broke, as did the left wing and the lower left extremities of the vulture. It was thus a frontal impact between the two. At the time of the accident, the radar return showed that the aircraft's ground speed was 100 kt. This translates into a kinetic energy on impact of over 8,323 joules, not taking into account the air speed or the speed of the vulture.

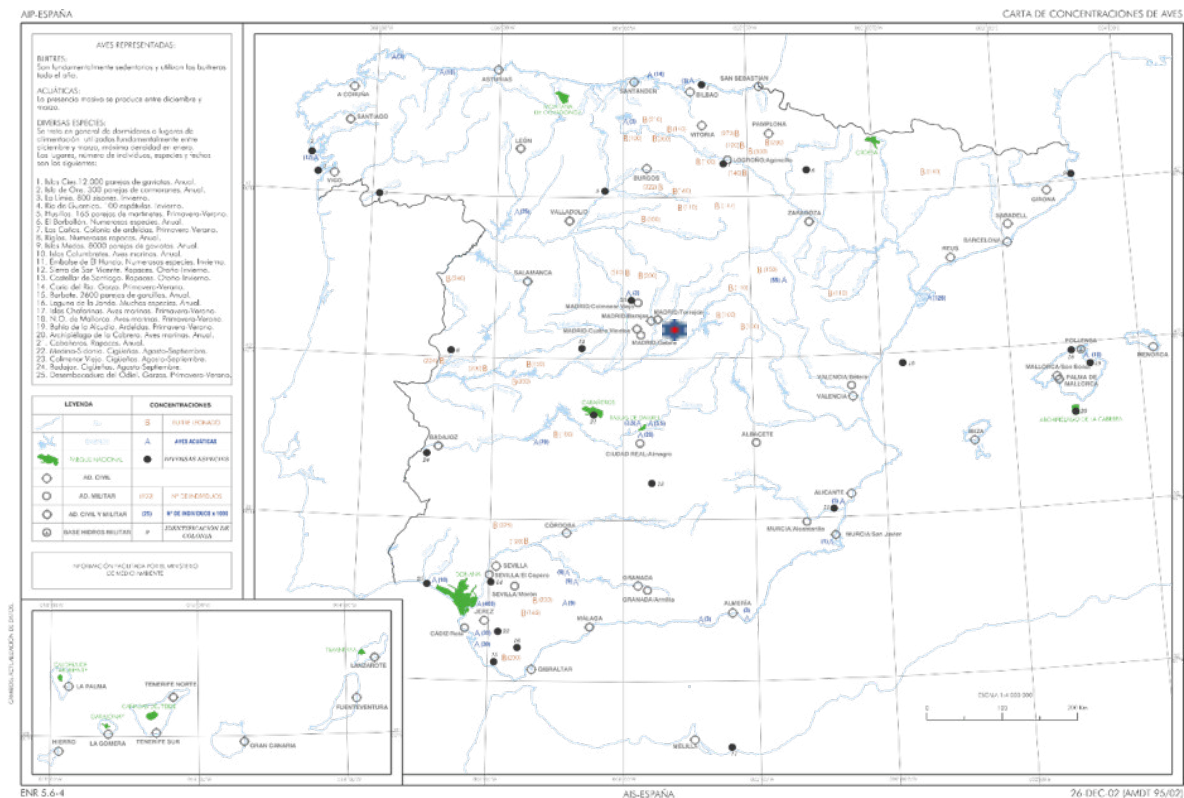
Figure 5. Bird activity chart

The red star on the AIP bird activity chart shows the location of the accident site, which is not identified as an area of bird activity.

REC 58/16: It is recommended that ENAIRE update the bird activity chart and the migration route charts for larger bird species published in the AIP dated 26 December 2002, to reflect the current distribution of colonies of vultures and other birds that are suitable for inclusion in said chart, and their migratory routes.

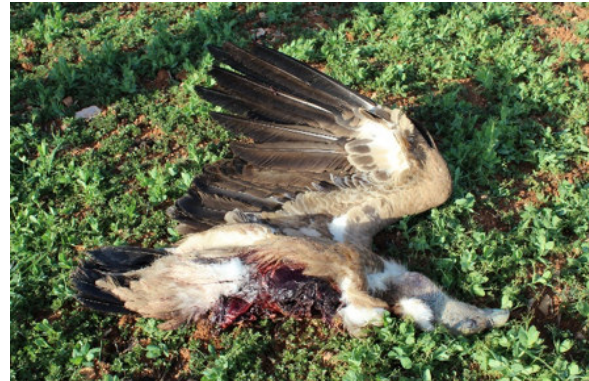
Figure 6. Griffon vulture that caused the accident

The vulture that impacted the accident aircraft was an adult weighing over 6.4 kg³.

³ It was not possible to find all of the vulture’s body; specifically, the lower left extremity and the left wing could not be found. The remains that were found weighed 6,400 gr.
