**COMISIÓN DE
INVESTIGACIÓN
DE ACCIDENTES
E INCIDENTES DE
AVIACIÓN CIVIL**

**Report
A-031/2016**

Accident involving a PZL W-3AS aircraft,
registration SP-SUC, operated by
Hispánica de Aviación at Pico del Cabrito
in the town of Villa de Mazo
(Santa Cruz de Tenerife, Spain)
on 10 august 2016

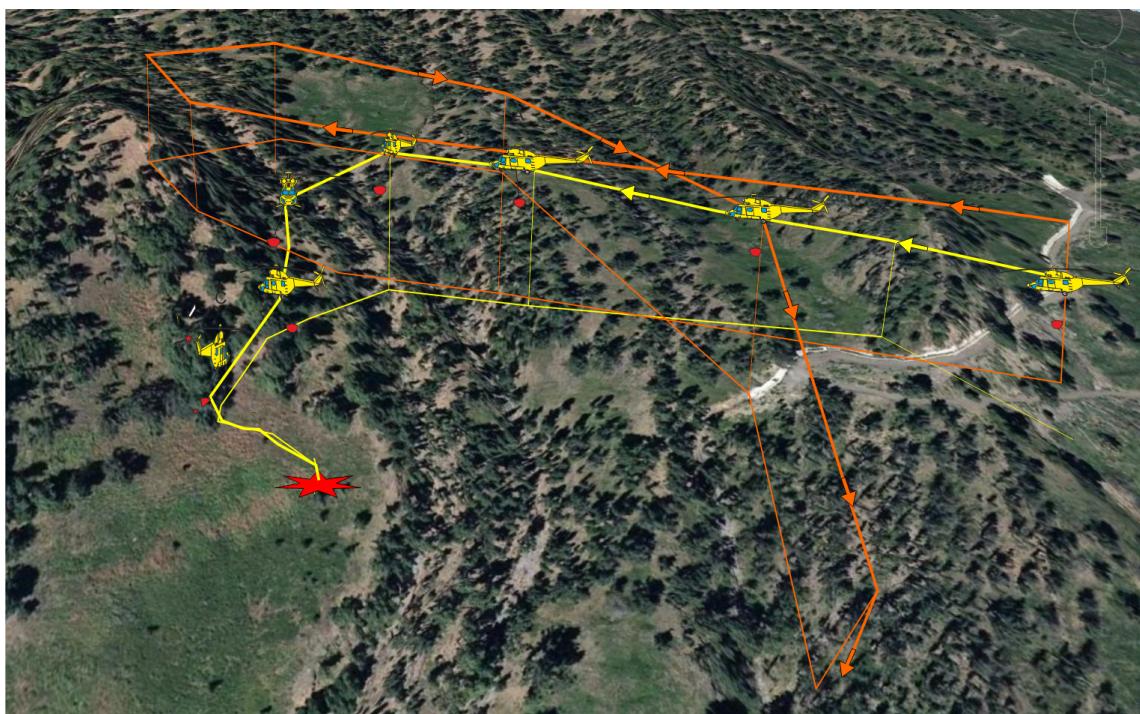
Figure 1. Helicopter flight paths

In the last segment, what started as a slight turn to the left developed into a high left-yaw rate situation.

The image below shows the helicopter's penultimate trajectory in red and its final trajectory in yellow:

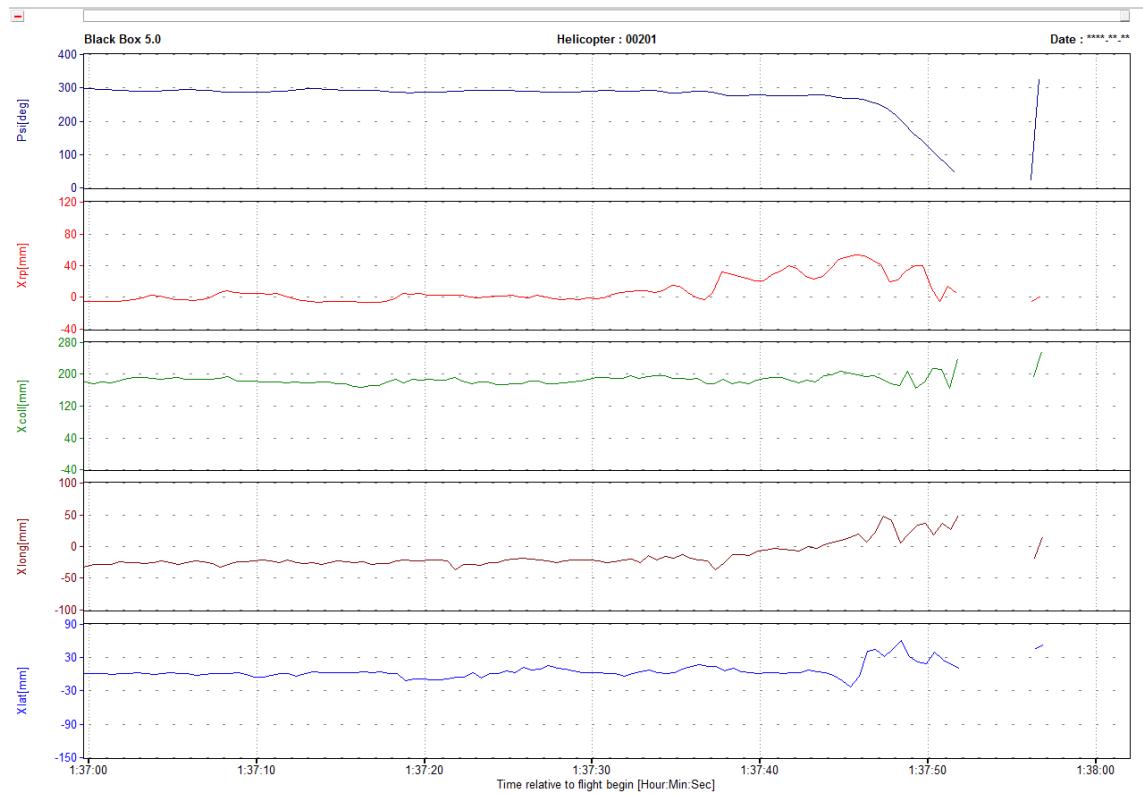
Figure 3. Inputs to the controls

The pilot flying unsuccessfully attempted to control the left turn by applying right pedal.

At 1:37:43 into the flight, the helicopter started to turn left. The turn continued until the impact, which must have occurred 9 seconds later, 1:37:52 into the flight.

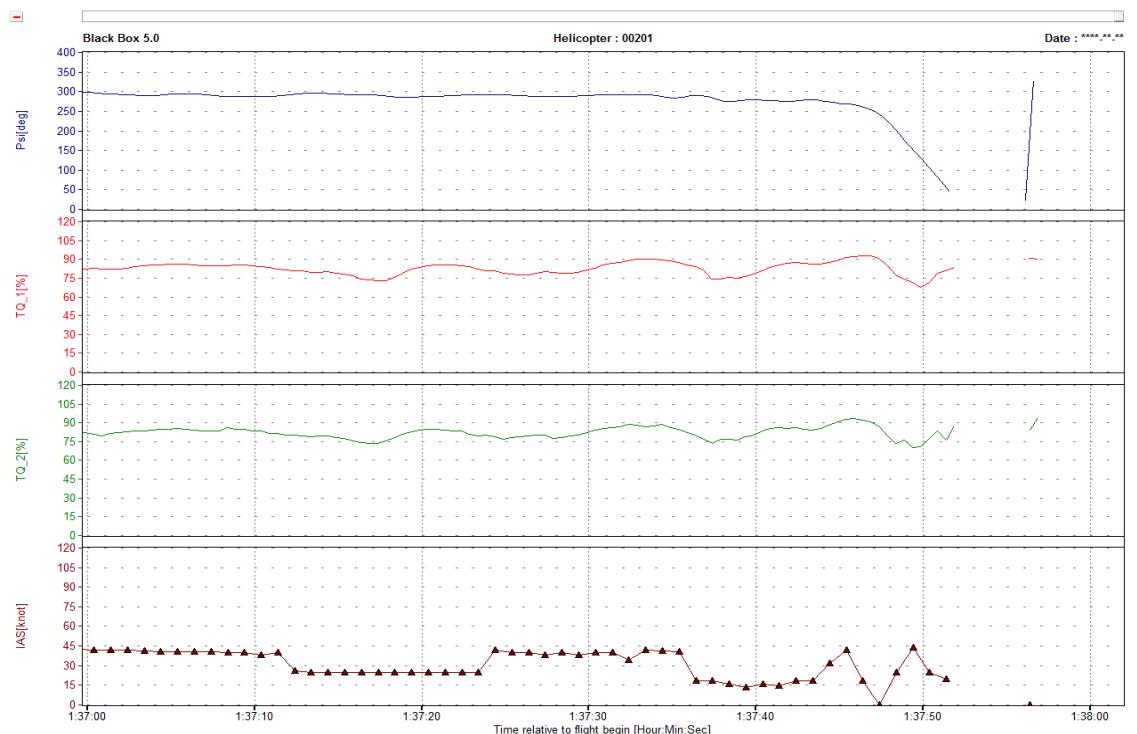
Figure 4. Graphs of the power and speed

The graph shows that after raising the collective pitch, the power in both engines went up. Then, 1:37:46 into the flight, the power in both engines started to oscillate.

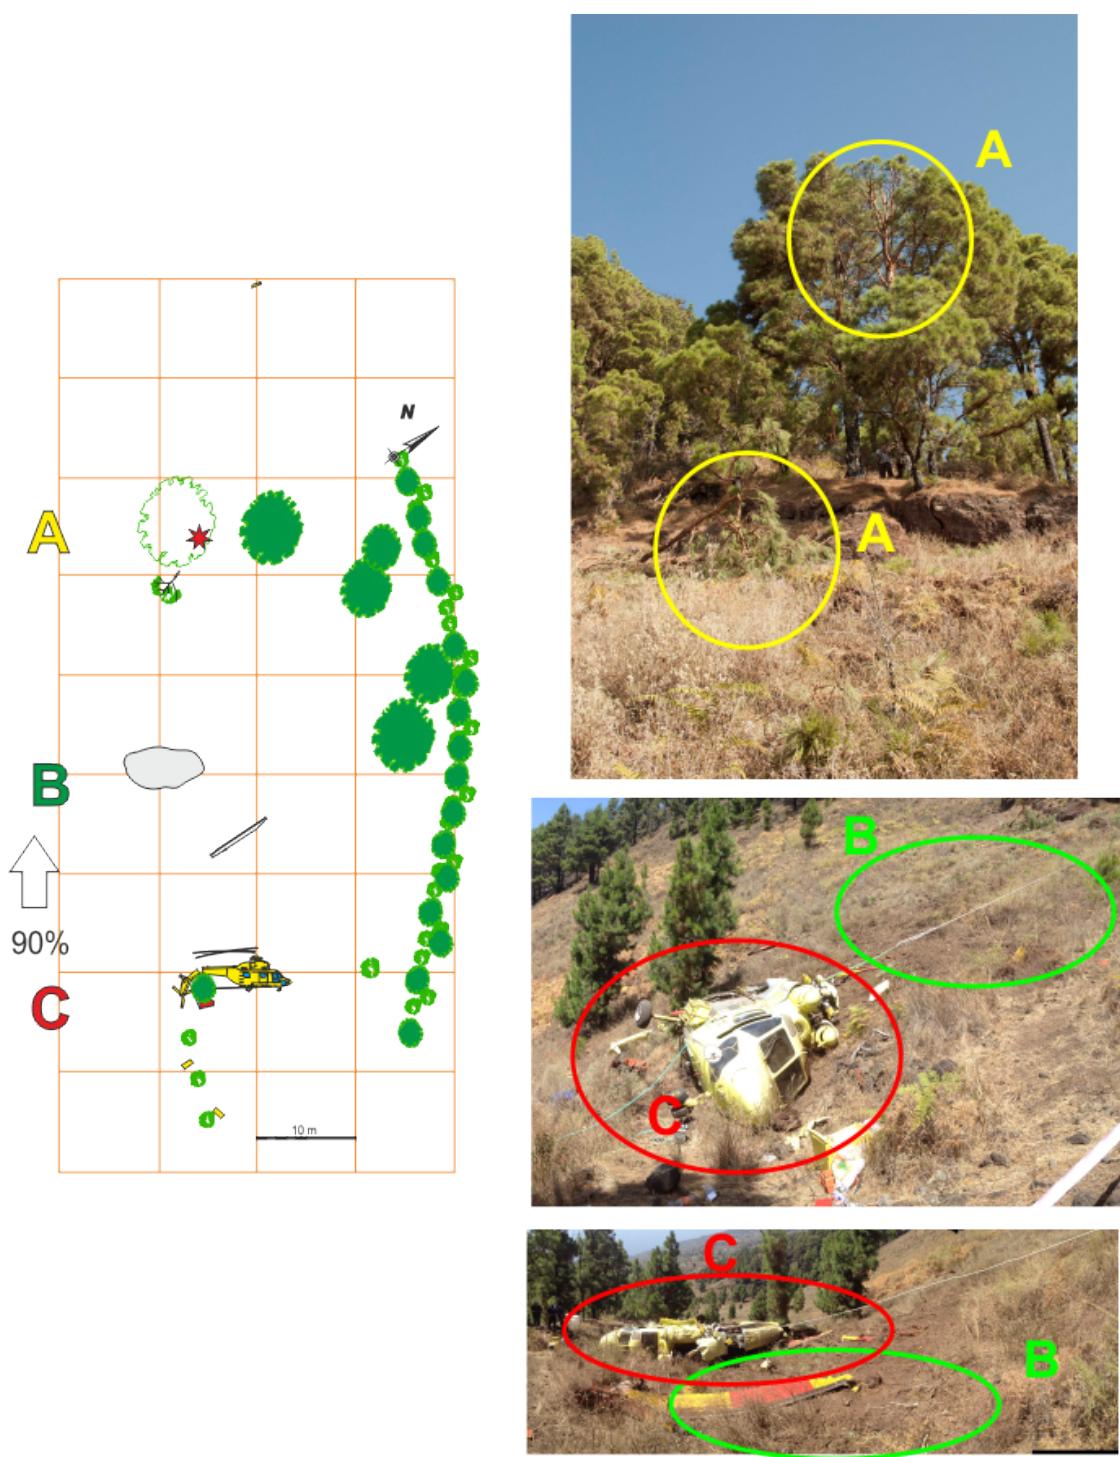
Figure 5. Diagram of the aircraft wreckage

Then, as the helicopter continued its turning descent, the tail boom struck another 20-cm thick pine tree, uprooting it. This tree was found underneath the helicopter. The bucket, which was still hooked to the external load hook, remained attached by the suspension cable to this other tree, in which the last third of the tail boom was also caught. It was the helicopter striking and being caught by the tree that must have stopped it from continuing to slide downhill.

Labeled B in the diagram is an area between the two trees hit by the helicopter that was dug up, probably by the landing gear wheel that had broken off where it attached to the fuselage. Since the ground was not hard, the hole's depth was about 40 cm. This impact with the ground probably absorbed some energy, thus helping bring the helicopter to a stop.

The tail rotor blades, broken at various points, were found in a wide area around the first pine tree. This top area in the diagram is labeled A.

At the bottom area, labeled C, the helicopter was found resting on its left side. There was impact damage to the main rotor head and part of the three blades were detached at the root. Most of the fourth blade was found halfway between the two pine trees. The tail cone, which was severed near where it connects to the fuselage, was only attached by the control cables that move the tail rotor. The tail rotor head was attached to its shaft, though two of the three blades were severed at the root. The screws on the tail rotor head contained bits of wood, indicating that it struck the tree while it was rotating.

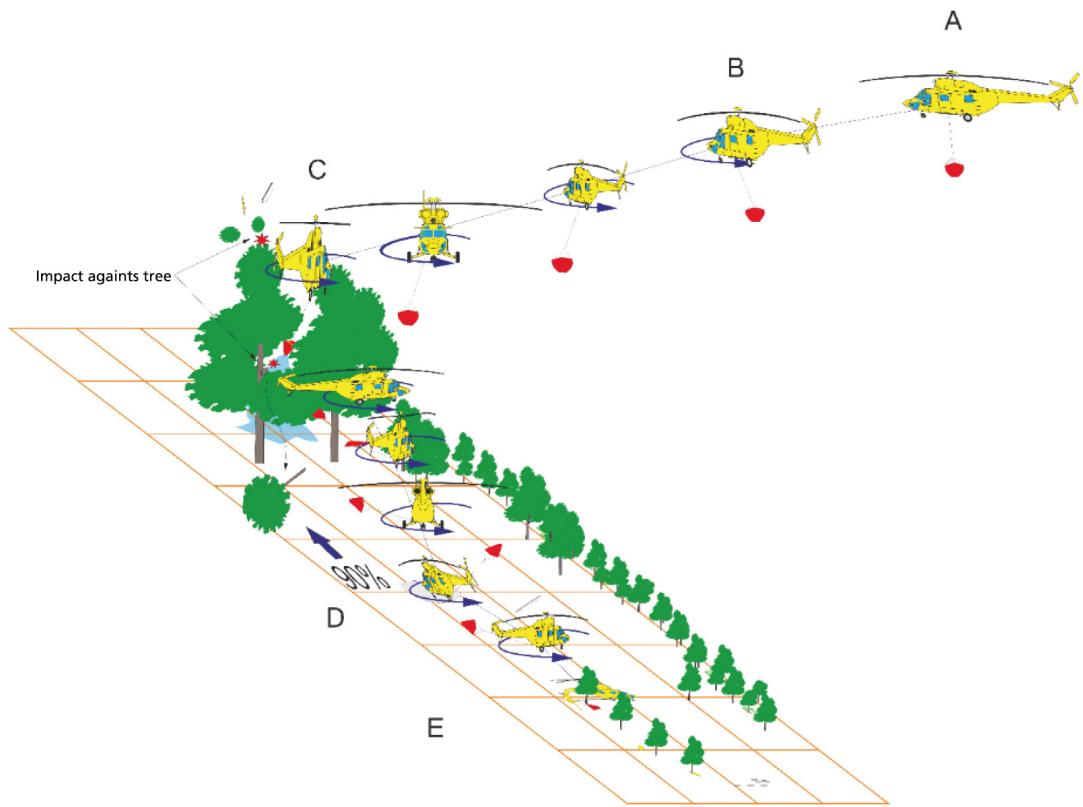
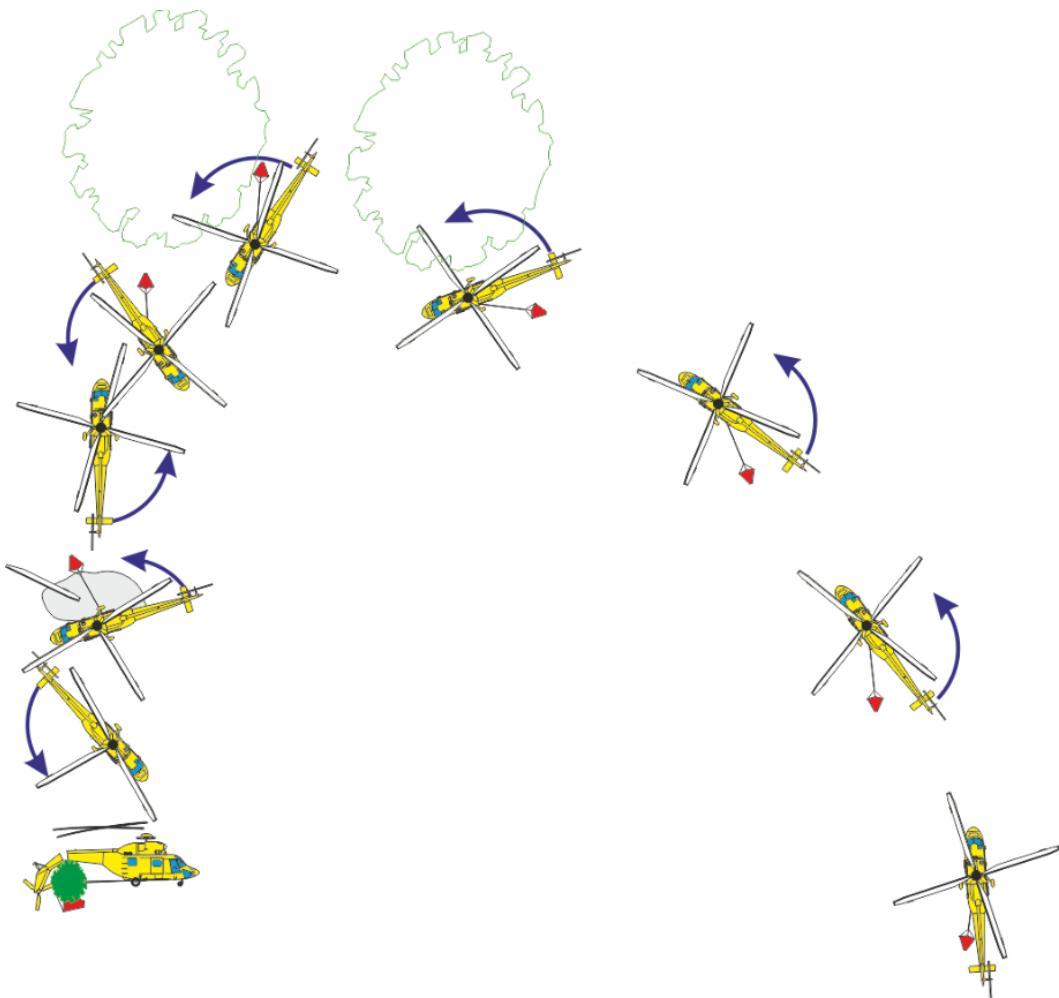
Figure 6. Simulation of the final seconds of the flight

The graphs below simulate the final seconds of the flight.
