Report IN-041/2016

Incident involving an Airbus A-321-211
registration D-ASTP, operated by
Germania, at the Fuerteventura Airport,
Canary Islands, Spain on 16 July 2016

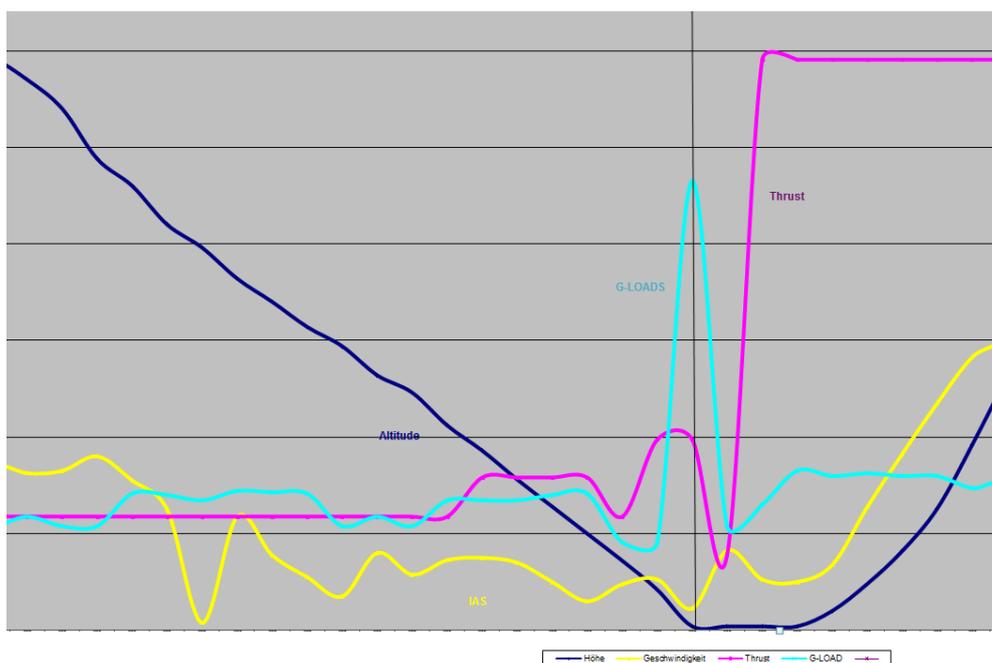
Figure 1. Curves for the altitude, IAS, thrust and G-load parameters during hard landing

Indicated airspeed – 142 kt

Vertical speed – 1000 ft/min

Airplane pitch angle – 3.9° up (or positive)

Maximum vertical acceleration – 3.32 g, with two values in excess of 2.2 g in the

previous 1/8 second readings.
Engine RPM (N1) – 60 and 66%.

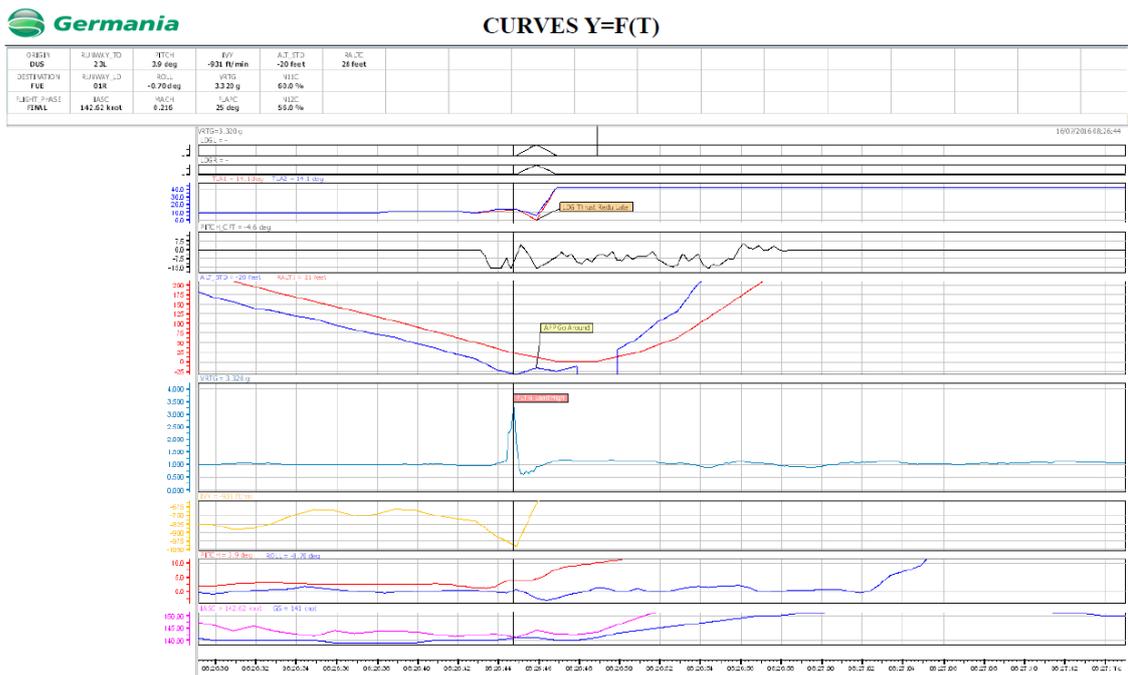
Figure 2. Graphs for the main DFDR parameters during the approach and landing

During the initial contact, there was a load of 2.242 g, the landing gear was compressed further and the N1 thrust setting was 60%.

0.25 seconds after the contact (TD), the maximum load reading was recorded (3.32 g).

0.50 seconds after TD the airplane started to bounce. Thrust was at idle.

0.75 seconds after TD, the aircraft indicated a load of 0.602 g.
