## Report IN-001/2017

Incident involving an Airbus  
A-320, registration EC-HTD, en  
route from the Malaga-Costa del  
Sol Airport to the Barcelona -  
El Prat Airport (Spain) on  
21 February 2017

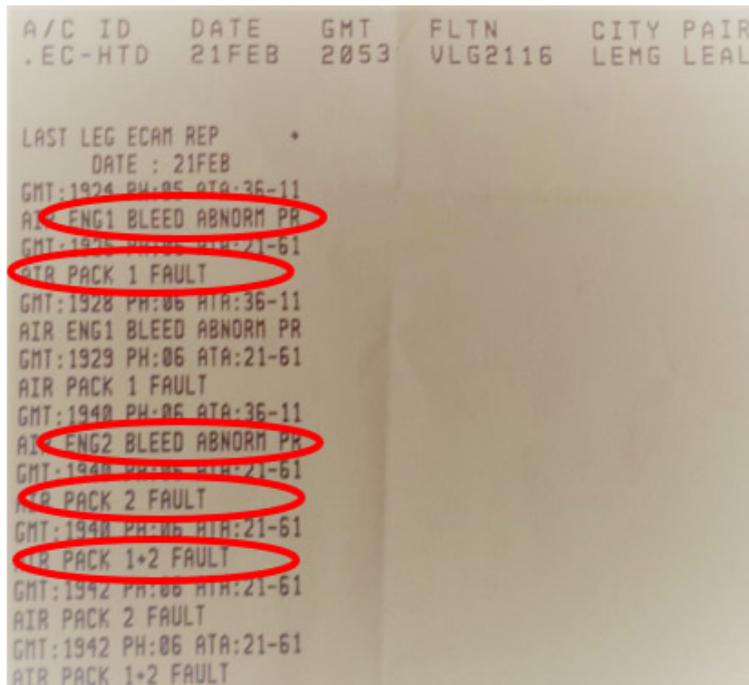
Figure 1. Post-flight report showing warnings on the ECAM display

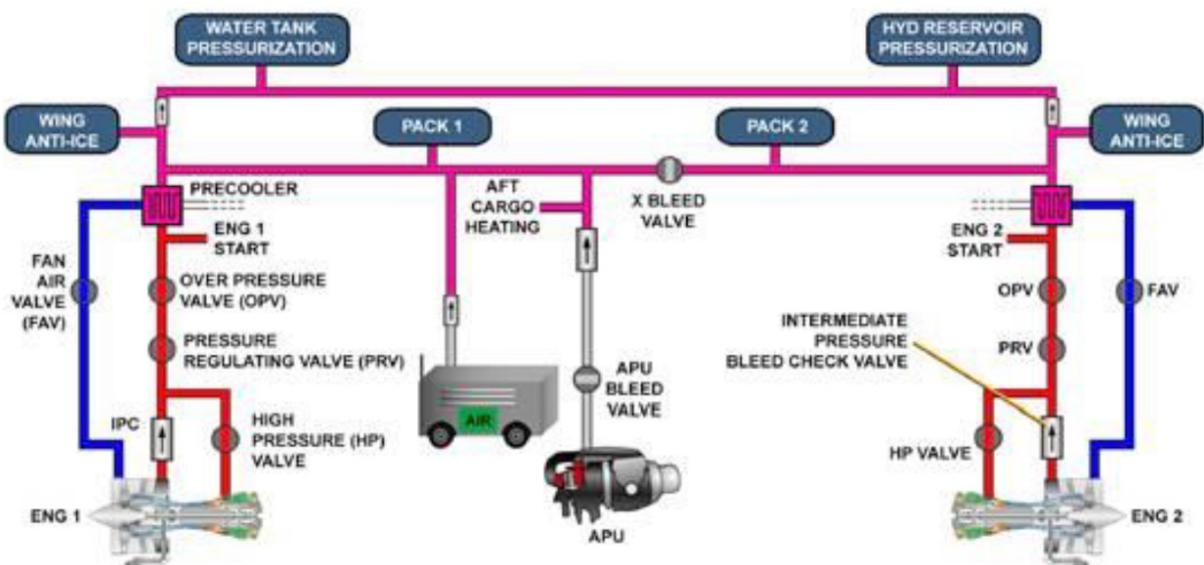
Figure 3. Simplified pneumatic system diagram

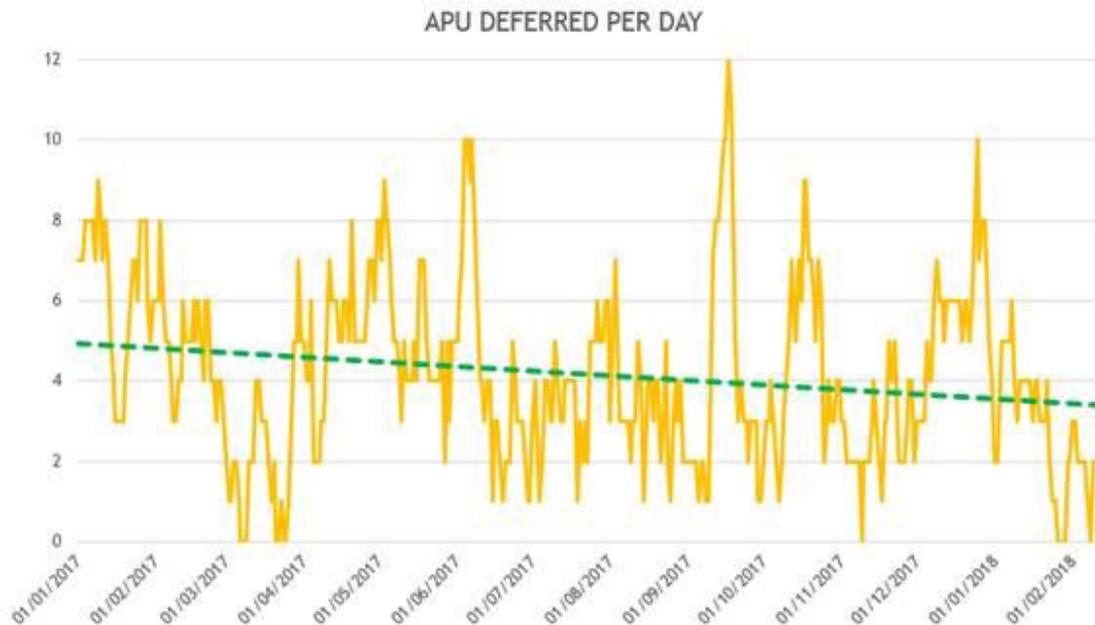
Figure 5. Trend in deferred APU items (source Vueling)
