Report A-006/2017

Accident involving a Diamond DA-40 aircraft, registration EC-LRF, operated by One Air Aviación, at the La Axarquía aerodrome (LEAX), in Vélez-Málaga (Málaga, Spain) on 8 May 2017

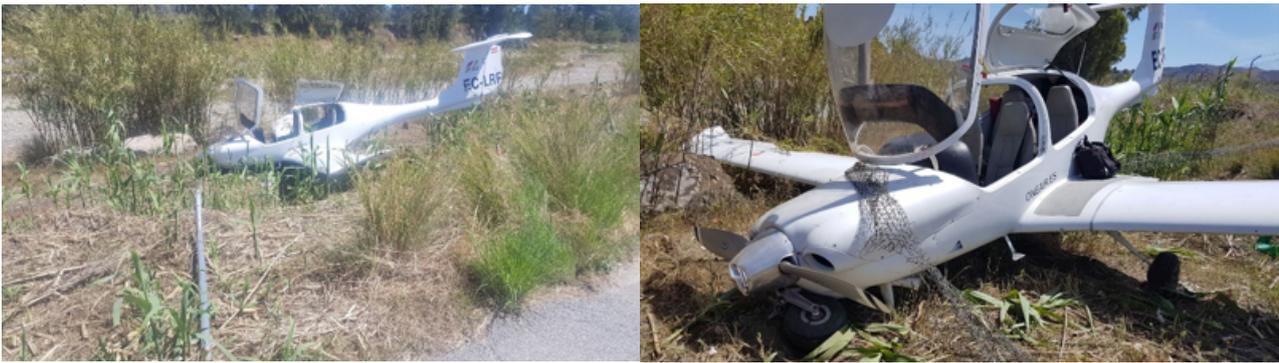
As a result of the impact with the aerodrome perimeter fence, the aircraft sustained damage to its propeller, engine covers and the leading edge of the wing. The front landing gear broke off and the right main landing gear leg was bent backward.

Figure 1. Final position of the aircraft.

There was no wreckage dispersion. As a result of the impact with the fence, the forward landing gear broke off the aircraft and the right main landing gear leg was bent backward. There was also damage along 25 meters of the fence.

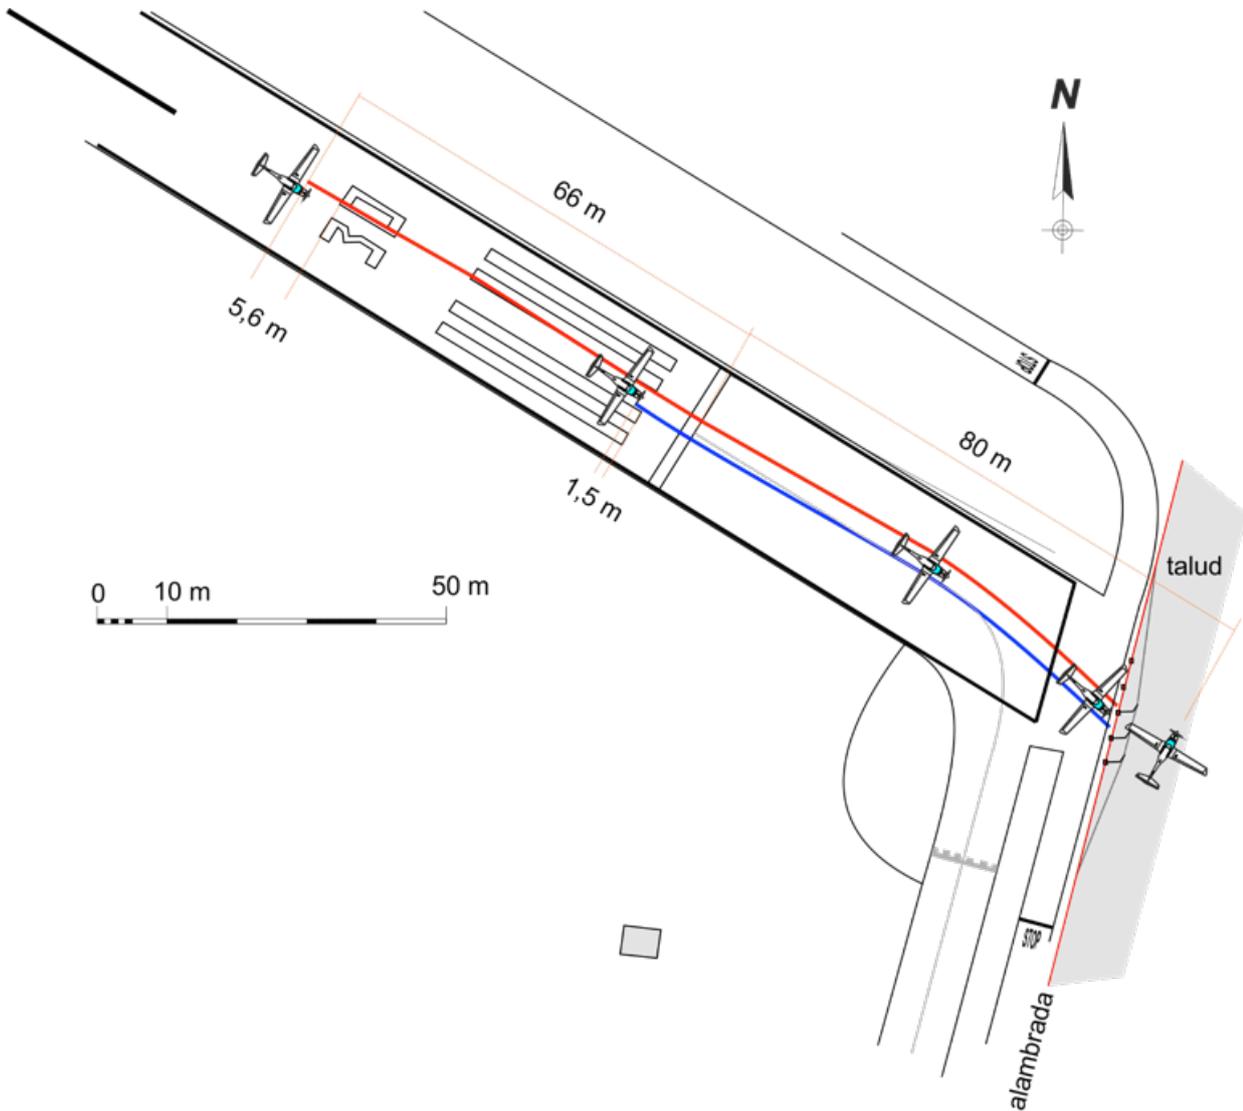
Brake marks parallel to the centerline were found on the runway from the main landing gear wheels. The first tracks in the direction of travel seemed to correspond to the left leg, and they started 66 meters before the end of the runway (runway 30 threshold). The tracks from the right leg appeared further on, 9 meters before the threshold. Beyond the end of the runway, the tracks veered to the right of the centerline and finished at the aerodrome's perimeter fence.

Figure 2. Diagram of tracks on the ground.
