Report ULM IN-006/2018

Incident involving a FLIGHT
DESIGN CT2KL aircraft,
registration EC-DX3, in the
municipality of Torre Pacheco
(Murcia, Spain) on 6 March 2018

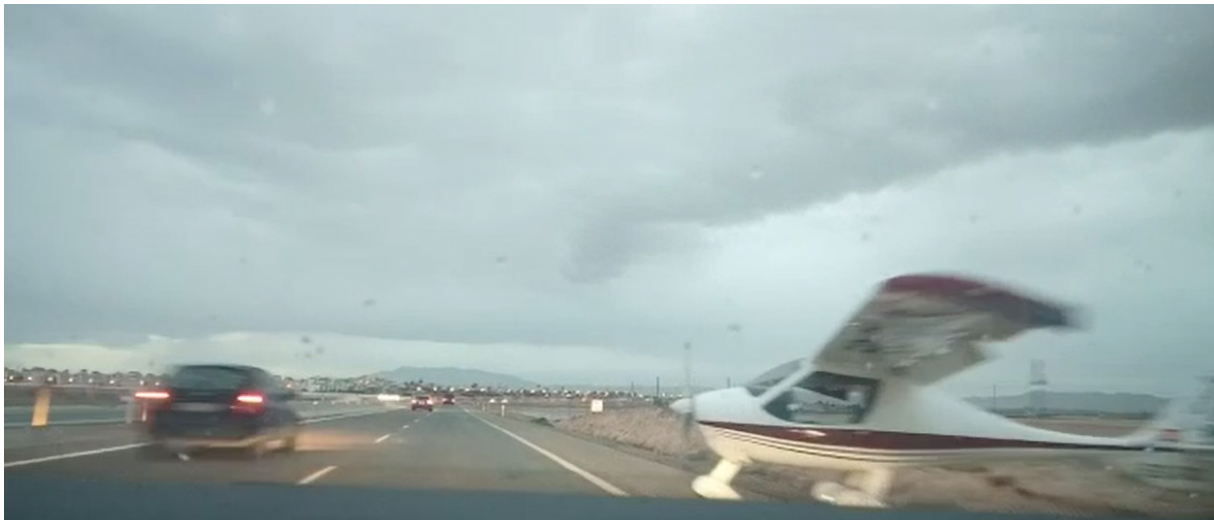
The pilot was not injured and the aircraft sustained no damage. After the airplane stopped, and with the help of someone who was nearby, he left it on the shoulder and it turned it 90° to the left pushing the horizontal stabilizer, so that it stayed with the wings parallel to the road and thus prevent it from invading it.

Figure 1. Aircraft on the shoulder after landing

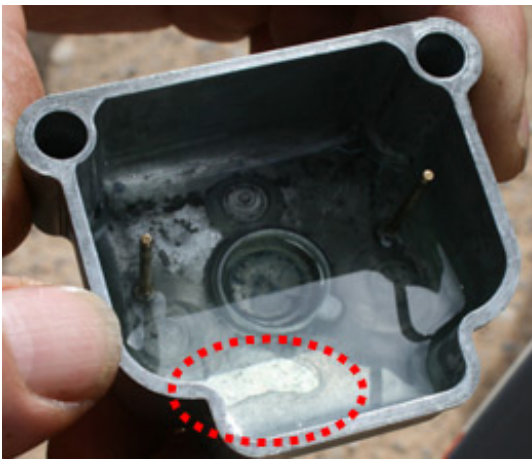
- Both the aircraft and the engine were in good overall condition.
- All of the spark plugs were in good condition.
- The magnetic plug was also in good condition and had no particles.
- The compression was verified to be good in all four cylinders by moving the propeller. The engine was then started and measured with a gauge, yielding normal values (11.5 Kg/cm² in #1, 10.5 Kg/cm² in #2, 10.1 Kg/cm² in #3 and 10.5 Kg/cm² in #4)
- The carburetors were removed. They looked new, which is consistent with the information provided that indicated that they had been installed the previous day. The floats in the left carburetor were in good condition and the jet was not plugged. There was a water bubble in the tray. The right carburetor had the same appearance. Practically all the liquid that had gathered in the tray was water.

Figure 4. Left carburetor

After inspecting the engine and its components, it seems clear that the cause of the engine failure was the large amount of water in the fuel system (tanks, carburetor trays and the gascolator filter), which prevented the fuel from reaching the carburetors normally.

In addition to the above, before any flight, the water in the system has to be drained, meaning the water inside the tanks has to be removed so that when the engine is started and fuel is drawn into it, there is no water in the lines, which could keep fuel from reaching the carburetors.

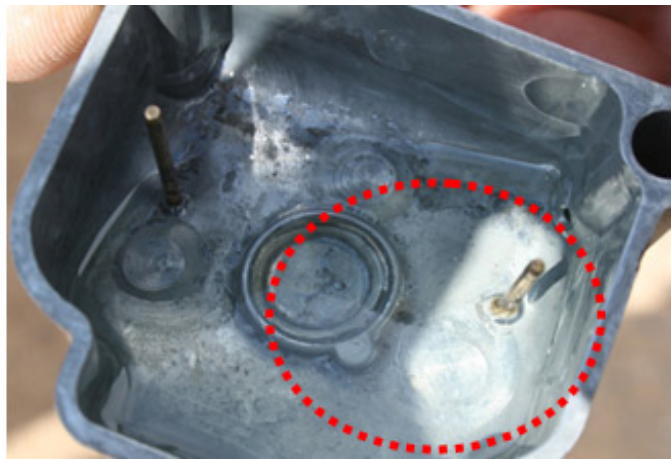
Figure 5. Right carburetor

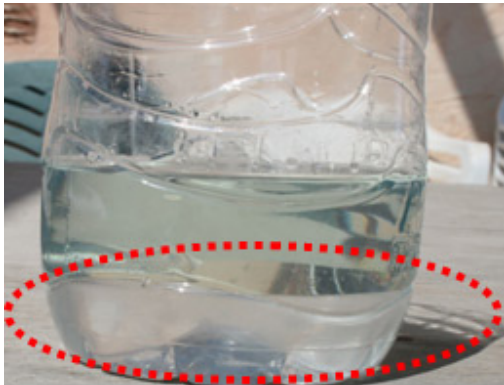
Figure 6. Water in the fuel

- There was also water in the gascolator filter.
- Almost all the fuel that was in the wings, approximately 10 l, was removed. There was also a large amount of water inside, as shown in the photograph in Figure 6.

The amount of unusable gasoline was 6 l, and when the tanks were emptied, around 10 l was gathered, this amount being very close to the unusable amount. In these conditions, the likelihood that there was water in the tanks was very high.

The tanks should not be left with low fuel in them for long periods of time so as to prevent water from building up in the fuel system. This precaution is always applicable, but more so in areas with high humidity, such as locations near the coast, as in this case.
