**DATA SUMMARY**

Date and time	<b>Monday, 11 April 2011; 14:00 local time</b>
Site	<b>Mijares (Ávila, Spain)</b>

Registration	<b>SP-SUH</b>
Type and model	<b>PZL W-3A, PZL W-3AS</b>
Operator	<b>LPU Heliseco Ltd.</b>

Date of approval	<b>28 November 2012</b>
------------------	-------------------------

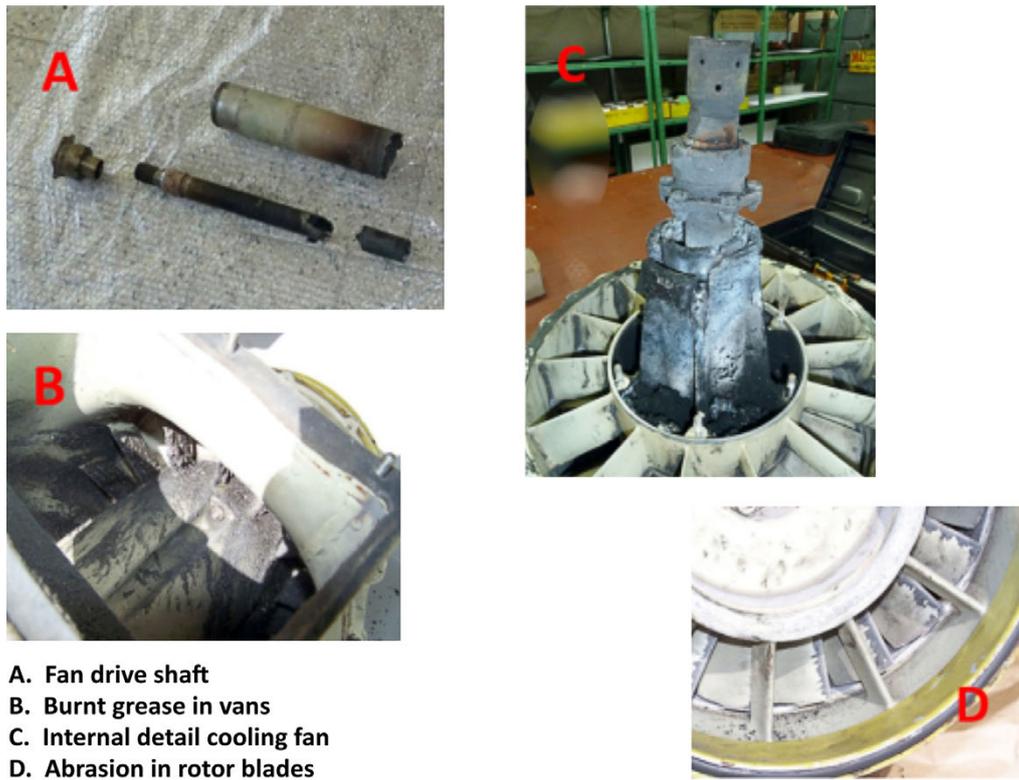
Figure 3. Close-up of the fan components

The fan drive shaft was fractured with its casing. Both had been affected by the temperature and by the torsional stress produced by the rotation of the shaft (Figure 3, A). The appearance of the aft bearing area on the rotor shaft that attaches to the clutch coupling (I) showed this to be the source of the highest temperatures (Figure 3, C).

The remains of burned grease were found inside the fan (Figure 3, B), and there were dents on the outer case that contains the lubricating grease for the bearings, see Figure 4. The lubricating grease in the clutch was also burned.

The rotor blade tips were found to have contacted the perimeter of the air conduit (Figure 3, D). They also rubbed against the outside of the stator stage aft of the rotor.

The findings from the tests concluded that the failure resulted from the high grease pressure used during the lubrication of the aft bearing on the fan rotor shaft, causing it to malfunction. The internal damage caused to the bearing led to high friction inside said bearing, resulting in temperatures that, with prolonged operation, reached a value of around 600 °C. This caused the lubricating grease under the fan cover to combust and the clutch grease to ignite.

The temperature reached in the ensuing fire caused the aluminum alloy in the drive shaft to reach its melting point (between 490 and 500 °C) such that the strength of the shaft decreased by up to six times in the fracture area. This effect was exacerbated by the torsional stress to which the drive shaft was subjected.

**REC 97/12.** It is recommended that the aircraft manufacturer, PZL Swidnik, S.A., carry out the actions detailed below involving the PZL W-3AS aircraft and proposed in the wake of the investigation into the cooling system fan on said aircraft:

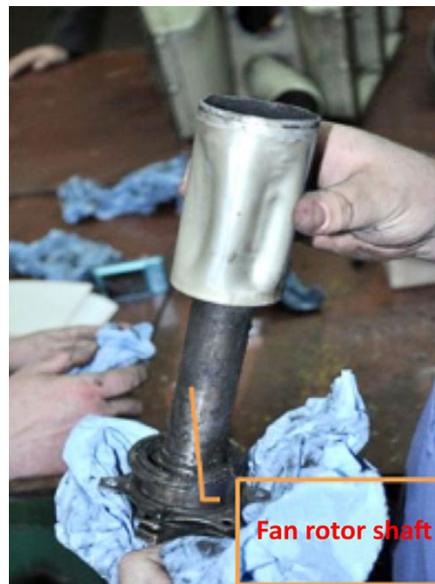
Figure 4. Dents in the outer case

Other tests were conducted to determine the effect that the grease pressure used during lubrication, the type of lubricant used, the condition of the grease and the grease gun had on the dents found on the outer case of the rotor shaft. These tests were carried out in accordance with the fan manufacturer's standards on the original fan components, except for the damaged parts.

The pressure at which the lubricant was applied was monitored during one of the tests, which revealed that at a pressure of 20 bars, the new grease issued from both check lubricating orifices. Subsequently, when the assembly was subjected to dynamic lubrication, internal pressures of approximately 50 bars were reached that caused denting of the outer case of the rotor shaft, and degraded the joints and rings that comprise the bearing seals. It even caused detached material to clog the check orifices.
