## Report A-029/2011

Accident involving a  
Bombardier CL-600-2B19  
(CRJ200), registration  
EC-ITU, operated by Air  
Nostrum, at the Barcelona  
Airport, on 30 July 2011

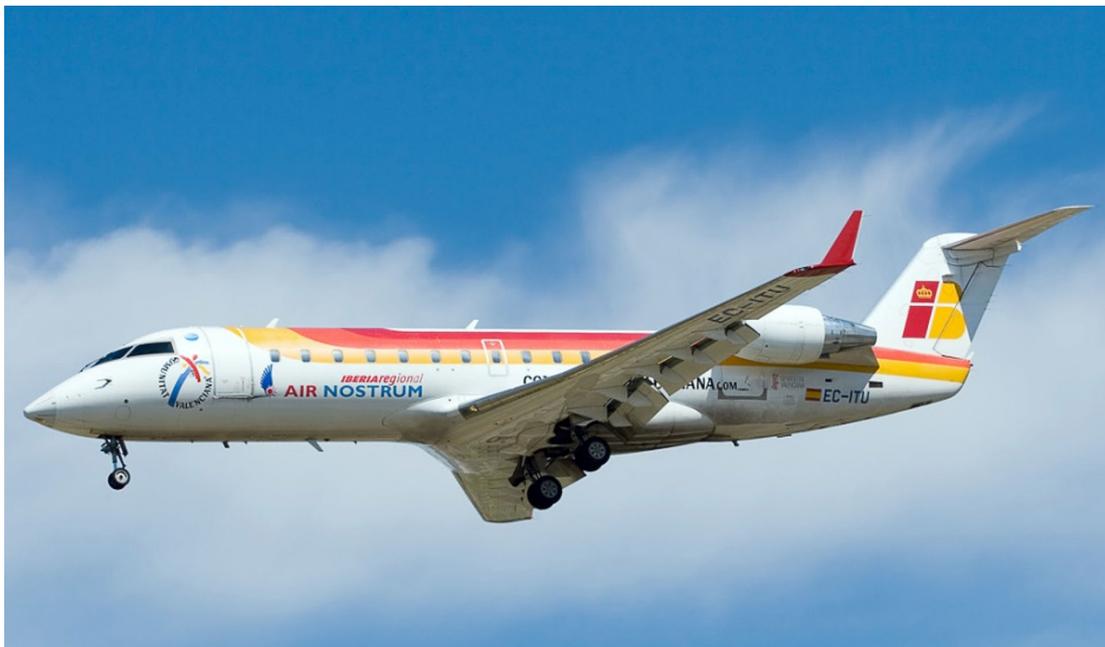
Figure 1. Photograph of the aircraft

The high descent rate reached in the final phase of the approach led to a hard landing (3.66 g's), which caused material damage to the aircraft.

The aircraft underwent the hard landing inspection specified in the maintenance manual (AMM 05-51-01) at the Barcelona Airport. This inspection revealed damage to the areas where the landing gear attached to the structure. The repair work had to be performed at the operator's base in the Valencia Airport, meaning the aircraft would have to be taken there on a ferry flight.

Once these preliminary repairs were made the airplane flew to the Valencia Airport, where the repairs were completed.

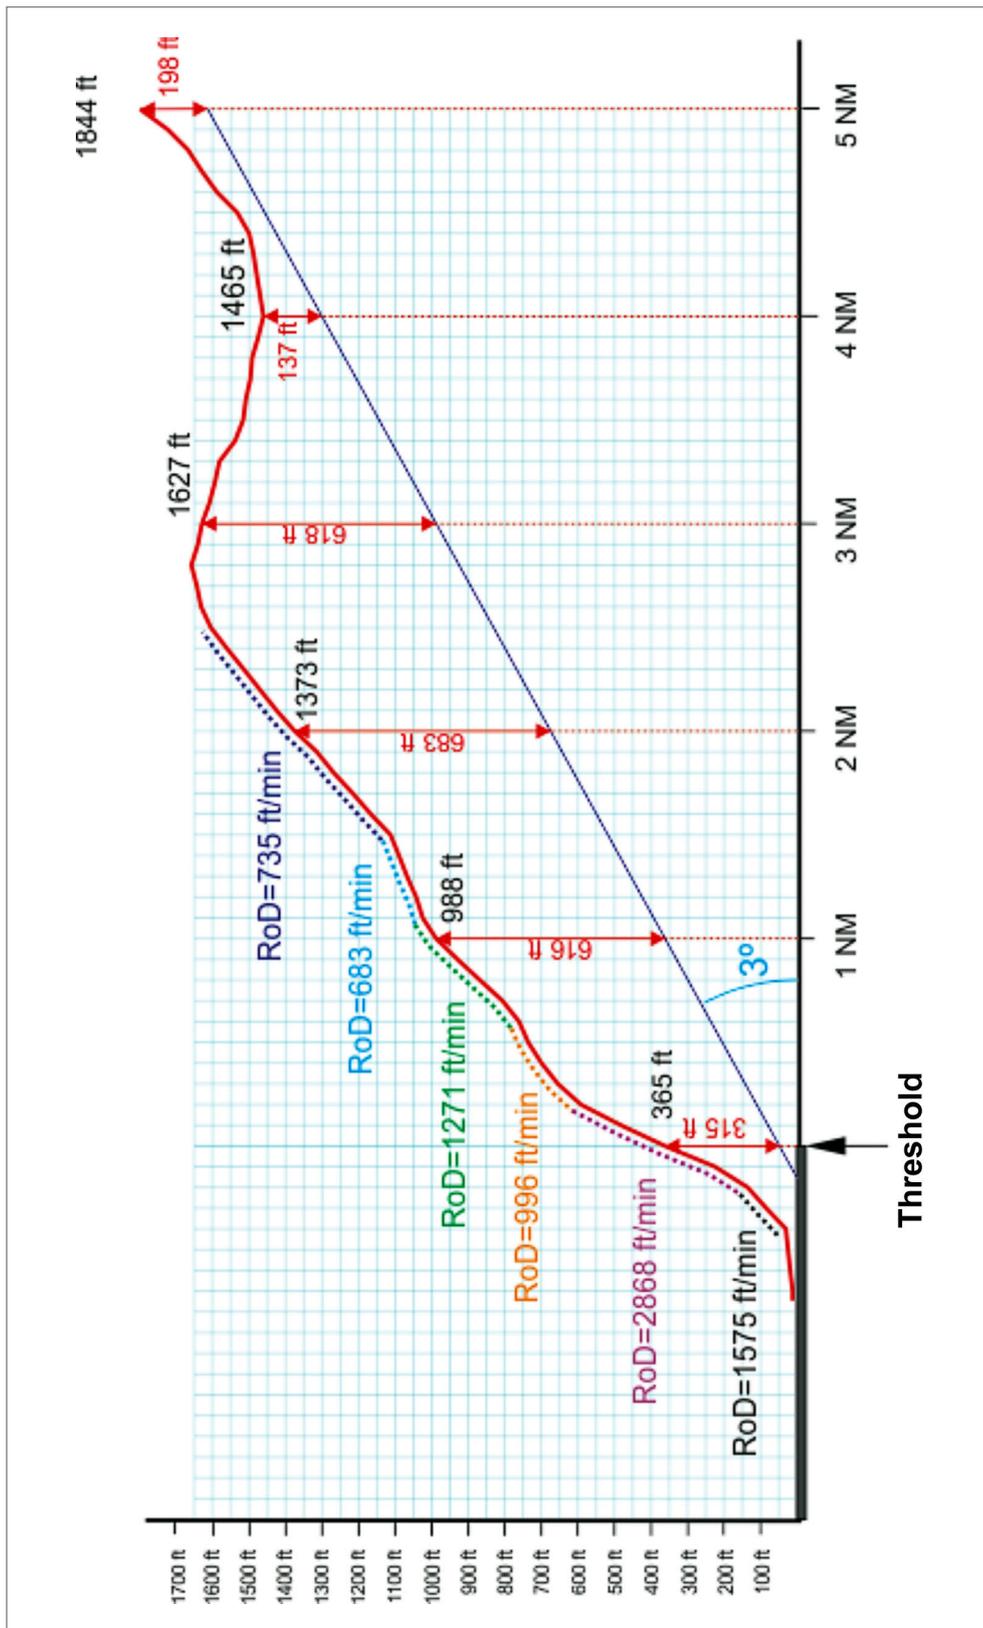
Figure 8. Altitude profile of the last 5 NM of the aircraft's flight path. The descent rate is shown for each segment (color coded) along with the excess altitude above the standard glide slope

To avoid flying into the layer they interrupted the descent and started climbing to 1,700 ft, which caused them to have an excess altitude over the glide slope of up to 775 ft.

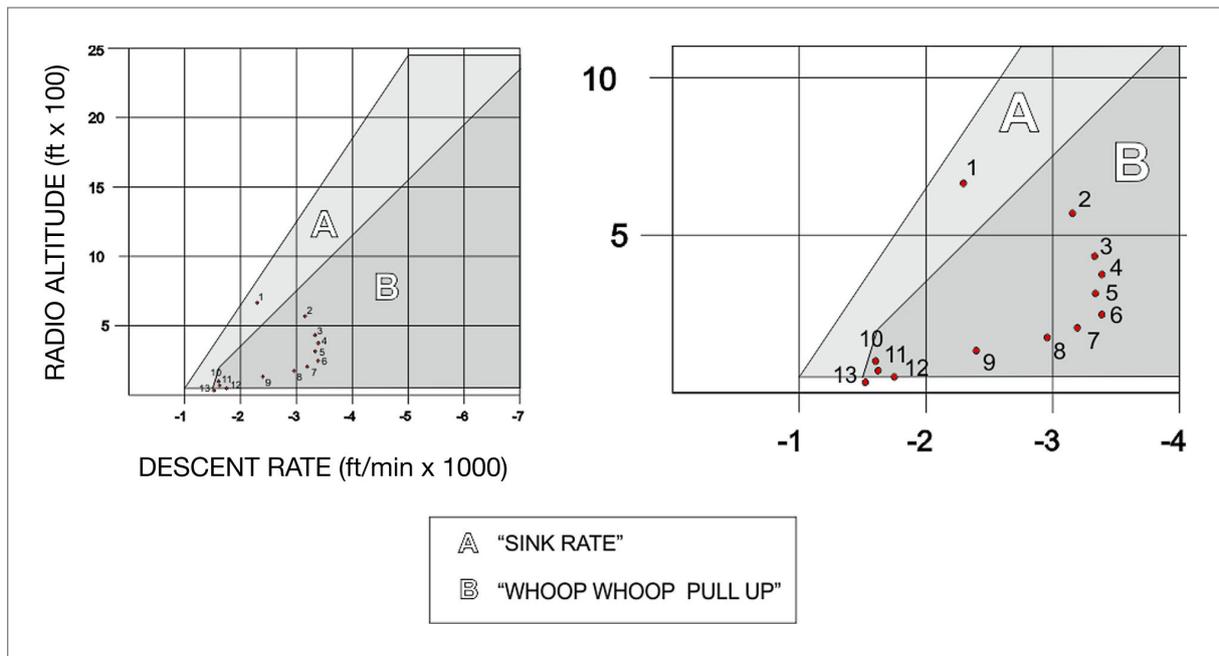
Figure 9. Graph of the mode 1 EGPWS alerts (left) and close-up of same graph (right)

Figure 9 shows the design criteria for the EGPWS mode 1 alerts (excessive descent rate), which are generated based on the (barometric) descent rate and the radio altitude. The graph shows two areas labeled A and B. If the aircraft's flight conditions correspond to area A, the EGPWS issues a "sink rate" warning, and if it is in Area B it will signal "whoop whoop pull up".

Also shown on this figure are the points defined by the parameter pair of descent rate and radio altitude for the 13 seconds during which the EGPWS was issuing alerts. Based on this, the initial alert should have been a “sink rate” warning and the remaining twelve “whoop whoop pull up”.

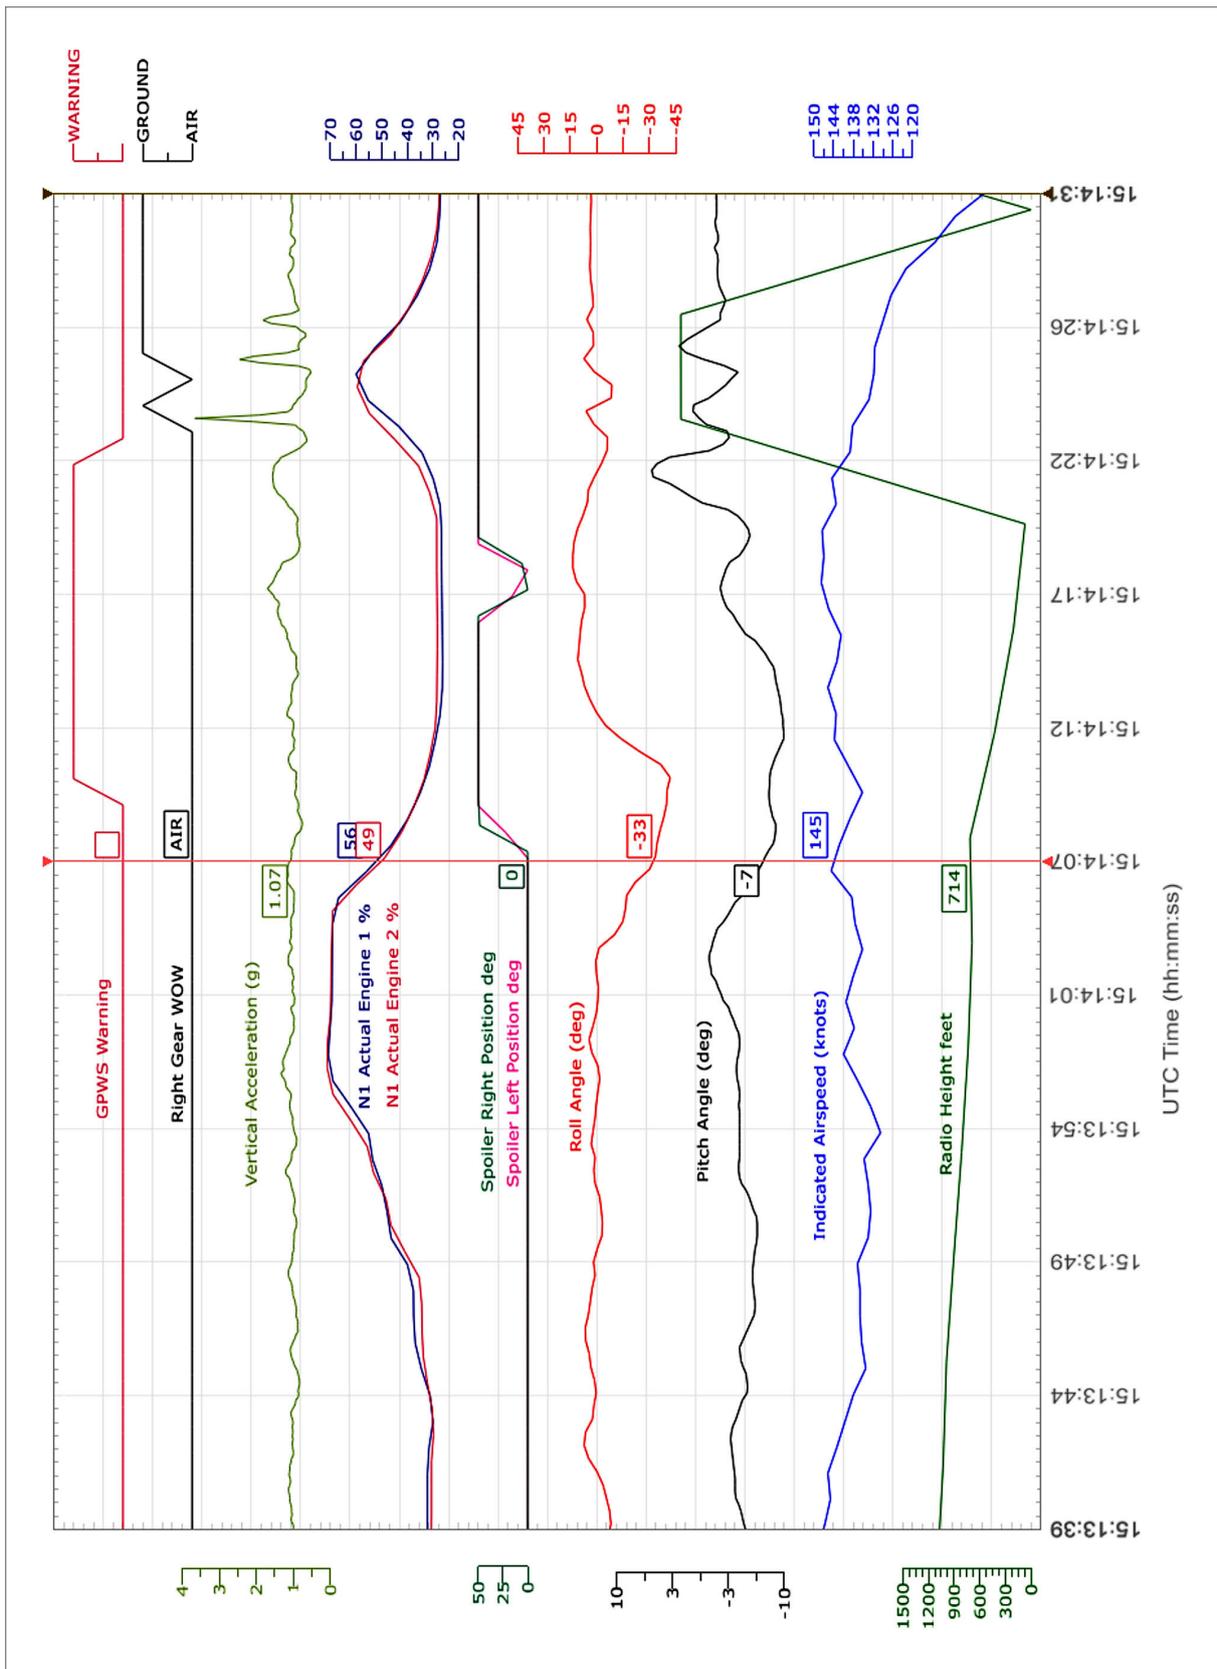
Figure 10. Trend in various parameters during the final approach phase

The graph in Figure 10 provides a representation of the values of various parameters (EGPWS warnings, weight on wheels of the right main gear leg, vertical acceleration, N1 for both engines, air brakes, roll angle, pitch angle, IAS and radio altitude). It starts at time 15:13:39 and at an approximate altitude of 1000 ft, which almost coincides with the start of the second segment (light blue color) shown in Figure 8, and continues until 15:14:31, that is, eight seconds after the aircraft’s initial contact with the runway.

This third phase spanned nineteen seconds, from 15:14:20, corresponding to a radio altitude of 50 ft, until 15:14:39, with the airplane already on the runway.

At the start of this 3rd phase the aircraft was at an 11° right roll angle and a 6° nose down angle. Its IAS was 144 kt. Both engines were at flight idle.
