Report A-037/2011

Accident involving
two Bell 212 aircraft,
registration EC-GIC and
CC-CIS, operated by INAER,
at Bienservida (Albacete),
on 30 September 2001

Final report

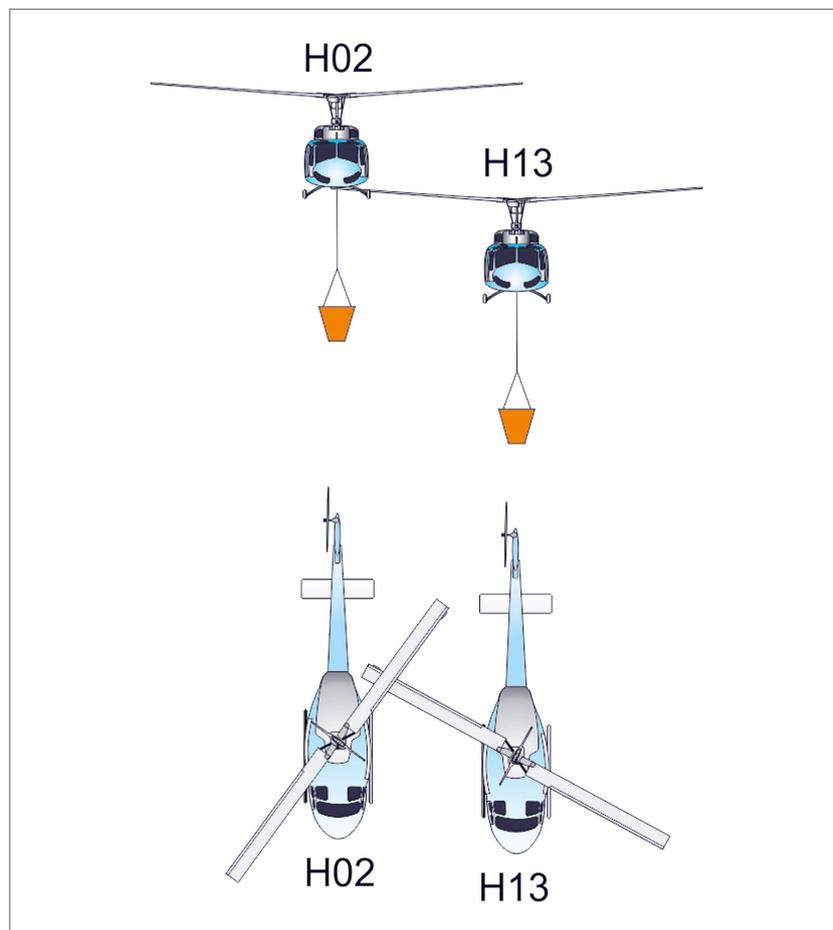
Figure 5. Position of both aircraft just before the impact of the first blade

The collision between the two aircraft occurred overhead the pool, when none of them was in translational²⁸ flight and they were a few meters above the pool at a level position, both roll and longitudinal wise. Figure 5 shows the position of both aircraft just before the initial impact:

The first contact among the helicopters occurred between one of the two blades of the main rotor of the H13 and the aft side of the left skid of the H02. This first contact broke the rear crossbar where it joins the left skid and placed the blade moving forward horizontally between the left skid and the belly of the H02 helicopter. In that same movement a second contact occurred, this time against the anchor cables of the bambi bucket, cutting them. The bambi bucket of the H02 did not suffer any damage and fell into the pool.

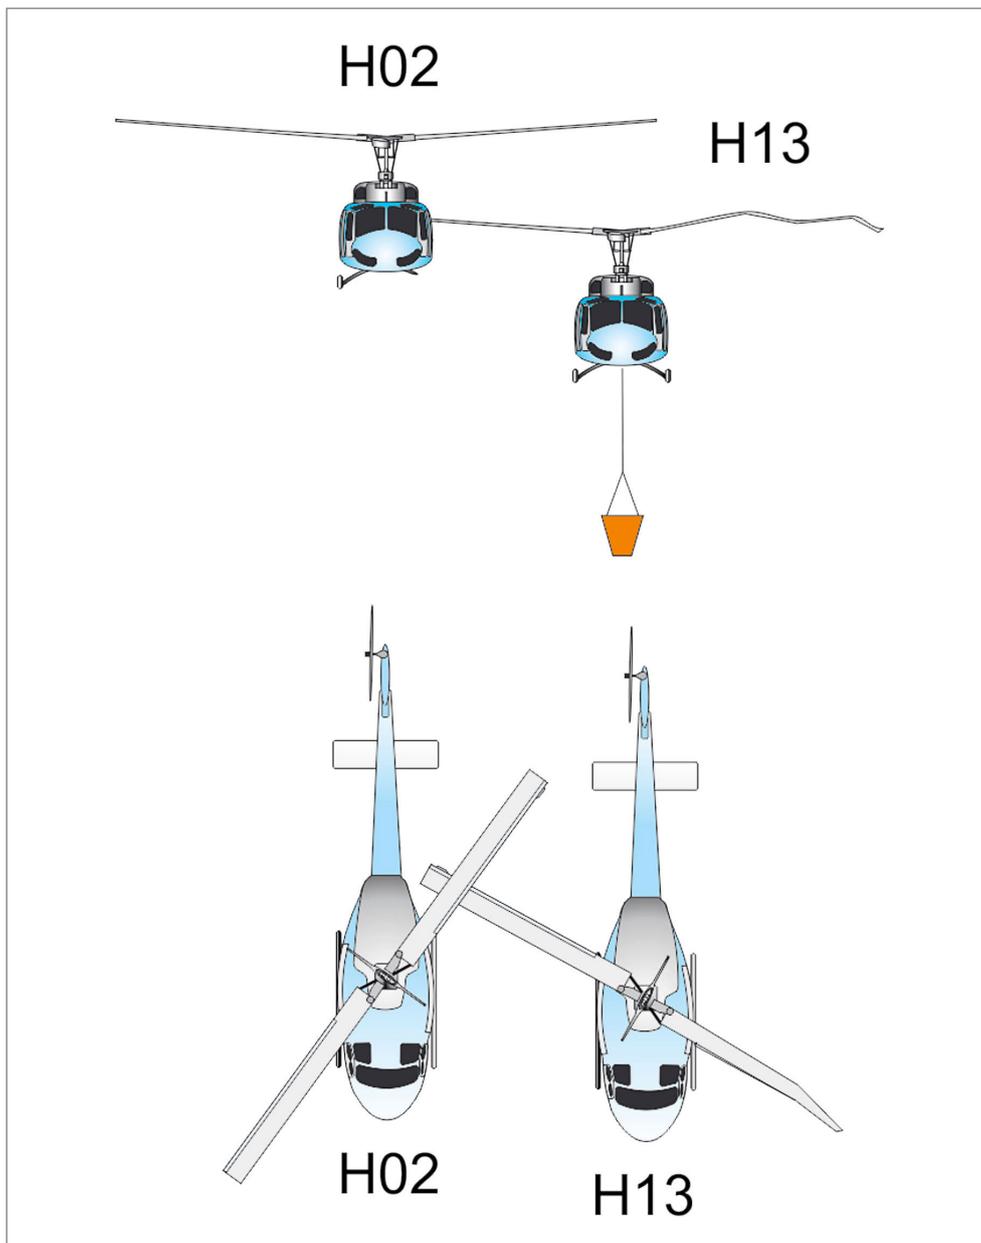
Figure 6. Position of the two aircraft just before the impact of the second blade

most external side the fuel tank of the H02 (placed in the right-hand side of the H02, behind the last seat row) causing a big flame towards the front that reached the pilot of the H02.

This blade did not detach from the H13 either, but it did break into various fragments that became detached. The tip of the blade (a fragment of about 60 cm long), where its counterweight is, became detached stopping at the passenger cabin of the H02 just behind the pilot seat. The right skid of the H02 was not hit by any blade of the H13. After the abovementioned collision of the two blades of the H13 main rotor into the

H02, both aircraft plunged vertically into the pool, but before reaching the water, another impact occurred between the aircraft as detailed next:

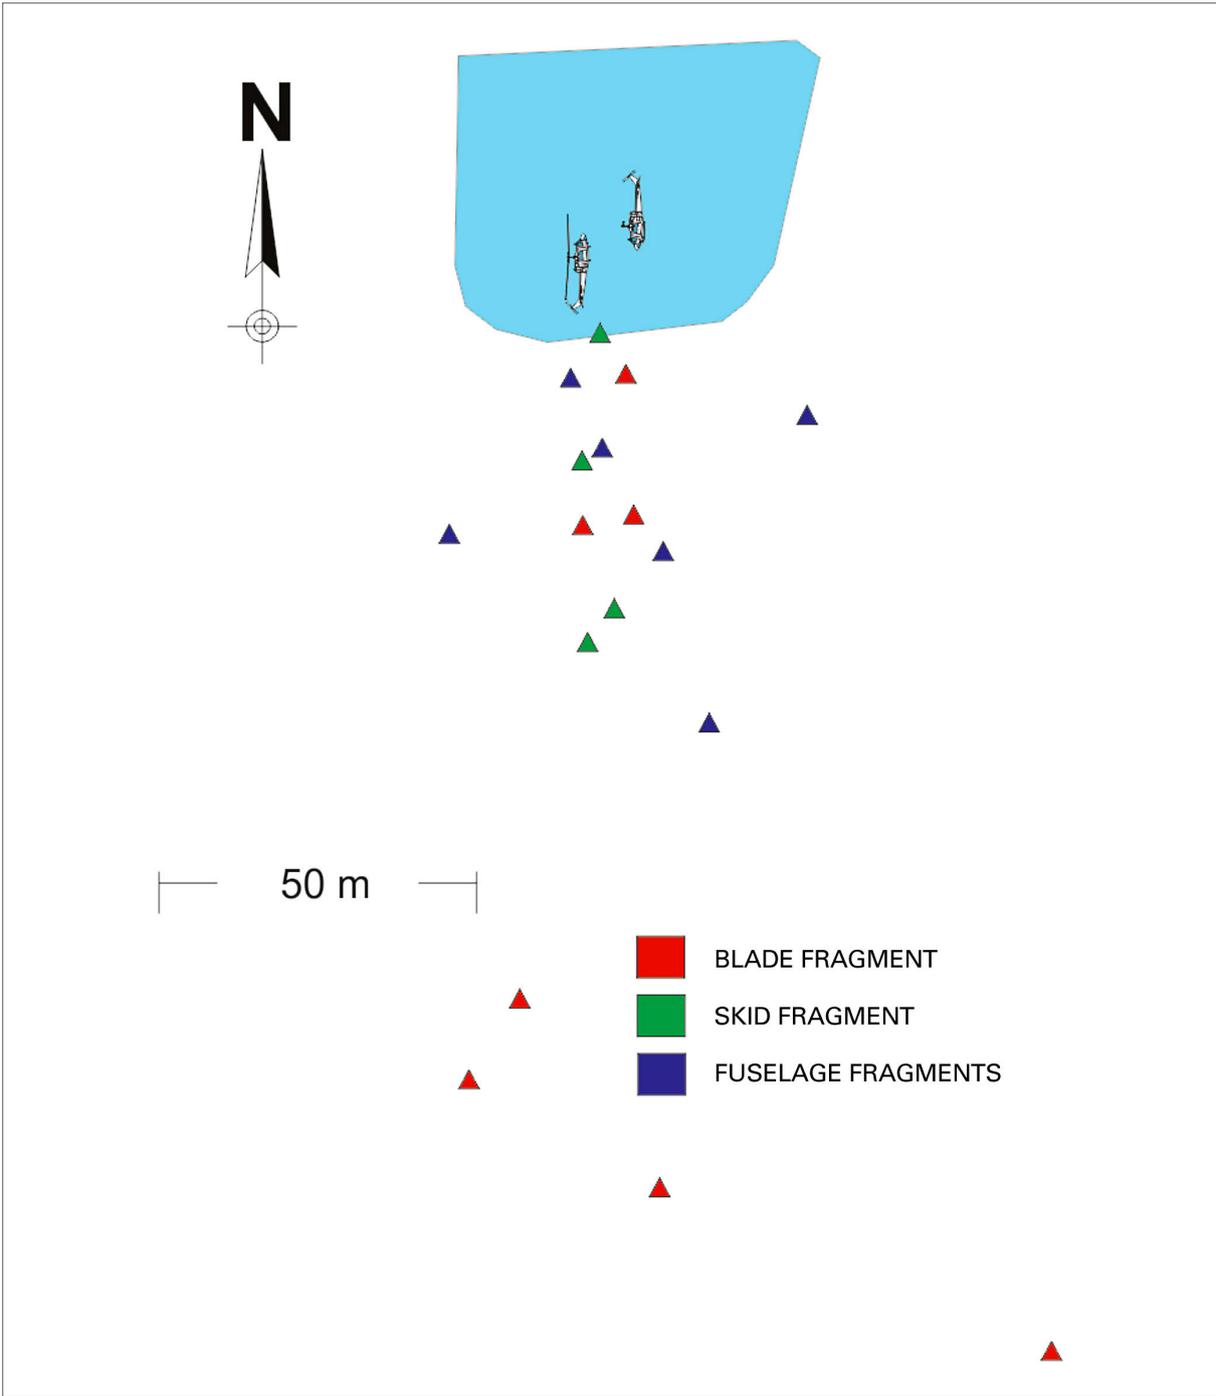
Figure 7. Distribution of debris chart

The main debris of the two helicopters stayed inside the pool, except for the parts that were thrown outside the pool by the impact of the main rotor blades of the H13 against the H02.

The projection of the debris was towards the south.

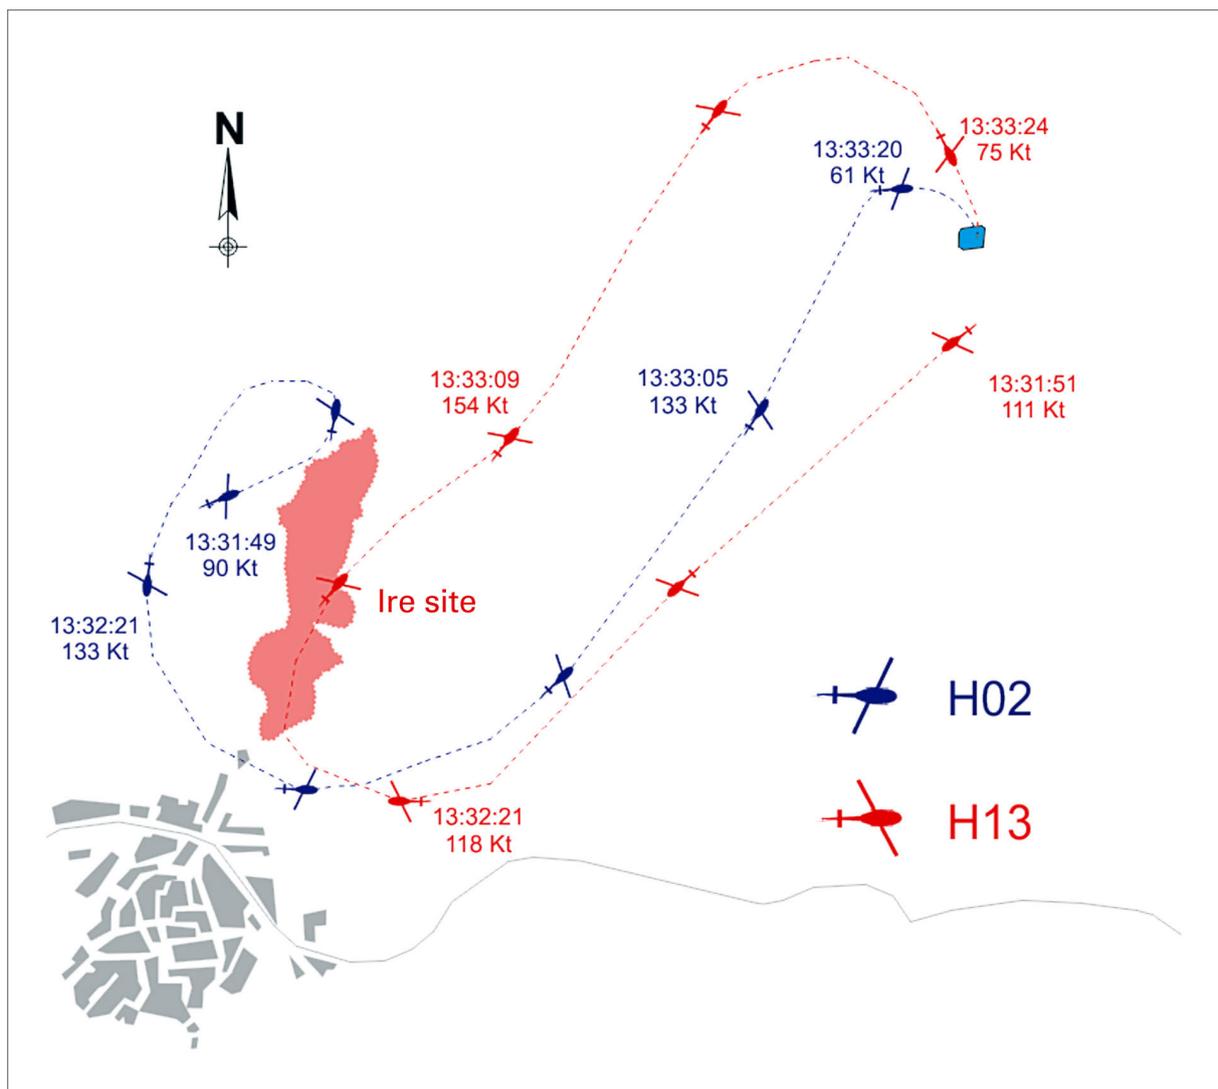
Figure 8. Flight pattern prior to the impact of the H02 and H13

From the information of the CVR that the H02 had installed and activated it has been possible to know that the communications among the 3 helicopters involved in the fire fighting were few in general, and in particular, practically null regarding reporting position of the helicopters to confirm arrivals or departures from the water drop in the fire site or approaching and departing the pool for the water load.

However, the H02 flew the segment from the fire site to the pool heading northeast also but more to the south than the others, which caused that the last turn to the right to enter final approach to the pool left a pattern considerably shorter than that of the other two aircraft, ending the turn practically on the pool and having a worst visibility of the same.

This route difference makes that the one flown by the H02, from the fire site to the pool, was shorter in distance. Not having set waypoints that fixed the flight pattern, promoted the fact that each pilot flew their flight pattern without a fixed pattern, leading to unequal routes that caused the order established to load the water to break.

As a consequence of the non-existent coordination among the three aerial means involved in the fire fighting operation, that caused that two of the participating aircraft met at the pool to load water, a flight collision occurred.

- REC 32/13.** It is recommended to INAER Helicópteros, S.A.U. as responsible of the operation to establish a procedure to define the flight patterns that the aircraft must comply with during the fire fighting operations so once it is established the aircraft follow it as precise as possible. This procedure will have to be incorporated in the Operations Manual of the company and in the Training program of the crew.

- REC 33/13.** It is recommended to INAER Helicópteros, S.A.U. as responsible of the operation to establish a protocol to coordinate its aerial means in the absence of the ACO. This protocol will have to be incorporated in the Operations Manual of the company and in the Training program of the crew.
