## Report A-043/2013

Accident involving a BOEING 767-332 ER aircraft, registration N-182DN, operated by DELTA AIR LINES, at the Madrid-Barajas Airport (Madrid, Spain) on 5 December 2013

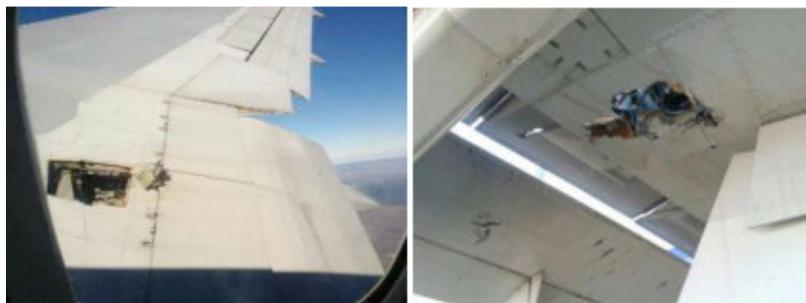
During the takeoff run, the right rear tire on the right main landing gear burst, with the detached parts of the tire striking the underside of the wing, puncturing it and also fracturing important hydraulic system components. When these components detached, they struck the top side of the wing, causing the loss of a panel there.

Figure 1. Photographs of the holes in the upper and lower wing

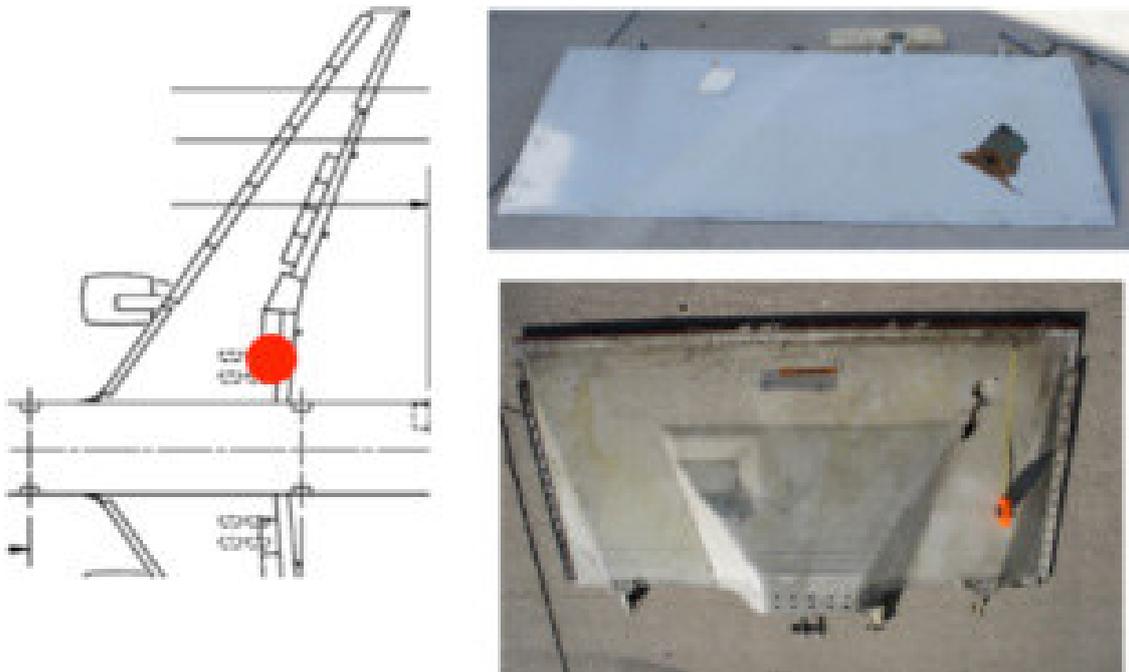
Both the top and bottom sides of the no. 7 spoiler on this wing were damaged, as were the drag panels, though the spoiler was operative.

Figure 13. Spoiler no. 7

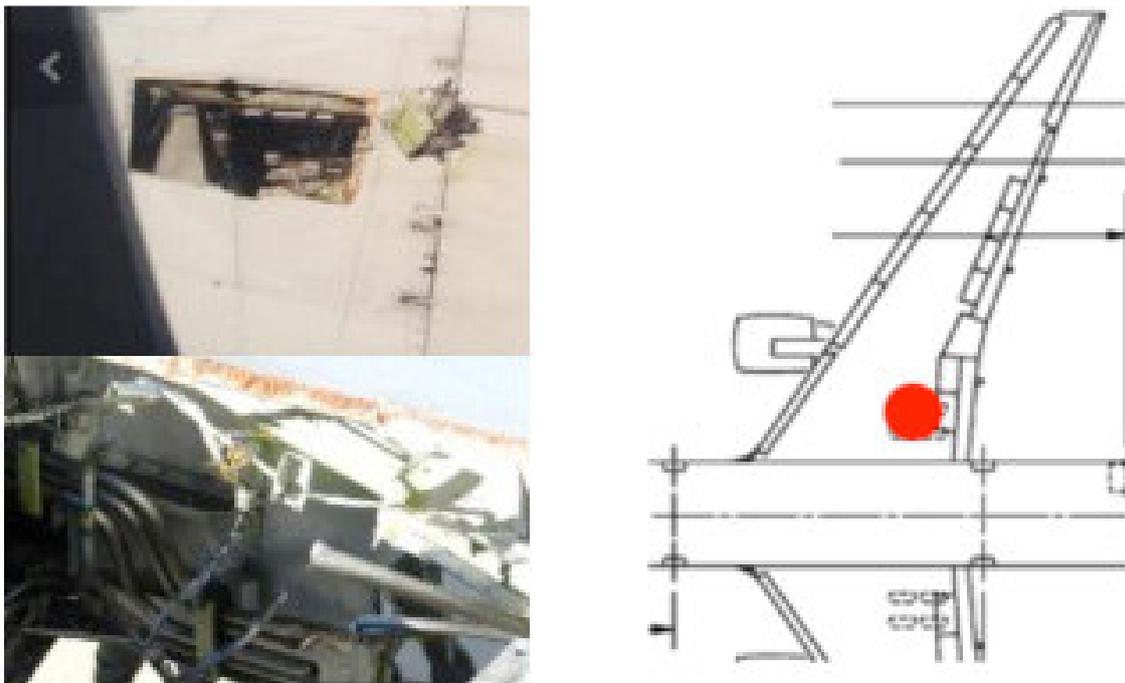
The antiskid pump was separated from its housing and was on the top surface of the right wing, held only by an electrical cable. The hydraulic lines that supplied it were broken. Both the antiskid pump accumulator and its related hydraulic lines were broken (Figure 14).

Figure 14. Panel perforated by the antiskid pump

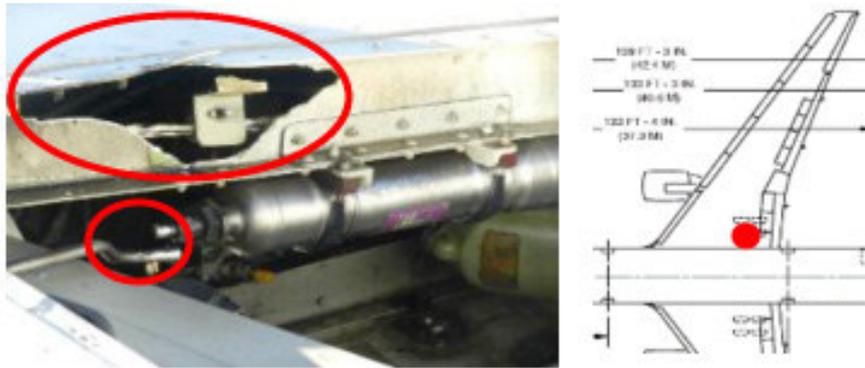
A rib on the trailing edge had a significant fracture (Figure 15), and the upper xxx was noticeably bent. The damage noted in the hydraulic system affected the nos. 1, 6 and 12 spoilers, which were rendered inoperative.

Figure 15. Aft spar and accumulator

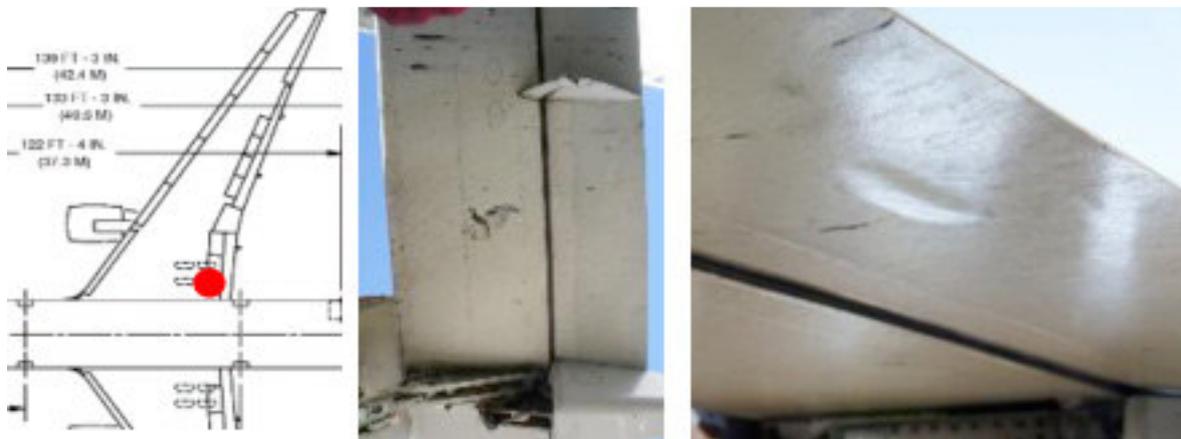
Figure 16. Damage to right wing flaps

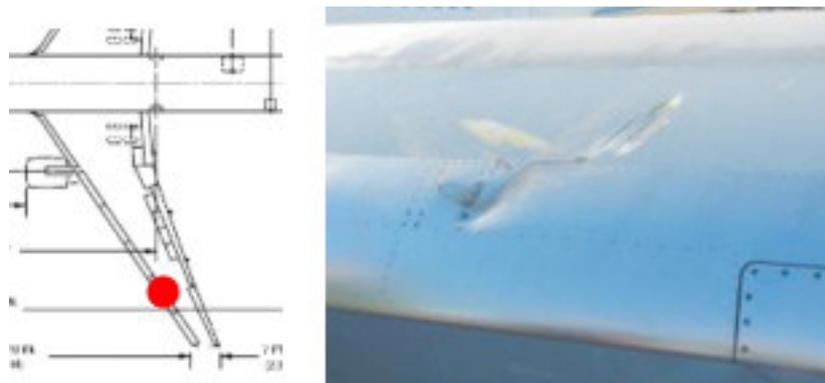
The most apparent damage was to the top surface on the leading edge of the slat. There were also some yellow paint marks in that area.

Figure 17. Damage to the slat

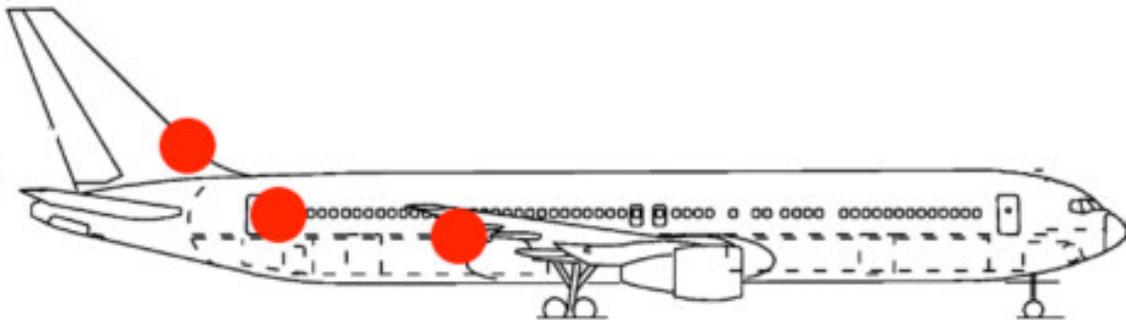
All along the fuselage and the tail there were various marks on the right side at the points marked in Figure 19; specifically, over one of the windows, at the aft door and on the vertical stabilizer front fairing. As for the landing gear, the right front tire exhibited two puncture marks on the tread, as well as scuff marks.

Figure 18. Damage to fuselage

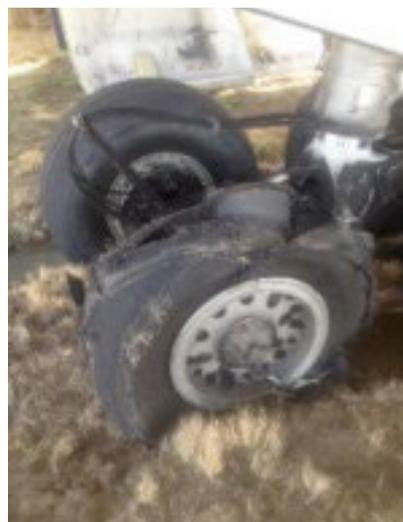
The right rear tire on the right main landing gear (wheel no. 8), which had blown out, had lost more than half of its tread, which tore along 180°, detaching in pieces of various sizes that were found on both the takeoff and landing runways.

Figure 19. Wheel No. 8

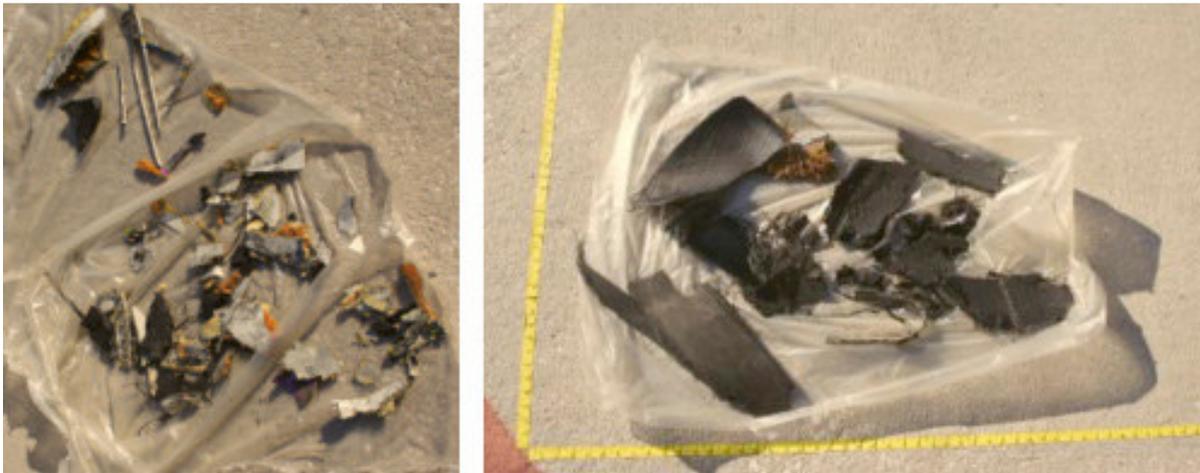
An inspection of the runway from which the aircraft took off turned up parts of the tire from wheel no. 8, hydraulic system tubing, parts of the panels that were damaged and a metallic piece shaped like a small strip, measuring 87 mm long, 5 mm wide and 1 mm thick. It was slightly bent at the center, forming an angle of approximately 160°. This piece was the same shape as a slot located below the tread on the tire that exploded, into which it fit perfectly. See photographs in Figure 23.

Figure 20. Some of the debris found on runway 36 L

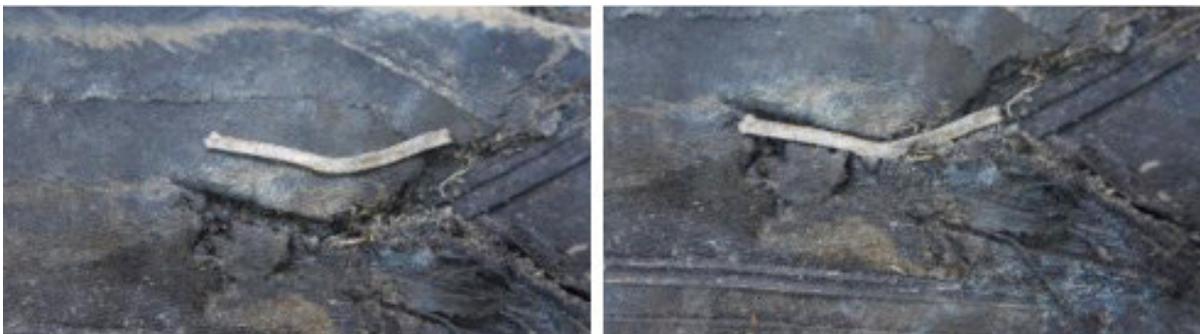
Figure 21. Metal part found on runway 36L, and placed in slot in tire

The tear on the tire was visually inspected by the manufacturer, which concluded that the tear started underneath the tread, specifically in the area that contained the piece of debris that was found on runway 36L. From there, the tear progressed along the inside of the tire following the layout of the fibers, and ripped the tread until part of it detached.

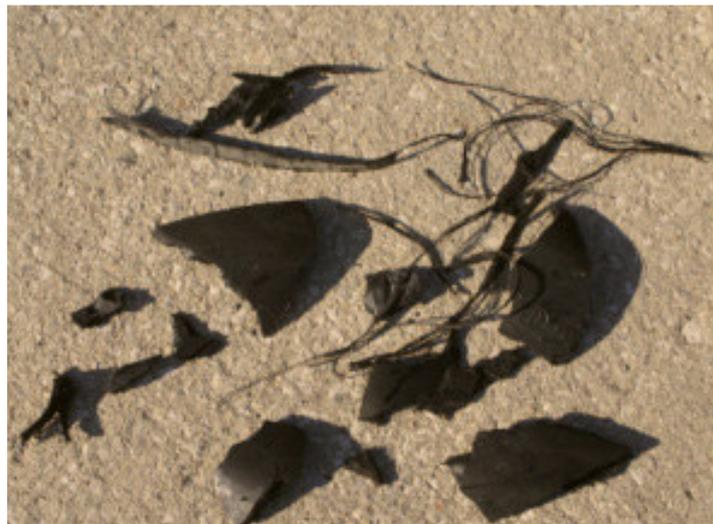
On runway 32L only a few bits of tire were found, as shown in Figure 24.

Figure 22. Debris found on runway 32 L

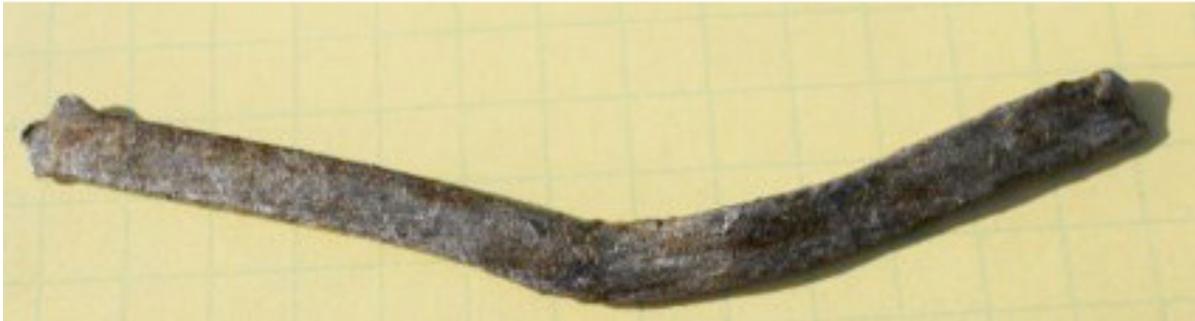
The piece found on runway 36L was a small strip and measured 87 mm long, 5 mm wide and 1 mm thick. It was slightly bent at the center, forming an angle of approximately 160°. A simple observation with the unaided eye of the two sides of the piece revealed signs on its surface that it had been crushed and dragged.

It was examined in a laboratory using non-destructive eddy current testing. This revealed a high level of ferromagnetism and indicated that its composition corresponded to that of an austenitic stainless steel.

A study of its microstructure showed the presence of elongated grains that were longer in the longitudinal direction of the piece than in its transversal direction. This granular morphology could have originated during the manufacturing process of the piece from which the fragment detached, via lamination in the longitudinal direction. But it could also have been produced later if the piece was on the ground a long time and subject to continuous crushing forces.

Figure 23. Piece found on runway 36L
