## Report A-037/2015

Accident involving a SOCATA TB-9 aircraft,  
registration EC-LIQ, in the municipality  
of Ronda (Malaga) on 24 December 2015

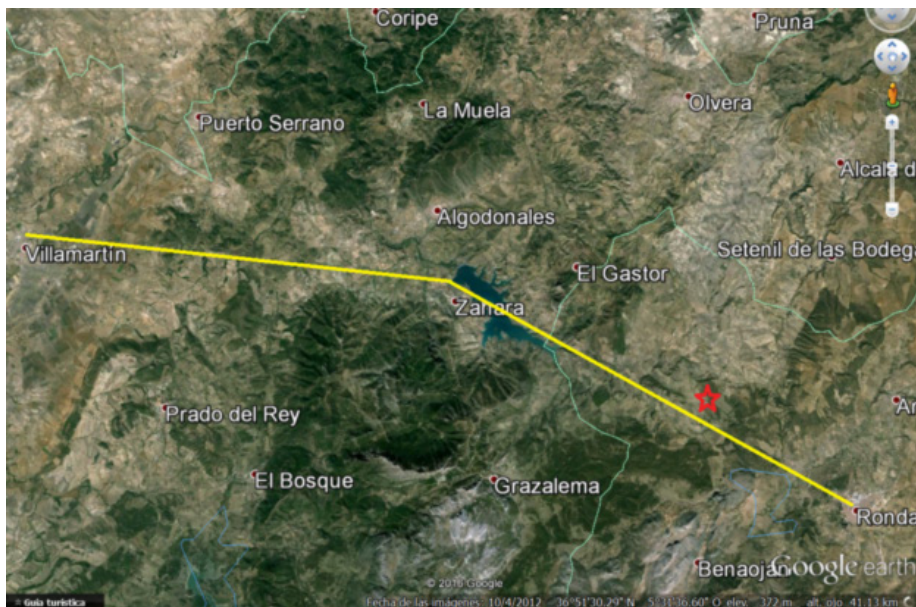
Figure 1. Flight path and accident site

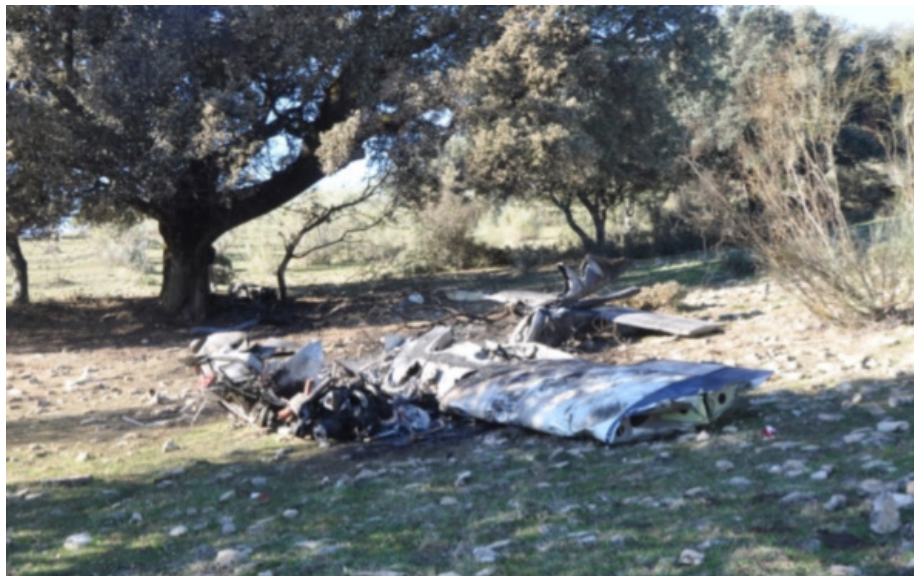
Figure 2. Aircraft EC-LIQ after the accident

The aircraft's right wing impacted the trunk of a large oak, and the aircraft's nose struck one of the branches, which was also of considerable size. Both the right wing and the assembly consisting of the two blades and the propeller cone detached from the aircraft.

The aircraft was destroyed by the impact and by fire that broke out afterward.

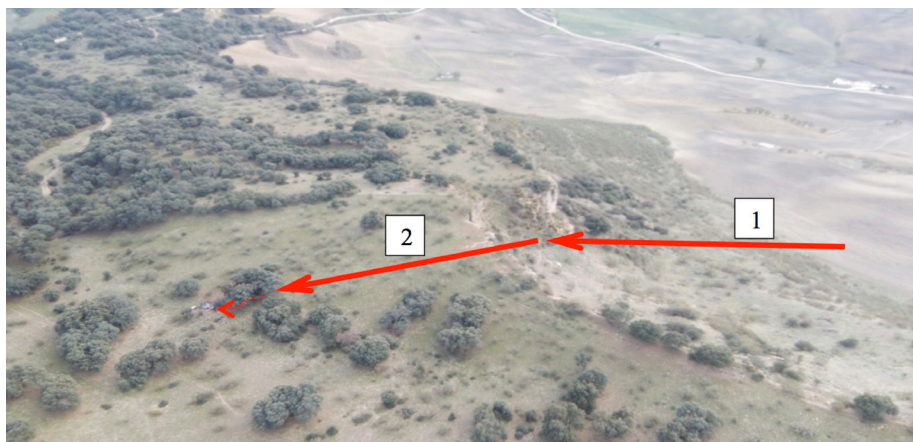
The aircraft approached the impact site on an upward flight path from the valley that was practically perpendicular to the valley wall (arrow 1 in the figure below), which it cleared by a very narrow margin (as further explained below, this was determined by the marks left in the vegetation). From there the aircraft continued flying without touching the ground, but only a mere 1-2 m above it (arrow 2), before impacting the tree.

Figure 3. Final flight path and impact of the aircraft

The valley wall is separated from the tree by 97 m, along 80 m of which investigators noticed that the branches of plants had been cut by the aircraft flying 1-2 m above the ground along an area of the same width as the aircraft's wingspan, that is, some 10 m. The aircraft did not leave any marks on the ground during this portion of its flight before it impacted the tree. The ground between the valley wall and the tree that the aircraft impacted slopes downward at about 7%. This means that after clearing the valley wall, the aircraft flew in a downward trajectory.

The aircraft impacted the tree while banking to the right, which caused the right wing to strike the trunk and the front part of the aircraft to strike a large branch. The impact caused the right wing and the propeller and its cone to detach.

The damage evident on the propeller blades indicated that it was windmilling at the time of the impact.

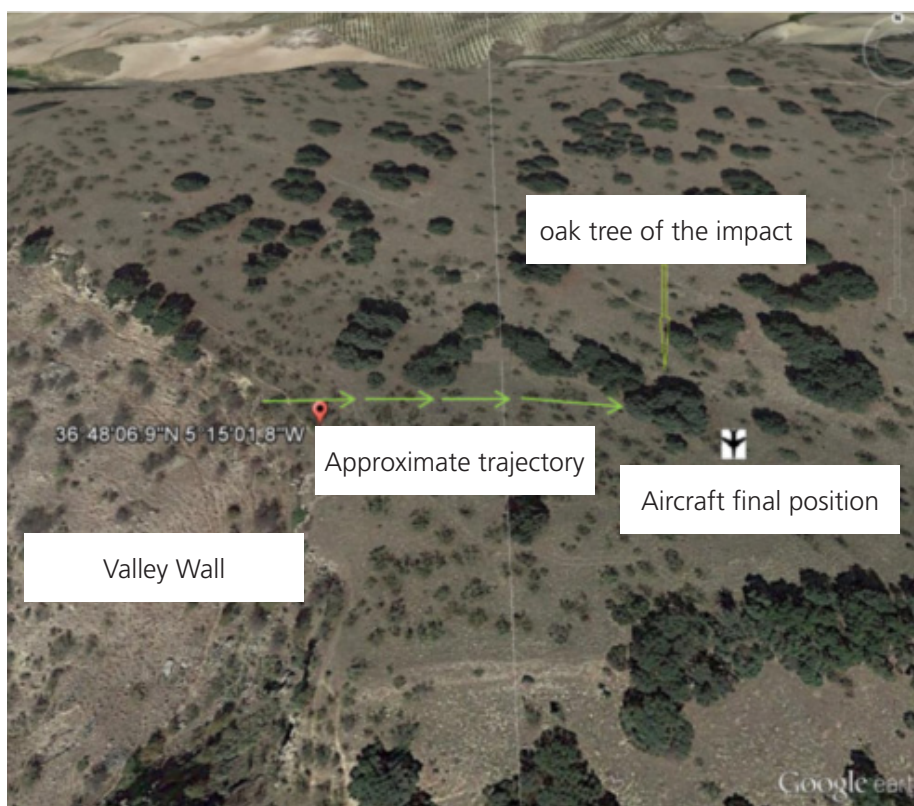
Figure 4. Final flight path and impact of the aircraft

The crash site was along a path on a direct heading from the Zahara reservoir to Ronda. To reach the crash site, the aircraft had to climb steadily since it had been flying low. To the right of the flight path, before reaching the valley wall, is a field where an emergency landing could be attempted if necessary. After clearing the valley wall, however, the area at the summit is full of oaks and shrubs and is not suited to making a safe emergency landing.

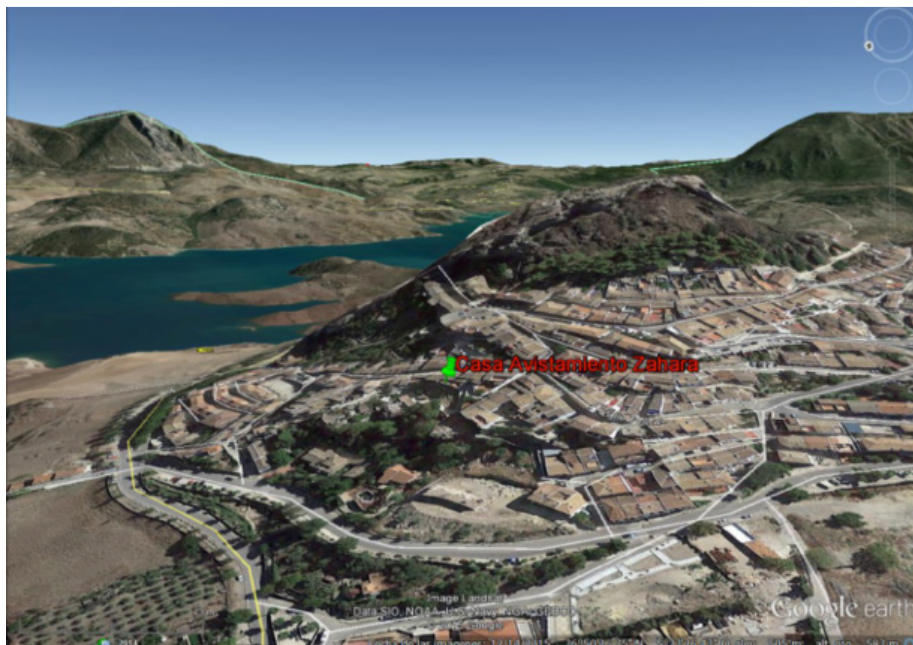
He noted his great surprise at seeing an aircraft of that size flying over the town at the same altitude as his balcony, there being structures in the surrounding area that were above the aircraft's altitude. In fact, at first he thought it might have been a radio controlled scale model, but he was quickly able to make out the persons onboard given their proximity to him, and he concluded it was a manned aircraft.

The engine was not making much noise and they were flying toward the reservoir in the direction of Ronda.

Figure 5. Location of the eyewitness
