## SAFETY INVESTIGATION REPORT

REPORT NO.: 15/2015

## DECK CARGO BARGE *AMT EXPLORER* Capsizing while under tow off the South Southwest coast of Sardinia 03 July 2014

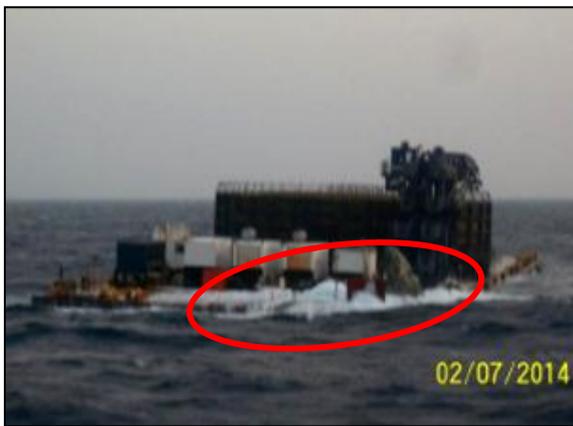
**Figure 3: Green seas shipped on the open deck from port side**

Most of the manhole covers which were not watertight were located forward to amidships and on the port side of the centre line. Figure 3 showed that green seas were being shipped from the port side.

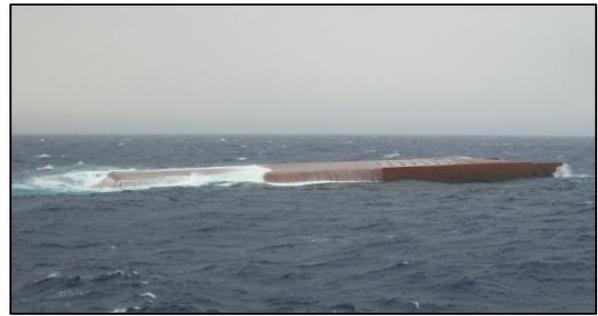
About an hour later, at about 0509, the tug boat master confirmed that the tow had been released and that the barge had capsized although still afloat (Figure 4). Soon after capsizing, the barge started to drift at about 1.2 knots. It was estimated that in this position, her freeboard aft was about 1.5 m and 1.0 m forward.

**Figure 4: AMT Explorer after capsizing under tow**

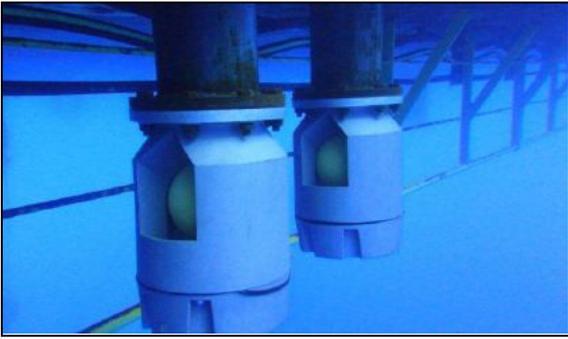
**Figure 6: Vent pipes (capsized barge)**

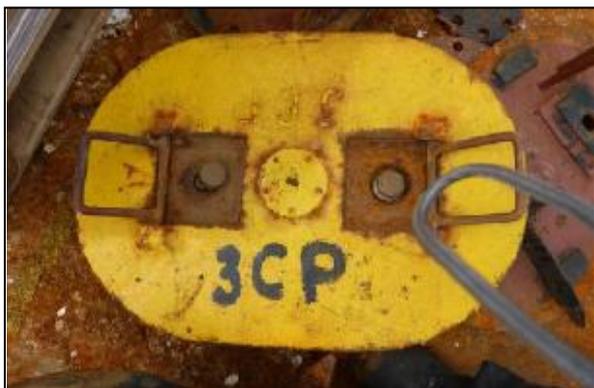
A likely source of water ingress was through the manhole covers. The manhole covers were secured using two strong-backs, each tightened with a single bolt (Figure 9).

Figure 9: A manhole cover showing on bolt on each strong-back

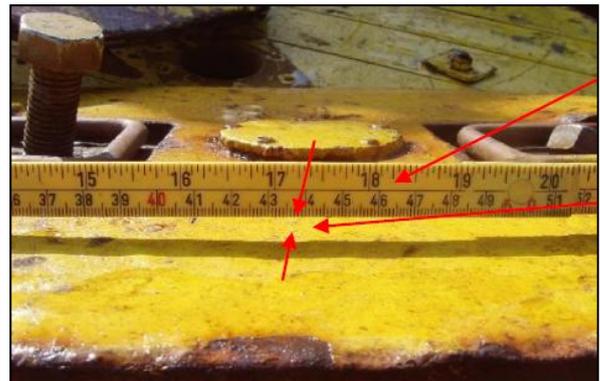
Most of the manhole covers were found to be deformed to various degrees (Figure 10).

Figure 10: Deformation (set-down) of one of the manhole cover by about 4 to 5 mm

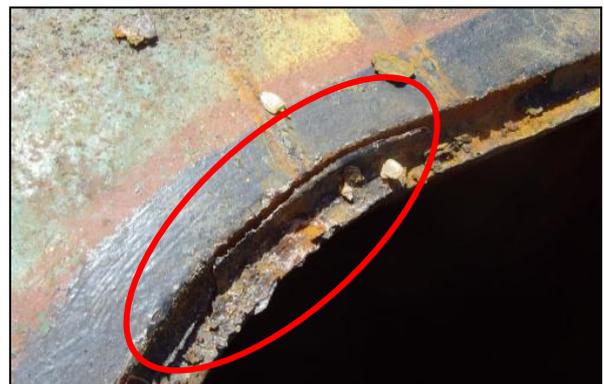
Indications of widespread corrosion on the manhole covers' sealing faces were also evident (Figure 11) and a potential source of water ingress due to the unevenness created by the flaking material.

Figure 11: Corrosion on the sealing face

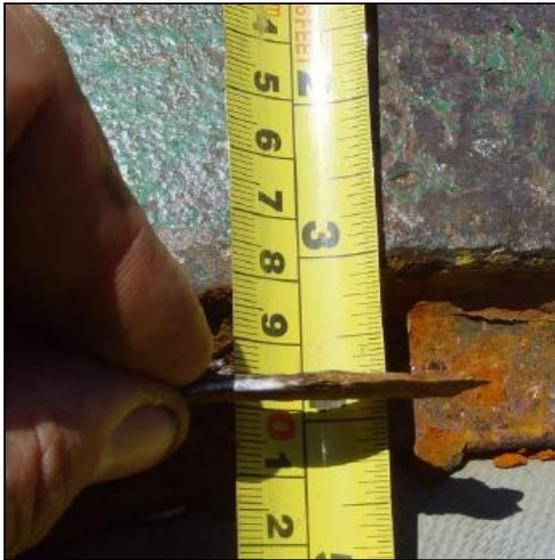
It was also very probable that the flaking material would have compromised the tightening effectiveness of the sealing manhole cover (Figures 12 and 13).

**Figure 12: Flaking material due to corrosion, compromising a watertight arrangement**

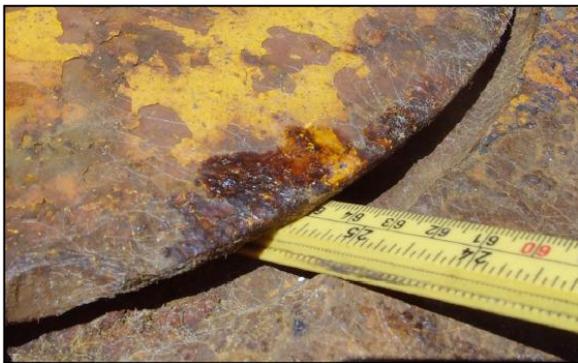
**Figure 13: Carpenter ruler (3\*3 mm) inserted in a gap between the manhole cover and the sealing face**

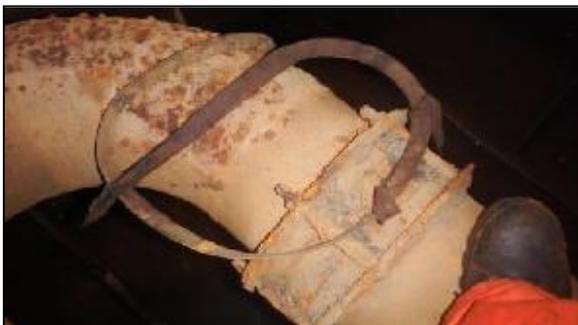
It has to be specified that the tightness of the cover may have been also compromised due to displaced rubber seals on a number of covers, which were found after the parbuckling operation (Figures 14 and 15).

**Figure 14: Displaced rubber seal inside a ballast tank**

The MSIU, however, was unable to confirm whether the rubber seals were displaced before the accident, during the course of the accident or post-accident as a result of the salvage work.

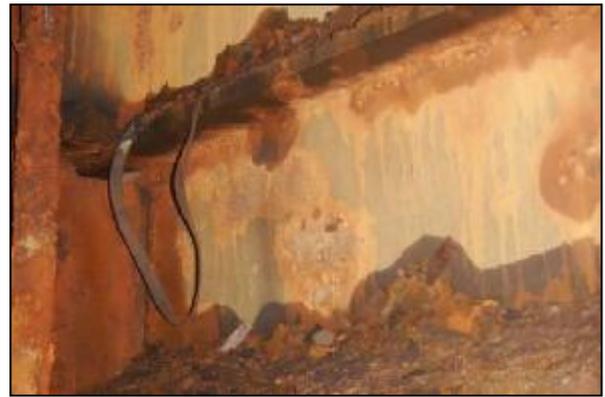
**Figure 15: Another displaced rubber seal inside a ballast tank**

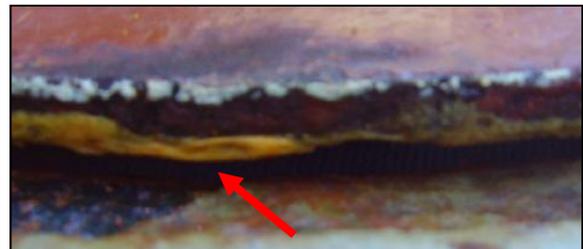
Expanding foam (Figure 16) and silicone (Figure 17) was also used on many sealing faces with the neoprene gasket in bad condition, although the MSIU was not able to determine whether this was applied before this particular voyage.

**Figure 16: Traces of expanding foam**

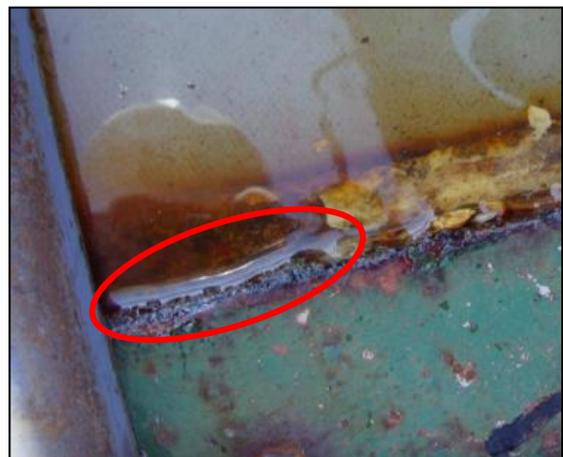
**Figure 17: Silicone applied to the sealing faces**

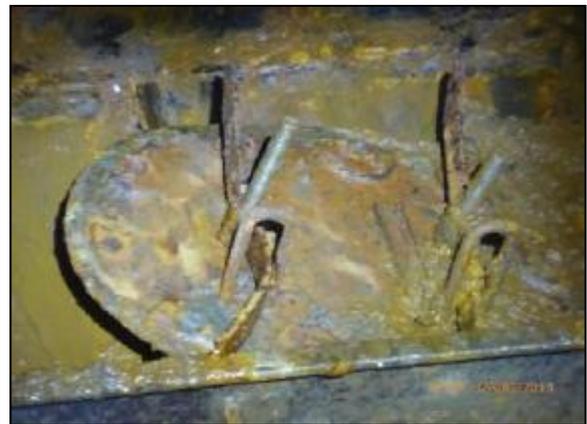
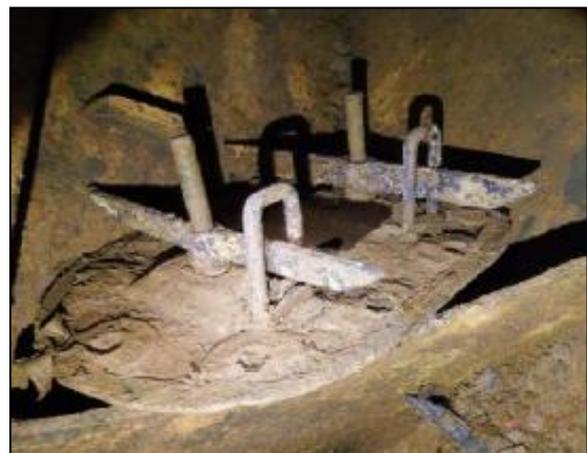
What is a primary concern for safety is correct and effective maintenance because this is one of the critical processes to ensure reliability. Figures 18-19 show the condition of a number of strong backs, which were wrongly fitted – a situation which could have contributed to a number of manhole covers (35 kgs) being lifted off.

**Figures 18-19: Manhole covers with wrongly fitted strong backs**

The lack of adequate oversight from any of the two parties is evident to the safety investigation. The physical condition of the manhole covers and other structural areas of the barge strongly suggest that the way maintenance data was used, did not prevent an incorrect diagnosis of the structural condition.

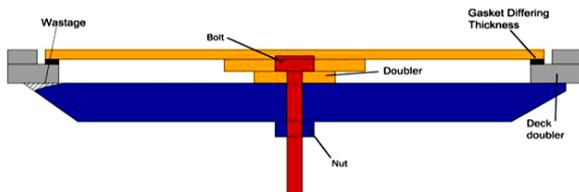
Figures 20-21 are a representation of the strong backs as designed and as fitted.

Figure 21: Strong back (incorrectly fitted)
