Report A-001/2020

Accident involving a Cessna
FRA-150-M aircraft, registration
EC-CVP, on 14 January 2020, in
the municipality of Villamanta
(Madrid)

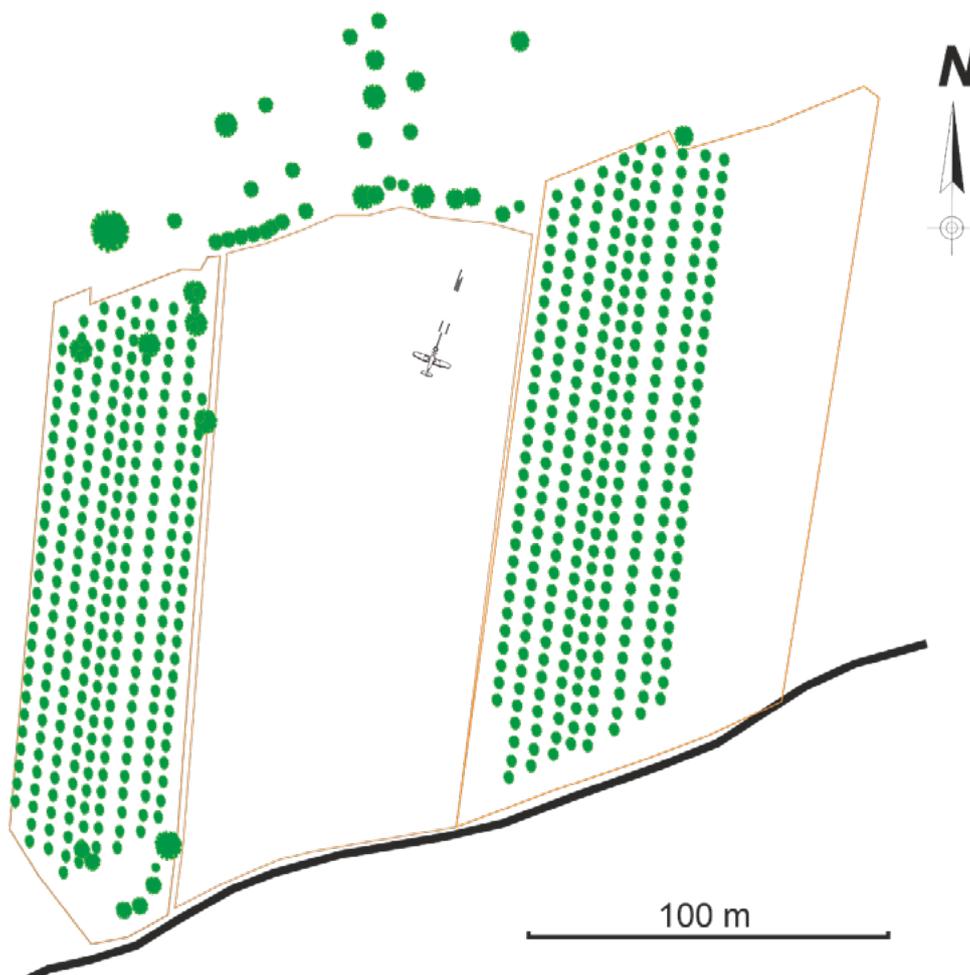
Fig. no. 2 - Sketch of the landing area

The rectangular field is approximately 175 m long and delimited at the first end (according to the direction of the landing), by a trough formed by its intersection with the negatively sloped field immediately before it, and at the far end by a country road.

The terrain was inclined in the approach direction and sufficiently compact for landing the aircraft. The trough end had irregular vegetation consisting of medium/tall bushes.

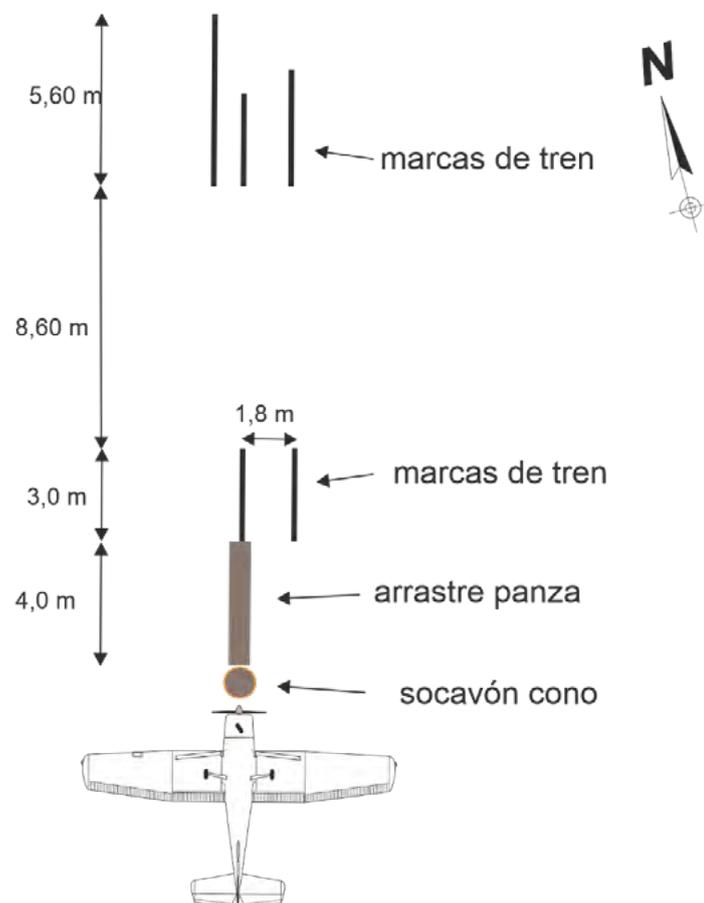
Fig. no. 3 - Detail of the track marks

Three parallel track marks could be distinguished, slightly deviated to the right with respect to the orientation of the field and with 1.7 m between the left track mark (3.80 m long) and the centre track mark (3 m long), and 0.9 m between the centre track mark and the right track mark (5.60 m long). The tracks started approximately 24 m from the start of the field (right track mark first).

At 8.6 m from the end of the first tracks, there was another set of two track marks, parallel both to each other and the previous ones, 3 m long and 1.8 m apart.

After those, there was a single wider track mark, parallel to the others and 4 m in length, which ended with a wide, shallow hollow. The aircraft was found 1 metre from the last track mark in an inverted position, with its nose pointing back towards the other track marks.

The track marks on the ground were made by the landing gear, with the right main gear leg making contact first and rolling 1.8 m before the left main gear wheel and nose leg also made contact.

Therefore, we have determined that the landing was inadequate because although the aircraft initially touched down with the main gear and dropped the nose wheel a few metres on, it then bounced back into the air (suggesting excessive speed on touchdown).

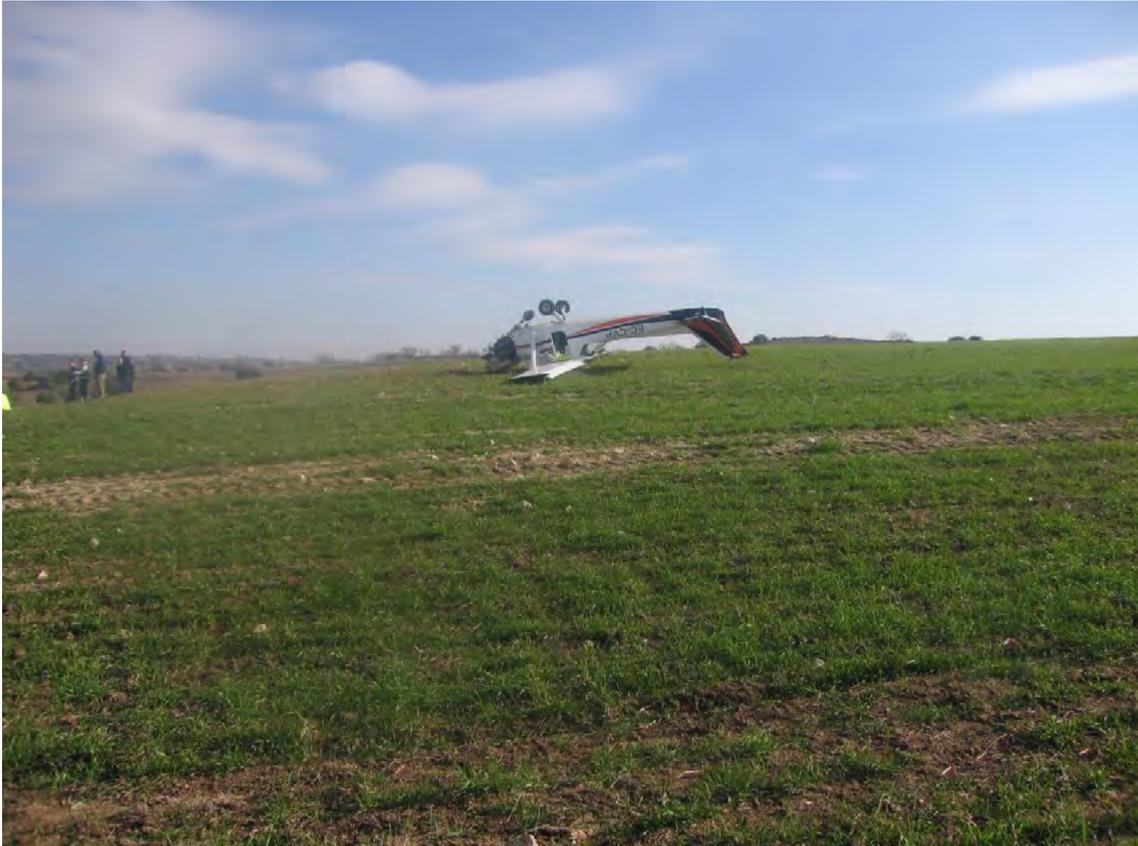
Fig. no. 4 - Aircraft in its final position

The aircraft's nose leg had broken off at the engine mount and was behind and slightly to the left. The main landing gear was undamaged, although the footboard on the left leg displayed traces of mud.

The propeller cone was intact, as were both of its blades, although one of them was bent back towards the aircraft.

The engine mount was broken at two points on the left side, where the nose leg attaches.

The tip of the right wing had a dent on its leading edge, the ailerons were moving freely, and the flap was deployed.

The tip of the rudder was deformed, and the anti-collision light had detached (although still attached by its wires) and was embedded in the ground.

The left wing had a few creases on its underside, close to where it attaches to the fuselage. The aileron was moving freely, and the flap was deployed.

The minor damages to the rudder (bent at the tip) and wings (creases on the left wing and a dent on the leading edge of the right wing) were caused by the aircraft impacting the ground.

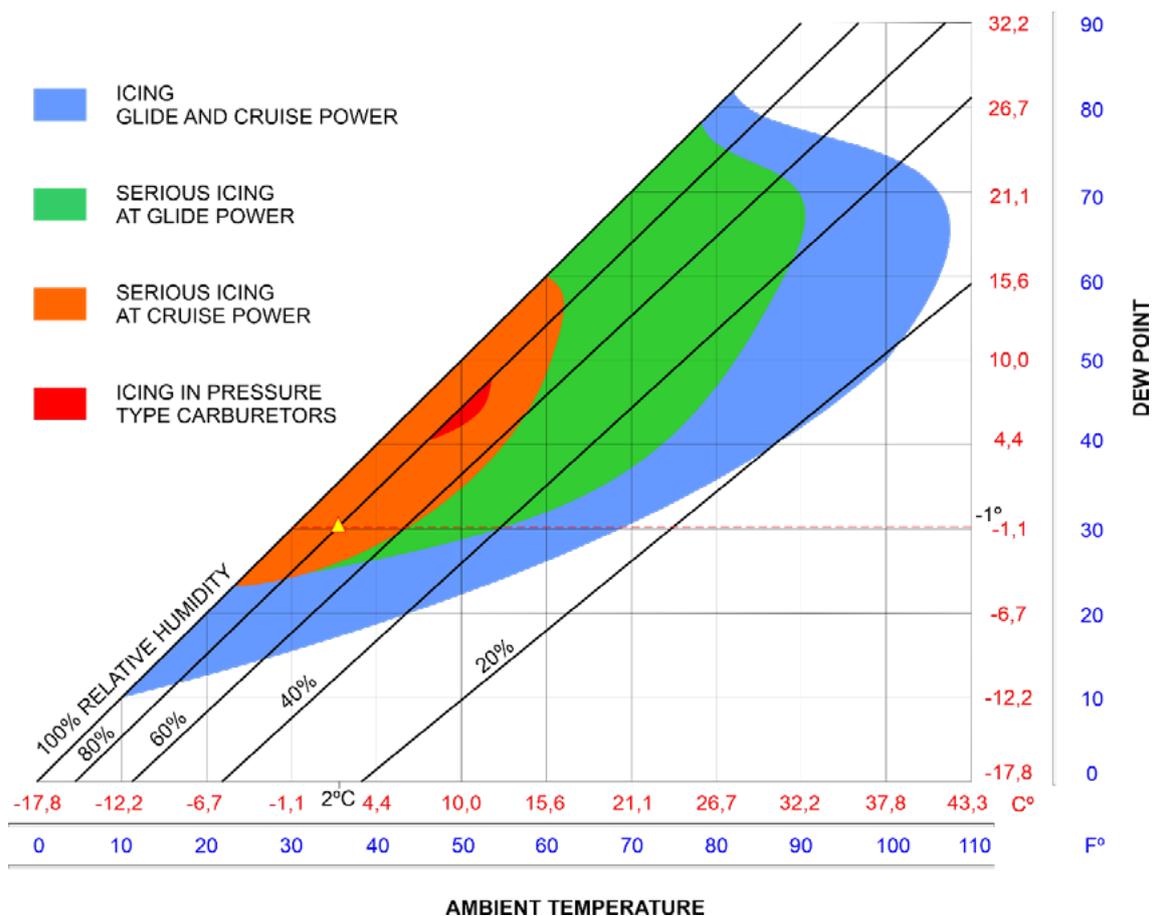
Fig. no. 5 - Table indicating the probability of the presence of ice in the carburettor

According to the meteorological data recorded in the METAR from Cuatro Vientos Airport at the time of the accident, the ambient temperature was 2°C, and the dew point was -1°C. The graph below shows that the conditions were favourable for the formation of ice on the carburettor.

We can also see that if we transfer the data from the closest meteorological stations mentioned in the AEMET report, which show temperatures of 0°C and -1°C, and relative humidity between 89% and 95%, we always end up in the 'serious icing at cruise power' zone.

The pilot may have been unaware that the weather conditions that day were conducive to ice formation, and possibly, the accident could have been avoided if he had kept the carburettor heater on throughout the cruise.
